**NORTHWEST 48<sup>TH</sup> STREET  
REDEVELOPMENT AREA  
Lincoln, Nebraska**

**BLIGHT AND SUBSTANDARD  
DETERMINATION STUDY**

**October, 2007**

**Prepared By:**  
**HANNA:KEELAN ASSOCIATES, P.C.**  
*Community Planning and Research*  
**Lincoln, Nebraska**  
[www.hannakeelan.com](http://www.hannakeelan.com)

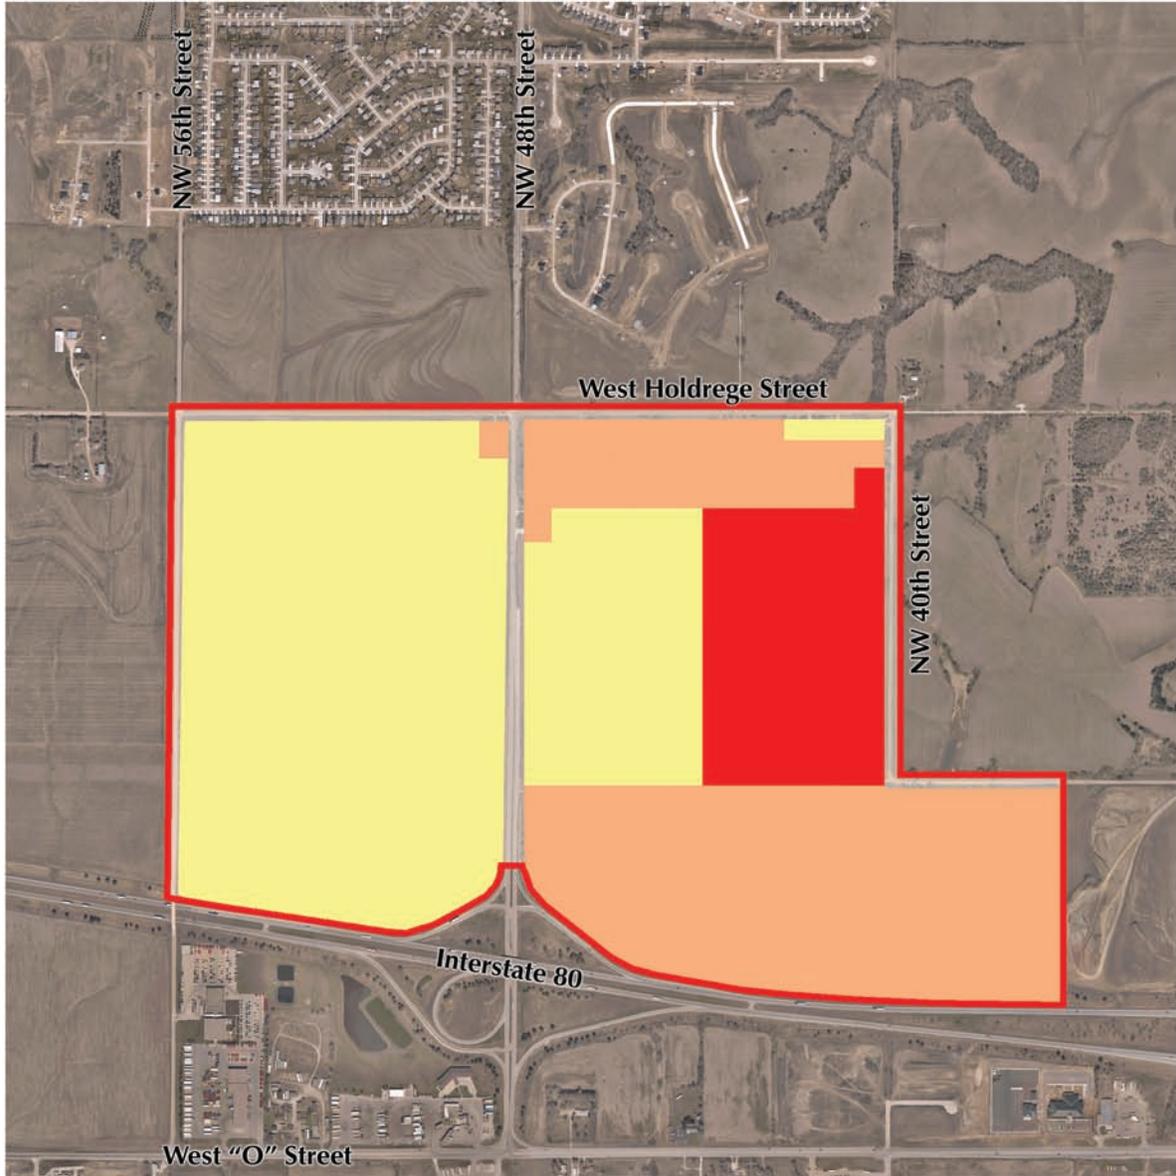
# Overall Site Conditions Map

Overall site conditions on a significant number of properties throughout the Redevelopment Area (a total of 58 percent) were generally found to be in “fair” to “poor” condition. The field survey determined that eight, or 42 percent of the total 19 parcels, are in “fair” condition, while an additional three parcels (16 percent) were determined to be in “poor” condition. This overall condition rating includes the general condition of structures and an evaluation of the land with improvements, such as sidewalks, streets, driveways, parking areas and landscaping.
