Section 4

Fluvial Geomorphic Evaluation

4.3 Geomorphic Field Reconnaissance

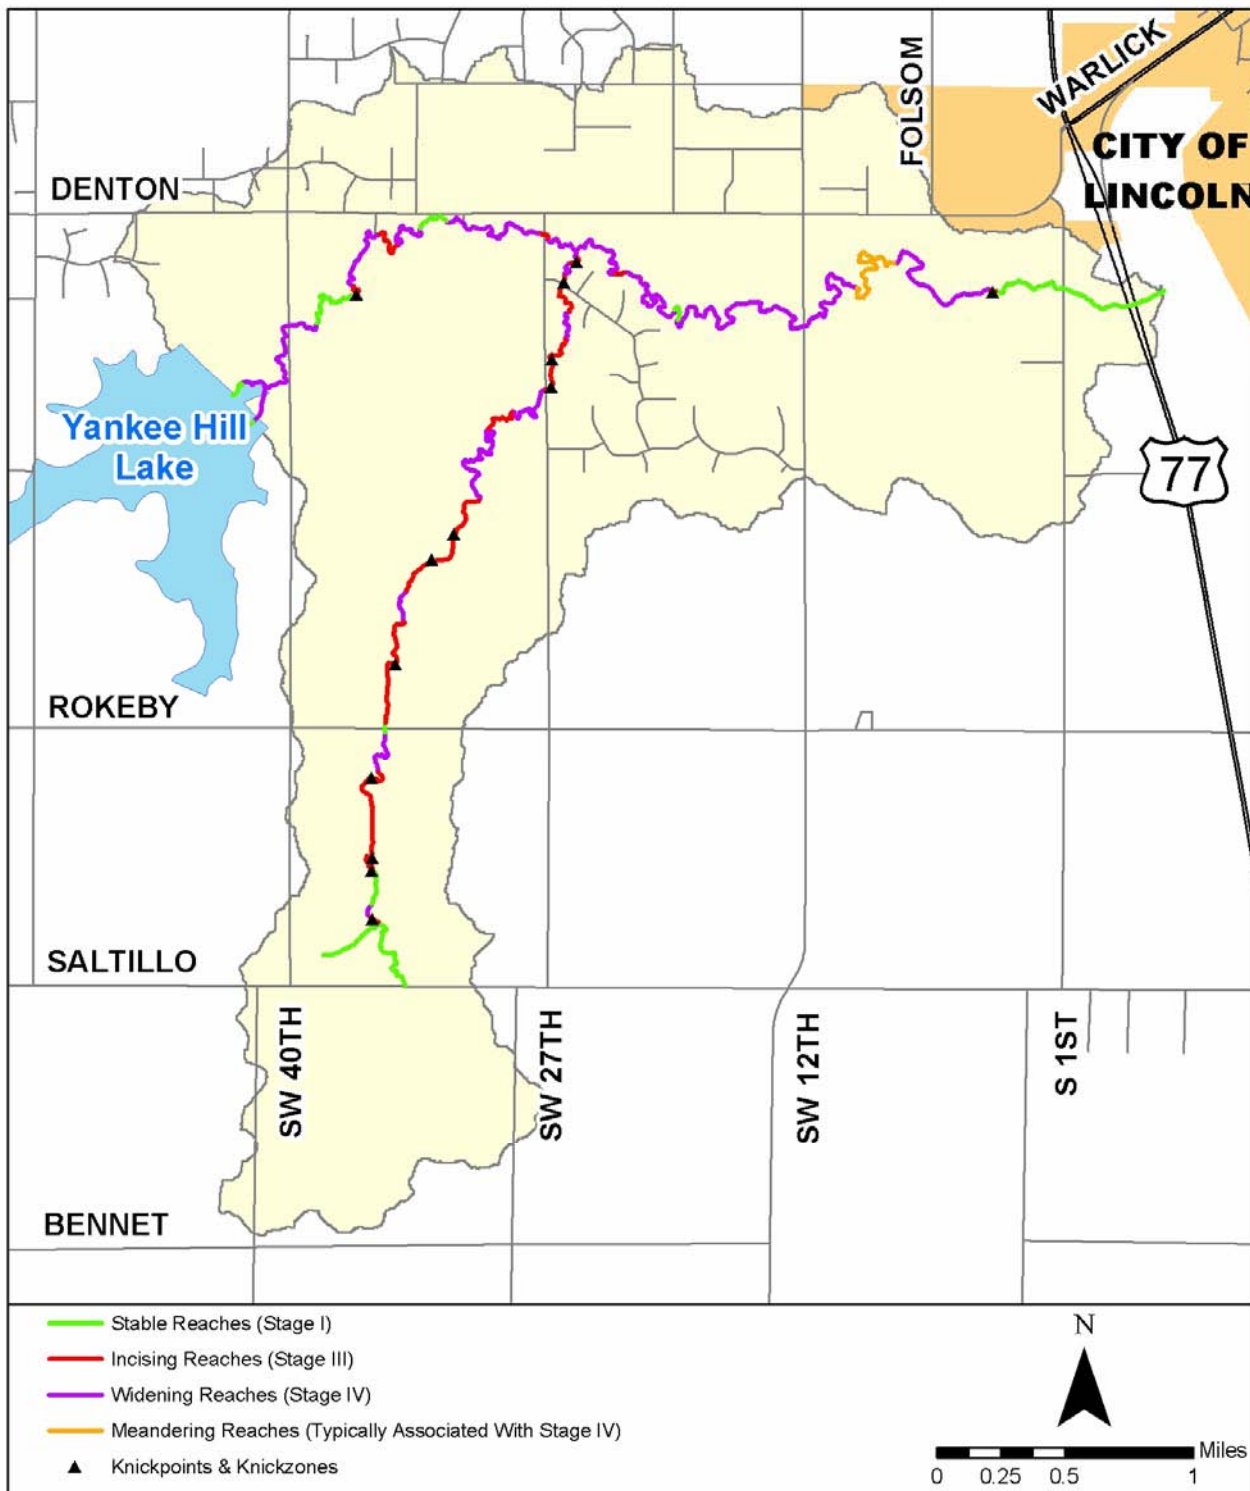
Figure 4-2
Cardwell Branch Geomorphic Processes

In general, the incising portions (Stage III) were found along the upstream portion, where active knickpoints were found at several locations. The creek progressed to widening (Stage IV) in the middle portions and widening to deposition (Stage IV to V) along the downstream portions. The presence of Stage V conditions may have been more prevalent if the primary source of sediment was coarser. The silt and clay and very fine sand of the alluvium, loess and glacial till comprising the uplands, banks, and channel bottom typically remained as washload during flood flows and thus did not deposit in bars. The mechanism of sediment transport was observed following the rainfall early on June 12, 2006. Figure 4-2 graphically illustrates the stream classification of the main stem as determined by the project team.

The stream reaches that are downcutting or incising typically contain knickpoints or knick zones that are migrating as headcuts upstream at varying rates or are temporarily abated by channel armoring. The knickpoints and zones are depicted on Figure 4-2. The stream lengths that are widening typically show more scouring along the bank toes; however, the rate of scour appears slow and for the most part the banks are not imminently endangered. The single stream length along the main stem that indicates active meandering is a location where significant scouring and mass wasting of

Based on the field reconnaissance effort, the Cardwell Branch stream reaches will continue to degrade until stream improvements are implemented. The focus of the stream improvements will be to address the channel incision which is causing instability problems throughout the study area. The knickpoints and knickzones are sites where the hydraulic slope is locally high enough to cause migrating erosion. Installing grade control structures will lower the slope below the threshold for bed erosion in this stream system. Because of the high erodibility of the streambed, it is necessary to dissipate the energy gradually over the length of the grade control structure. For this application, Newbury-style grade control structures are recommended, which provide artificial riffles along the streambed to distribute energy, while improving water quality by increasing dissolved oxygen and providing habitat. Figure 4-4 provides a typical Newbury-style grade control structure. Section 5 provides additional details on the recommended improvements to address the high priority stream stability problem areas.

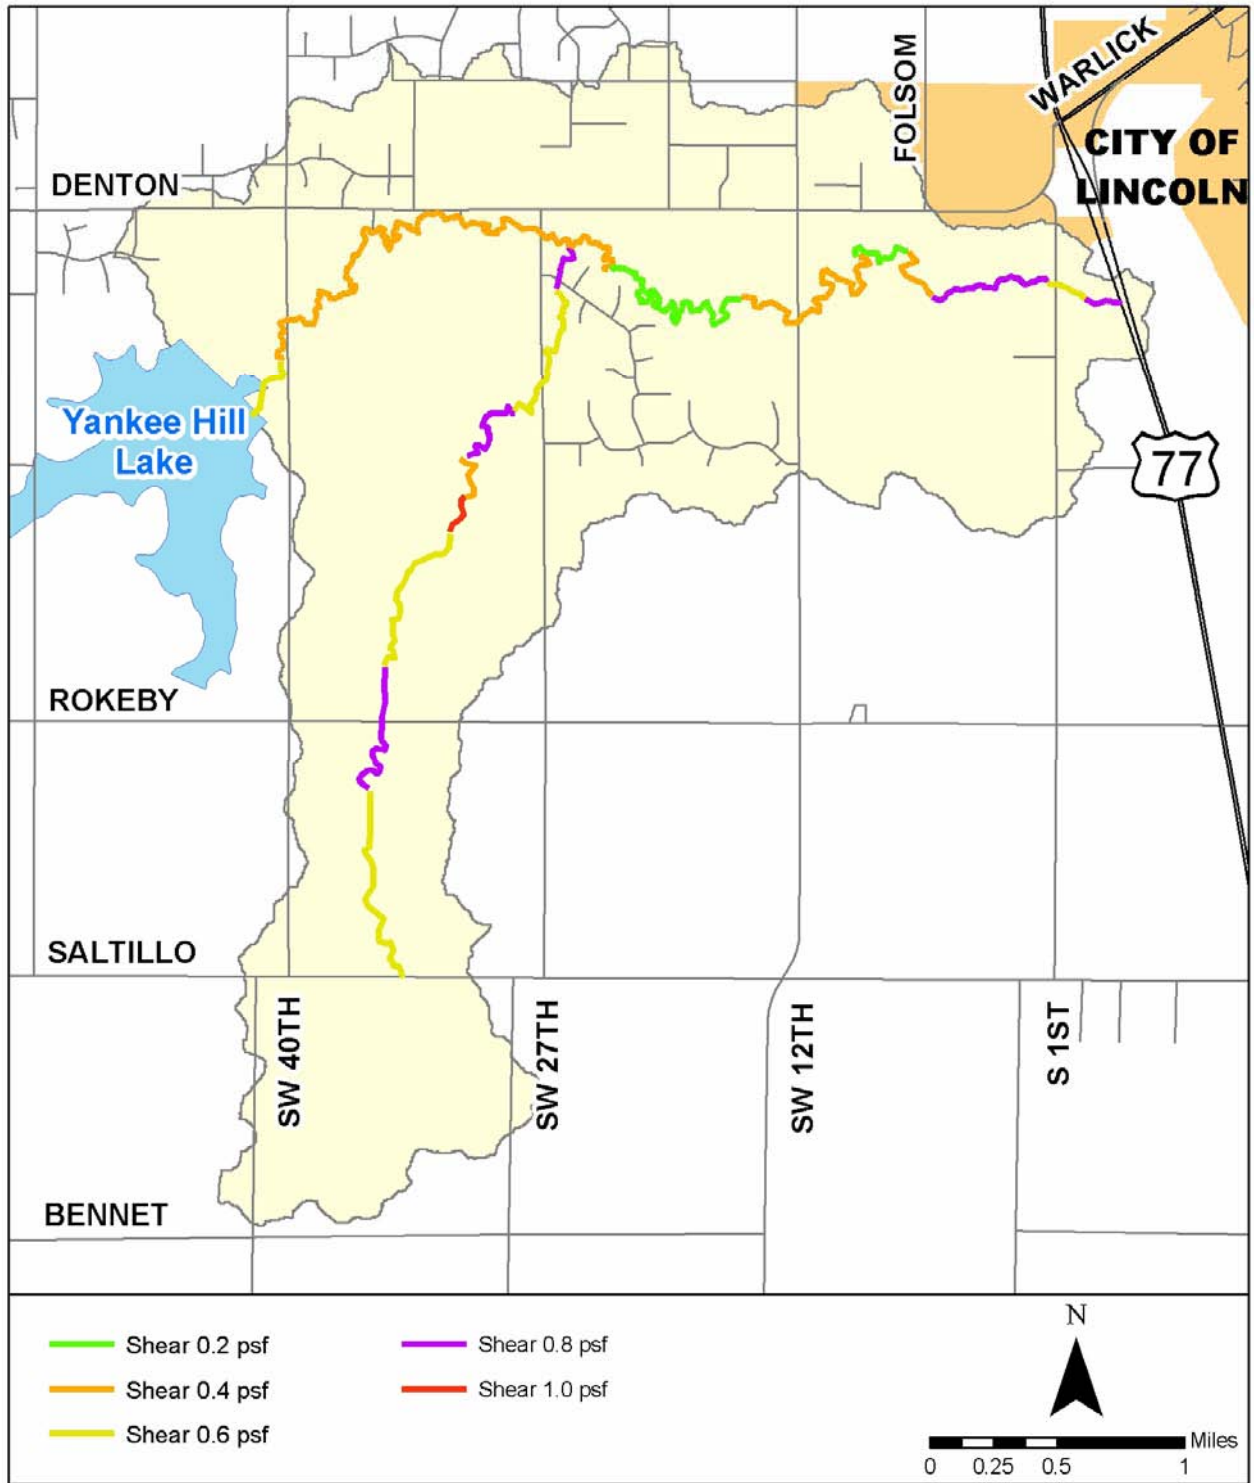
Figure 4-3
Cardwell Branch Shear Stress Values

Figure 4-3 presents the shear in the channel at the bankfull height (depth), which should be the stage of the channel-forming flow. This figure depicts shear along the channel, which was calculated using the slopes between each of the cross sections surveyed by USGS. The resulting values were then grouped in ranges of shear. As with USGS, a correlation was observed between the higher shear to higher erosion indicators, especially along the south tributary.

Specifically, calculated shears of 0.4 pounds per square foot (psf) or higher were found along the south tributary, where significant incision and widening were observed. Typically the calculated shears along the main stem were 0.2 psf or higher, where widening, more isolated incision and active re-meandering were observed. The highest shear calculated was along the south tributary between Rokeby and SW 27th Streets, which coincided with the severe incision conditions.

The direct correlation of specific shear values to specific erosion potential is not possible because of the variability of channel soils, vegetation, groundwater, and other external influences. However, shear values 0.6 psf and higher appear to correlate with longer lengths of incision found in the south tributary and shear values of approximately 0.4 psf appear to correlate with widening and shorter lengths of incision, as found along the main stem.
