Section 4

Fluvial Geomorphic Evaluation

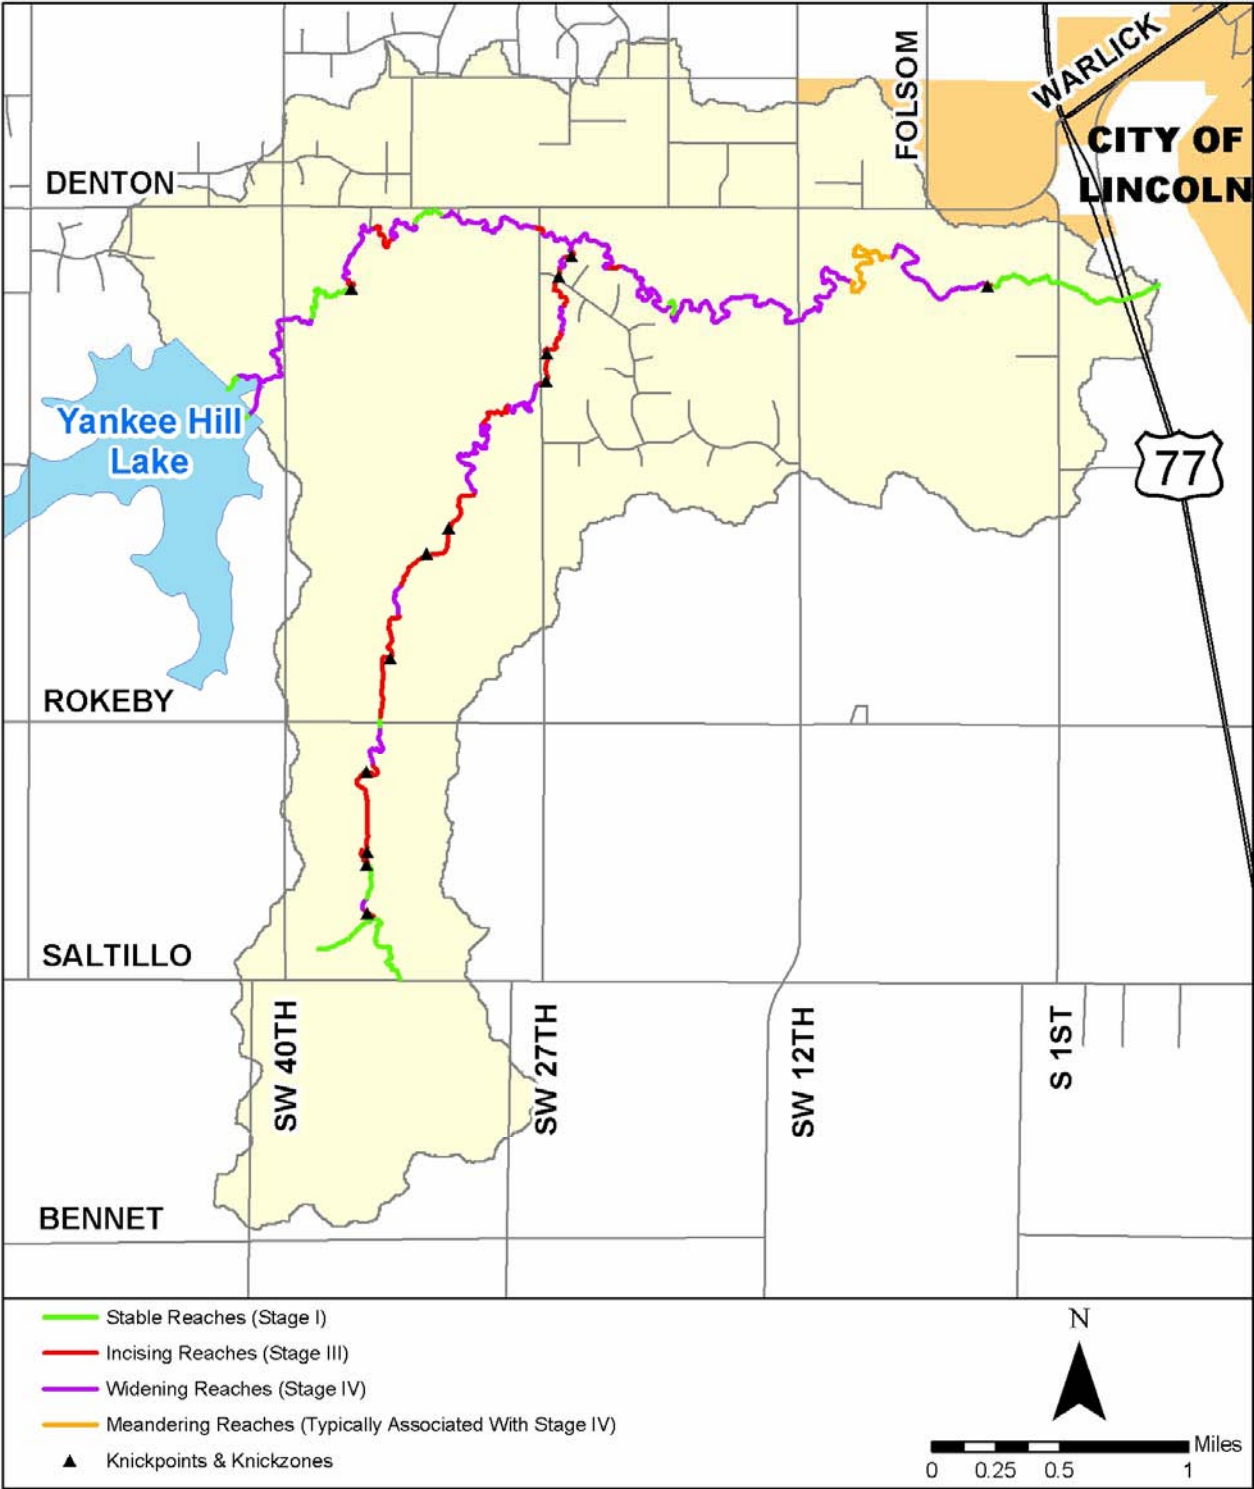
Figure 4-2
Cardwell Branch Geomorphic Processes

In general, the incising portions (Stage III) were found along the upstream portion, where active knickpoints were found at several locations. The creek progressed to widening (Stage IV) in the middle portions and widening to deposition (Stage IV to V) along the downstream portions. The presence of Stage V conditions may have been more prevalent if the primary source of sediment was coarser. The silt and clay and very fine sand of the alluvium, loess and glacial till comprising the uplands, banks, and channel bottom typically remained as washload during flood flows and thus did not deposit in bars. The mechanism of sediment transport was observed following the rainfall early on June 12, 2006. Figure 4-2 graphically illustrates the stream classification of the main stem as determined by the project team.

The stream reaches that are downcutting or incising typically contain knickpoints or knick zones that are migrating as headcuts upstream at varying rates or are temporarily abated by channel armoring. The knickpoints and zones are depicted on Figure 4-2. The stream lengths that are widening typically show more scouring along the bank toes; however, the rate of scour appears slow and for the most part the banks are not imminently endangered. The single stream length along the main stem that indicates active meandering is a location where significant scouring and mass wasting of

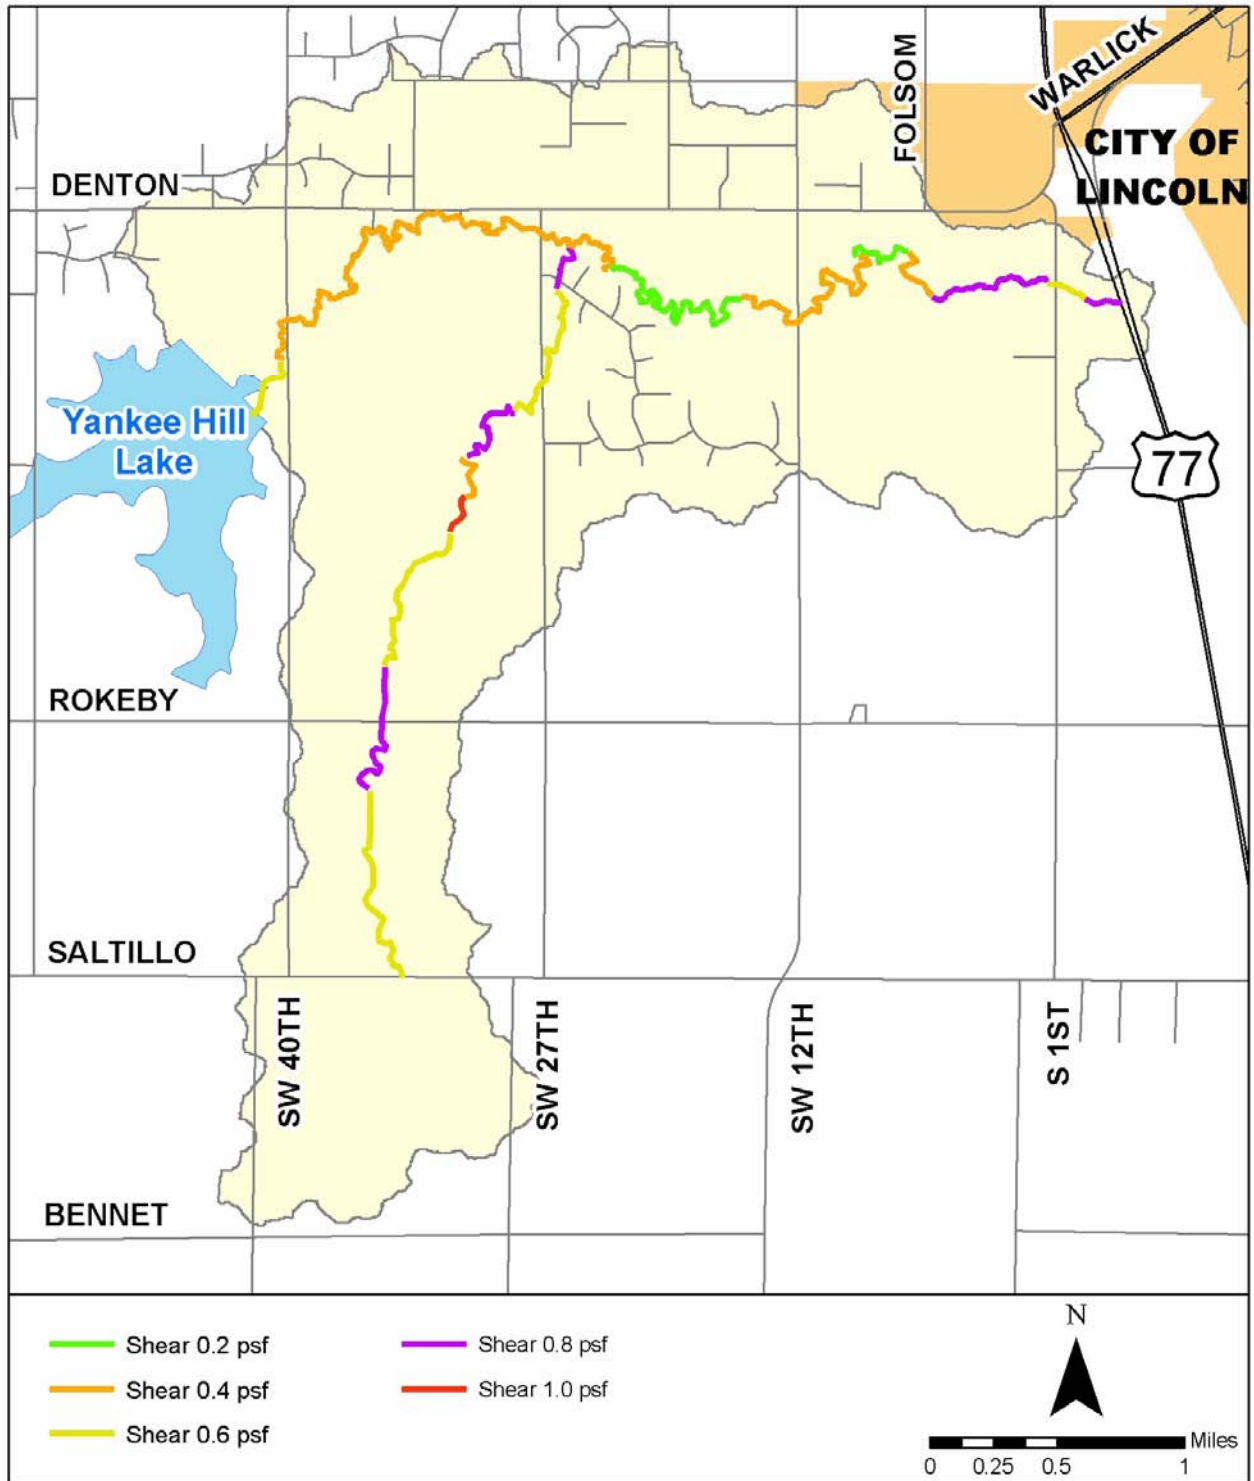
Figure 4-3
Cardwell Branch Shear Stress Values

Figure 4-3 presents the shear in the channel at the bankfull height (depth), which should be the stage of the channel-forming flow. This figure depicts shear along the channel, which was calculated using the slopes between each of the cross sections surveyed by USGS. The resulting values were then grouped in ranges of shear. As with USGS, a correlation was observed between the higher shear to higher erosion indicators, especially along the south tributary.

Specifically, calculated shears of 0.4 pounds per square foot (psf) or higher were found along the south tributary, where significant incision and widening were observed. Typically the calculated shears along the main stem were 0.2 psf or higher, where widening, more isolated incision and active re-meandering were observed. The highest shear calculated was along the south tributary between Rokeby and SW 27th Streets, which coincided with the severe incision conditions.

The direct correlation of specific shear values to specific erosion potential is not possible because of the variability of channel soils, vegetation, groundwater, and other external influences. However, shear values 0.6 psf and higher appear to correlate with longer lengths of incision found in the south tributary and shear values of approximately 0.4 psf appear to correlate with widening and shorter lengths of incision, as found along the main stem.
