Section 7

Fluvial Geomorphic Evaluation

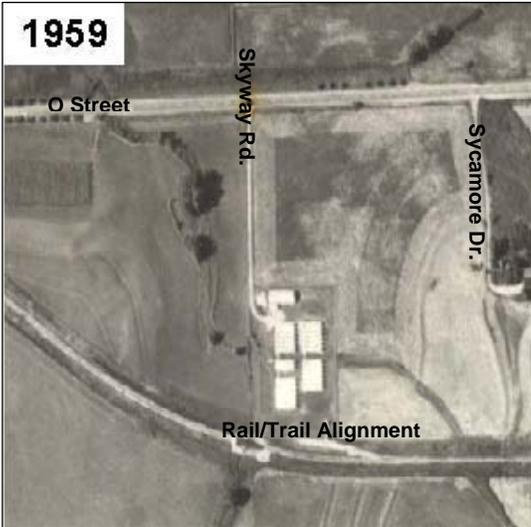
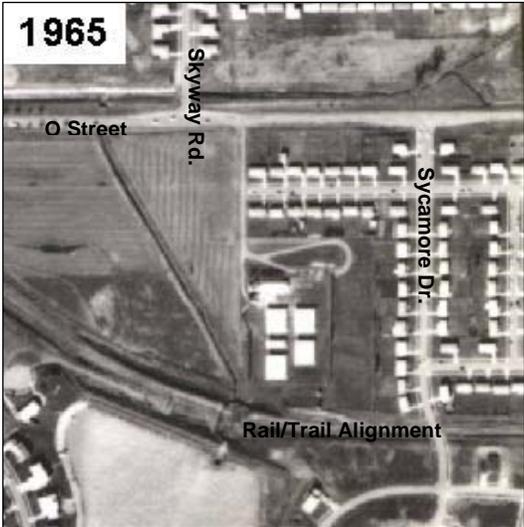
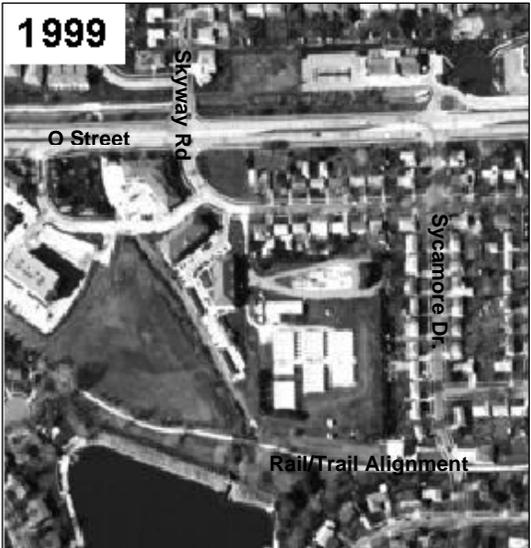
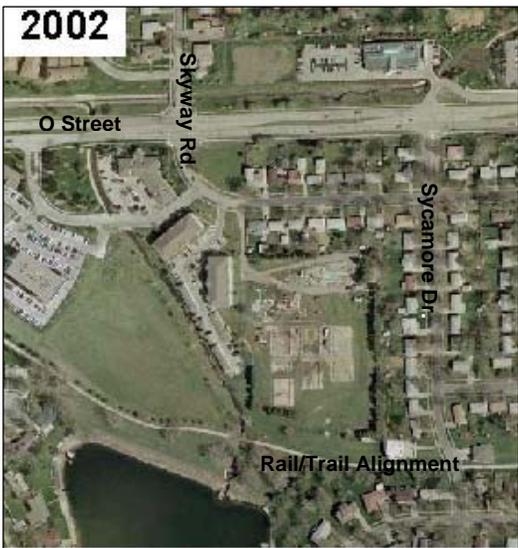
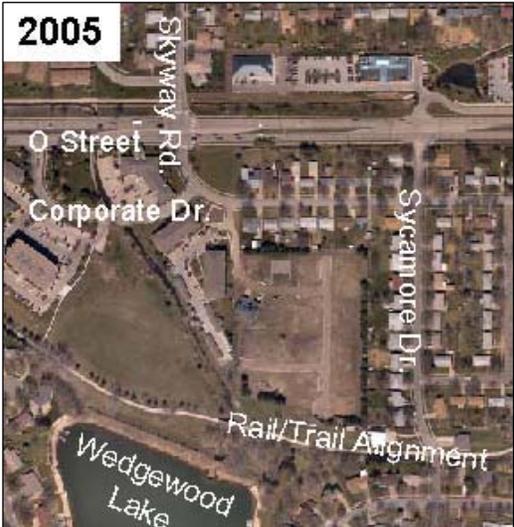
Figure 7-2
Segments 1 and 2 - Historical Photographs

Segment 1: Sycamore Drive Extension to Skyway Road: In 1959, the alignment along the north side of O Street was straight, indicating channelization with only a few isolated trees along the channel in a rural setting. The channel remained relatively unchanged through 1965 and nearby areas did not show signs of urbanization until 1999. By 1999, the Dialysis Center detention pond at the Sycamore Drive extension was present and the channel was lined with concrete upstream and downstream of this reach. Further, more trees are seen along the channel and signs of active meandering were visible along the upstream half of the channel. By 2002, many of the trees appear removed and the signs of remeandering along the channel are more pronounced, encroaching on O Street, especially along the east portion. By 2005, the channel meanders were essentially graded out of the channel and the channel is reasonably straight. The banks are essentially turf grass with isolated trees and brush as seen today.

Segment 2: Wedgewood Lake to Corporate Drive: As depicted on Figure 7-1, the main channel shows meanders in 1959 with a single row of isolated trees along the banks in a rural setting. The present day trail is a railroad alignment. By 1965, Wedgewood Lake and its dam are present and the channel has been straightened. Residential development is beginning to appear at a distance away from the main channel.

The railroad alignment was changed to a pedestrian/biking trail by 1999. Residential and commercial developments have fully encroached around the channel to the east and plans have recently been submitted to the City for development on the west (left descending) bank.

The channel shows some deviation along its straight alignment seen in 1965, but the overall alignment is straight. A scour pool, as seen today, is downstream of the spillway. Field investigations revealed current conditions are similar to the 1999 photograph.

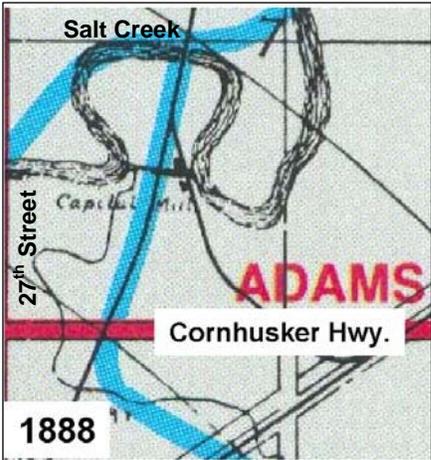
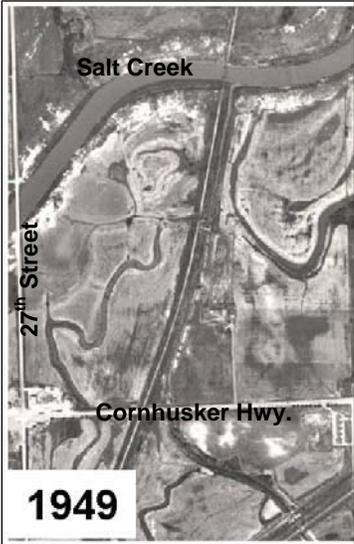
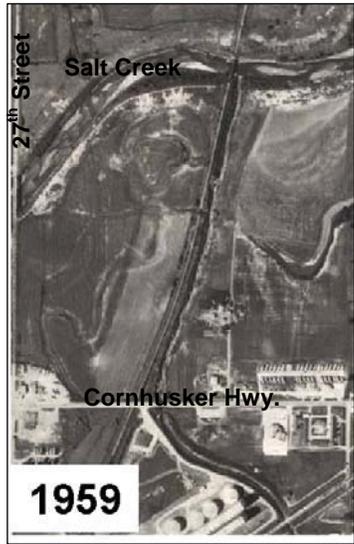
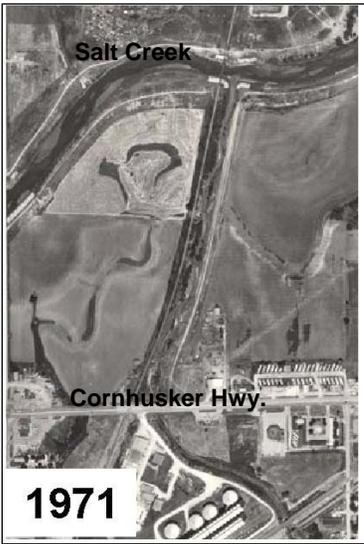
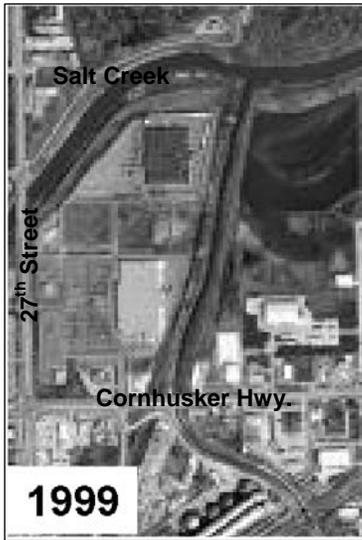
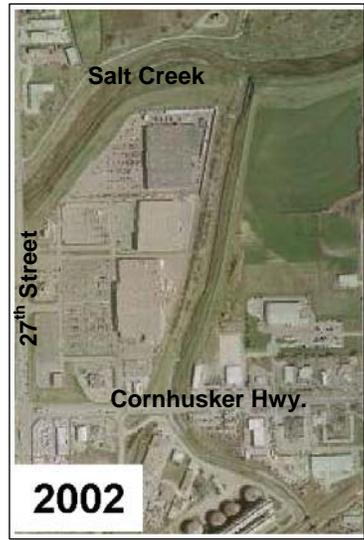
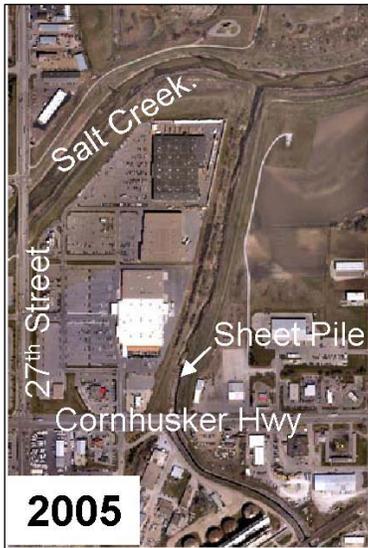
Figure 7-3
Segment 3 - Historical Photographs

Segment 3: Cornhusker Highway to Salt Creek Confluence Main Stem: Since 1888, the Deadmans Run and Salt Creek channels have been straightened and shortened. Deadmans Run, downstream of Cornhusker Highway, was shortened by approximately 15 percent (Figure 7-2). More importantly, the channel was straightened. Scroll marks, seen in the aerial photographs dating to 1949, indicate meandering radii for Deadmans Run in the order of 75 to 150 feet. As seen in 1949, the railroad had been aligned along the west side of the channel. Land use around the channel was rural. In 1971, the channel exhibited some meandering, but by 1999 the channel was again straightened. Between 1971 and 1999, the channel upstream was lined with concrete and the sheet pile wall was placed at the upstream end of the study reach. By 1999, the railroad was gone and commercial development encroached the channel along the west side and near the channel along the east upstream half. Further, by 1999, bank erosion is evident along the 650 feet of the upstream portion of the left bank, and becomes prominent by 2002, and even more prominent through 2005. It was not until 2005 that the erosion downstream of the storm sewer acting as a flow vane appeared. In 2007, corrective action is planned by the City's Wastewater Division to mitigate the erosion at the flow vane, as well as upstream of the area. Sheet pile walls are planned to be constructed in two sections to armor the low flow banks on each side of the stream with the intention of avoiding additional erosion in the area.

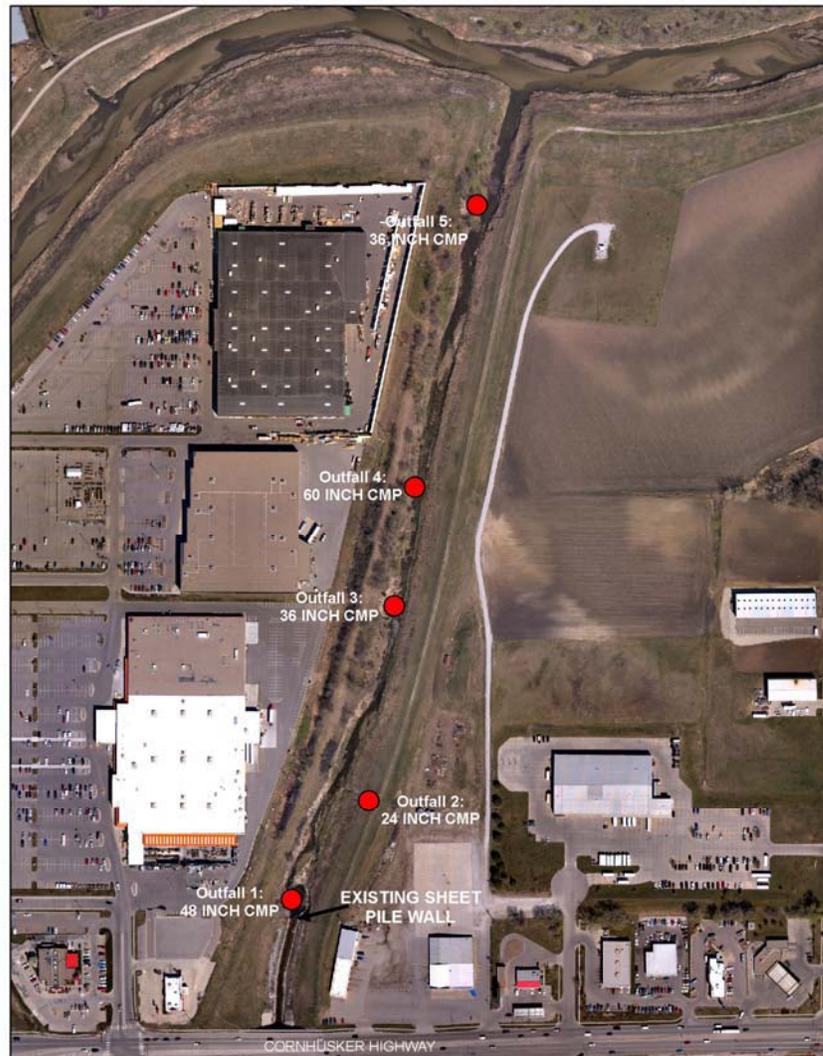
Figure 7-5
Segment 3 - Existing Outfalls

Segment 3: Cornhusker Highway to Salt Creek Confluence: The sheet pile wall located near the Cornhusker Highway crossing and at the end of the lined trapezoidal channel remains an effective grade control, abating migration of the headcut upstream. The scour pool downstream of the sheet pile wall appears to have sized itself accordingly to the drop and flow from the sheet pile wall. Immediately downstream of the sheet pile wall is a 48-inch corrugated metal pipe (CMP) along the left descending bank, labeled Outfall 1 in Figure 7-5. The flow during rainfall events from this outfall appears to direct the flow of the main stem over to the right descending bank, resulting in localized scour along this bank. This directing of flow also appears to set up the meandering front, such that the left descending bank shows erosion downstream.

The erosion continues along the left descending bank for approximately half the distance between the sheet pile wall and the confluence with Salt Creek. The right descending bank may not show as much scour because it was regraded. The creek is undergoing active re-meandering from Outfall 1 and Outfall 3. Outfall 3 is a destroyed 36-inch CMP along the left descending bank, approximately 1,000 feet downstream of Cornhusker Highway.

When Outfall 3 was installed, the outside bend of the meander was likely along the right descending bank. During higher flows, which overtopped the CMP outlet frame, the bank behind the frame scoured, exposing the fine glacial outwash sand that underlies the loess. The overtopped pipe became a flow vane, directing the flow perpendicular to the pipe alignment. Water flows over the pipe until the sand is eroded under the pipe and the undermined pipe collapses. This sequence is repeated along the inclined pipe and the erosion migrates to the left bank.

Between Outfall 3 and Outfall 6, localized bank degradation is observed, where the flows have acted as turning vanes. Sedimentation through bar deposition is prevalent along the entire unlined portion of this reach. The bars within the re-meandering segment are irregular, which would be expected. Downstream of Outfall 6, the bars become somewhat more regular-shaped. Closer to the confluence with Salt Creek, submerged ripples and megaripples of sand along the channel bottom are prevalent. Using Simon's Classification for urban channel evolution, this reach is classified as Stage IV/V.

For Segment 3, current conditions are endangering utility and building infrastructure along the left (west) bank, requiring stream improvements focused at abating the extensive active meandering. To assist the creek in its attempt to reach dynamic equilibrium, the following is recommended:

- Remeandering the entire reach with a two-stage channel that will also facilitate flood conveyance
- Reconfiguring the left descending bank and right descending bank
- Raising the channel bed downstream of the sheet pile wall with grade controls

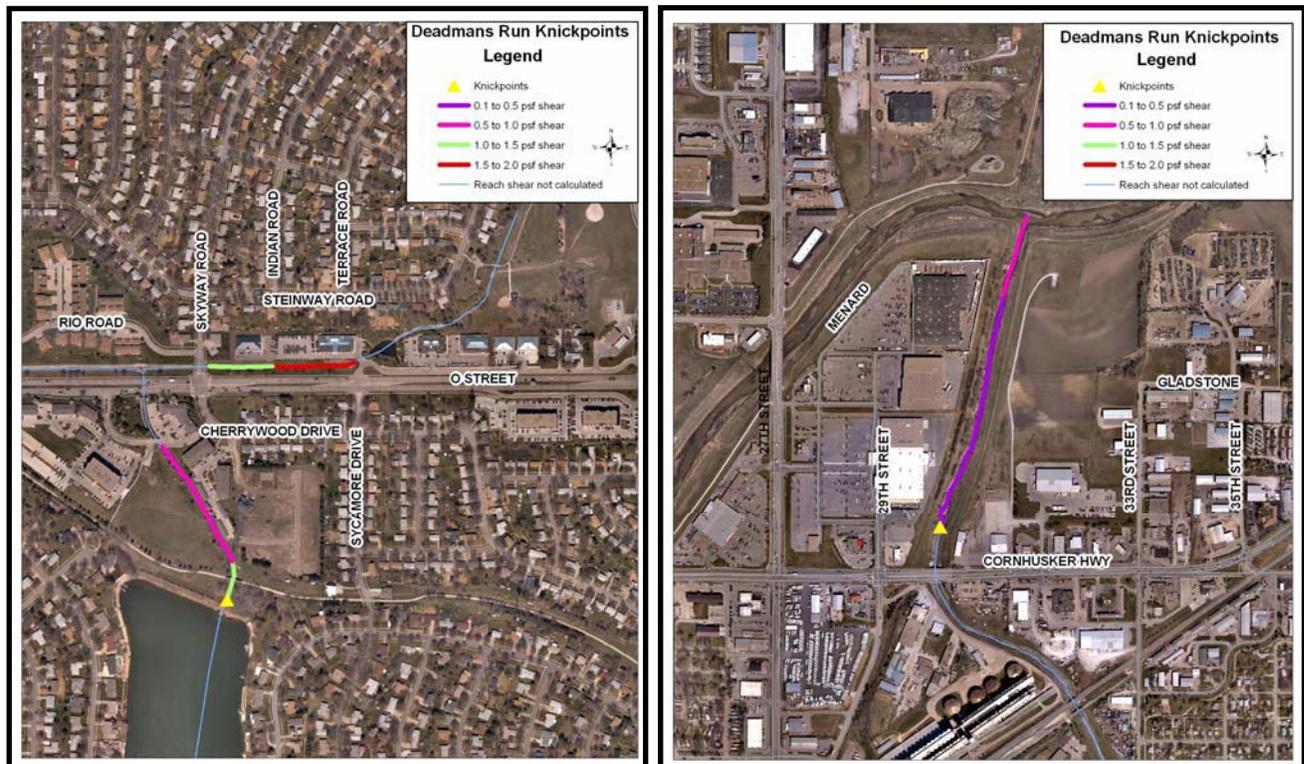
Figure 7-6
Deadmans Run Knickpoints

Segments 1 and 2 appear reasonably stable. The knickpoint downstream of the Wedgewood Lake's spillway (Figure 7-6) appears abated by the armoring in the channel. Segment 3 is undergoing a combination of widening and remeandering with mobile bar deposition. The knickpoint and zones in this area are depicted on Figure 7-6.

Figure 7-6 also presents the shear in the channel at the bankfull height (depth), which should be the stage of the channel-forming flow. These figures depict shear along the channel, which was calculated using the slopes from topographic contours provided by the City. Although Segments 1 and 2 are reasonably stable, higher shear values were calculated in these areas ranging from 0.9 to 1.7 pounds per square foot (lb/ft²). This is an indication that these reaches show a significant potential for erosion should the flows scour under the shallow-rooted and stressed bank vegetation or if current channel armoring such as the 6- to 8-inch diameter rocks are removed. This mechanism of scour became evident in the 2002 aerial photograph of the upstream reaches. Although the shear values (0.3 to 0.6 lb/ft²) in Segment 3 are less than those of the upstream reaches, the threshold shear of the silty/sandy bank

material (shear less than 0.1 lb/ft²) is less than the calculated shear. Thus, when scour is concentrated around structures such as the culvert outfalls, the underlying bank material provides little resistance to erosion under the back cover.

Segment 1 appears reasonably stable at this time; however, enhancements to the stability of the channel can be achieved by planting deeper-rooted woody and mesic prairie vegetation along the banks and placing several grade controls to maintain the channel slope. For Segment 2, establishing a wider vegetative buffer downstream of the pedestrian bridge will provide stormwater quality filtering. Each reach is encountering localized issues that should be addressed during routine maintenance activities. The severities of these issues are not critical and do not warrant inclusion in the recommended Master Plan improvement projects.
