Section 7

Capital Improvement Projects

7.4.1 Project HB-1: Grade Control Main Stem HBR005 at S Folsom St and Pipe Outfall Restoration along Bison Trail at Homestead

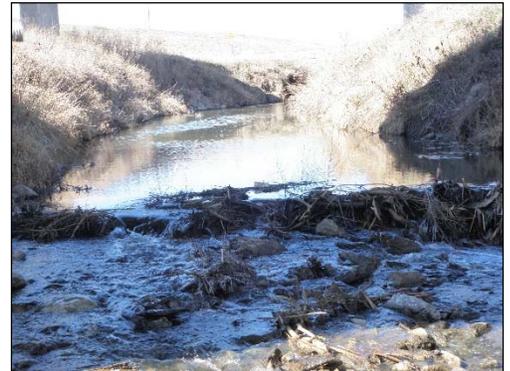
Figure 7-5: Debris jam knickpoint

Problem description: Two knickpoints are located on the main stem HBR005 at the S Folsom St Bridge, one under the bridge, and one approximately 110 feet upstream of the bridge. Each knickpoint is creating approximately a 6 inch to 1 foot drop in the channel. Also, scour and erosion is occurring at multiple pipe outfall locations along Bison Trail at Homestead Expressway. Potentially affected parcels are public and within state right-of-way. Close coordination between the City of Lincoln (City), the Lower Platte South Natural Resources District (LPSNRD) and the Nebraska Department of Roads (NDOR) will be required for the completion of this project.

Recommendation: Construct an engineered grade control immediately downstream of S Folsom St to halt the propagation of knickpoints upstream. Install scour protection at each pipe outfall to eliminate erosion and protect the pipe outfall and stream bank.

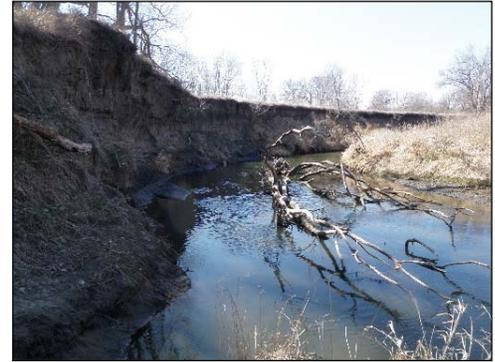
Figure 7-7: High Bank from erosion

Problem description: Bank erosion along main stem HBR005 is threatening W Van Dorn St about 1,050 feet southwest of the intersection of W Van Dorn St and S Folsom St. Potentially affected parcels are public and within the State right-of-way. Close coordination between the City, LPSNRD and NDOR will be required for the completion of this project.

Recommendation: Constructing bank stabilization along the left descending bank with associated grade controls as needed to protect W Van Dorn St.

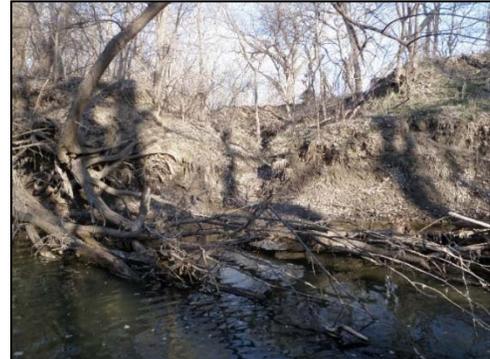
Figure 7-9– Knickpoint at tributary

Problem description: There is a tall knickpoint in tributary HB015R005 at the confluence with the main stem. The main stem flowline is several feet below the tributary on the right descending bank west of W Calvert St and SW 16th St. Upstream of the knickpoint, the tributary is showing early signs of incision. Potentially affected parcels are public. Close coordination between the City, County, LPSNRD and NDOR will be required for the completion of this project.

Recommendation: Construct grade control at tributary confluence to halt incision and protect the upstream reach. This project could be combined with a bridge or culvert at W Calvert St.

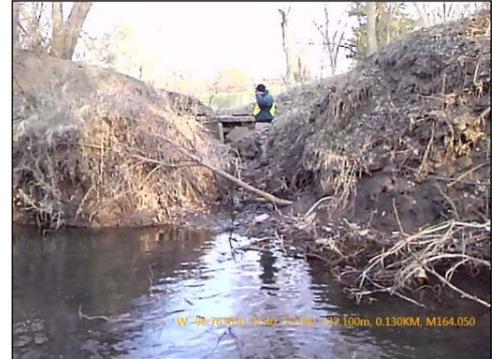
Figure 7-11: Knickpoint

Problem description: At this location there is an existing knickpoint in tributary HB0040R005 at the confluence with the main stem within Pioneers Park. The knickpoint is stabilized by an existing rubble grade control that is actively failing. This project will protect the pedestrian trail from channel erosion. When entering South Pioneers Park from S Coddington Ave, take the left at the first “Y” in the road. The access will be located directly before the next “Y” in the road. Project will be located on the left side of the road near the RR tracks. Potentially affected parcels are public property.

Recommendation: Remove existing failing grade control and construct one or more new grade controls to stop incision and protect the tributary and park.

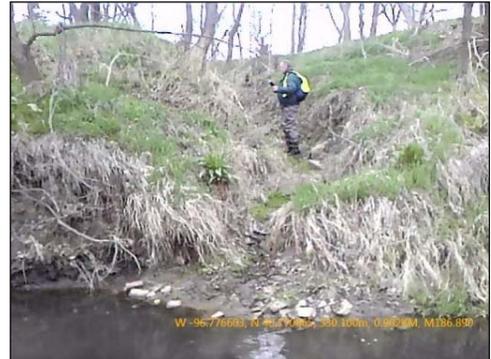
Figure 7-13: Knickpoint

Problem description: Knickpoints and erosion in tributary HB045R005 from the main stem to the outfall at the fence line on the southwest side of the Nature Center is potentially threatening the outfall. Access for this project is through the Nature Center from the southwest corner of the Pioneer Park Golf Course. Potentially affected parcels are public property.

Recommendation: Construct multiple grade controls and associated bank stabilizations to stabilize the tributary and stop incision.

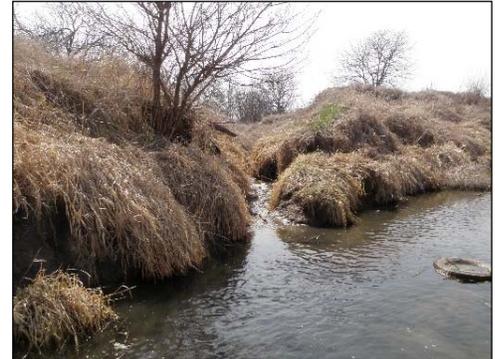
Figure 7-15: Knickpoint

Problem description: Knickpoint in the tributary HB055R005 near its confluence with Haines approximately 400 feet downstream of SW 56th St. The access is approximately 0.2 miles north of the SW 56th St and W Claire Ave intersection. Potentially affected parcels are private property.

Recommendation: Construct grade controls to stabilize tributary and stop incision.

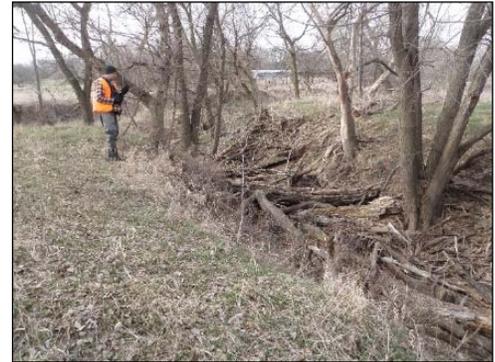
Figure 7-17: Knickpoint

Problem description: A large woody debris jam is holding up a greater than five foot tall knickpoint at the tributary HB070R005 confluence located approximately 1,500 feet south of W Pioneers Blvd. Potentially affected parcels are private property. Potential access may follow along an existing driveway and will cross two railroad lines.

Recommendation: Remove debris jam and replace with grade control and associated bank stabilization to stop incision.

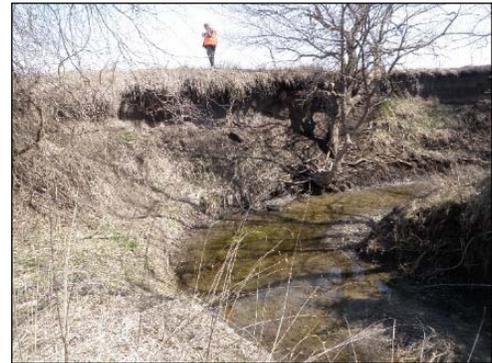
Figure 7-19: Knickpoint

Problem description: Bank erosion on tributary HB080R005 is threatening W Pioneers Blvd located approximately 1,520 feet east of SW 84th St and W Pioneers Blvd. Potentially affected parcels are both public and private property.

Recommendation: Construct bank stabilization with associated grade controls to stop erosion and protect the road. Include culvert outfall protection for the storm outfall on the right descending bank.

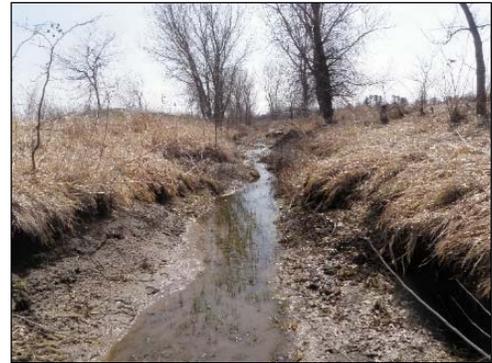
Figure 7-21: Incising Channel

Problem description: Multiple knickzones and active incision exists along a 1,700 foot section of tributary HB080R010 located east of SW 84th St and north of W Pioneers Blvd. Potentially affected parcels are private property.

Recommendation: Construct multiple grade controls along this reach to stop incision. There is approximately 14 feet of vertical drop in the profile elevation from the upstream to the downstream limit of this reach.

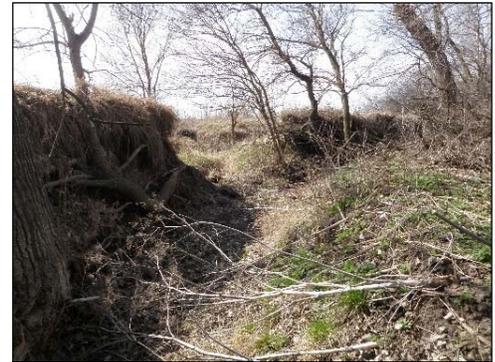
Figure 7-23: 4 Foot Knickzone

Problem description: 4 foot knickzone on the tributary HB035R040 immediately upstream of the W Denton Rd culvert (County Structure N-129) located 250 feet east of SW 60th St. potentially affected parcels are private property.

Recommendation: Construct a series of grade controls and associated bank stabilization to stop incision.

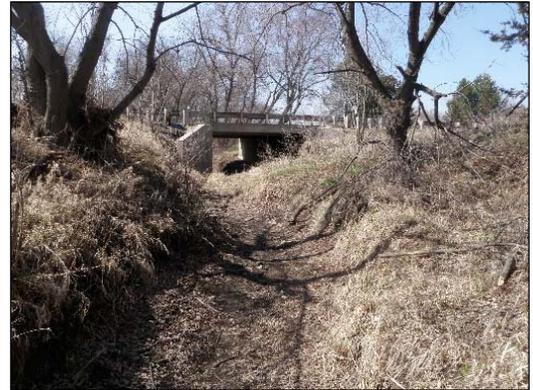
Figure 7-26: SW 84th St Bridge over Channel

Problem description: Accumulation of sediment and narrowing of the channel on tributary HB080R010 immediately downstream of the SW 84th St culvert indicates irregularities in sediment transport that may become a problem in the future.

Recommendation: Monitor this location for potential problems to include in future CIP planning.

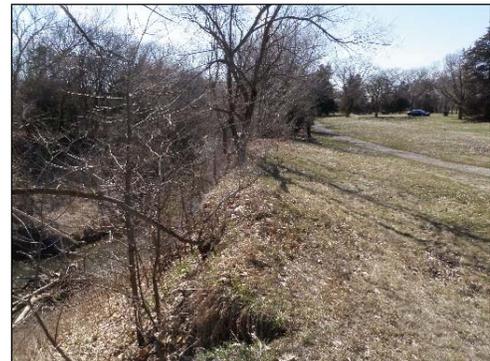
Figure 7-28: Trail by Bank

Problem description: An existing park trail is located near the top of the left descending bank of the Haines Branch main stem HBR035. Bank erosion is evident in this area and could potentially threaten the trail.

Recommendation: Monitor the progression of bank erosion at this location and plan to potentially relocate this section of trail in response to erosion.

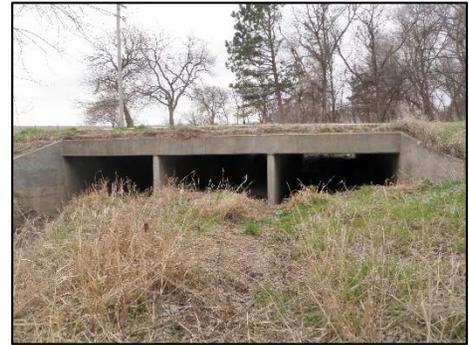
Figure 7-30: W Claire Ave Culvert (O125)

Problem description: Hydraulic analysis based on available hydrologic and as-built data, indicates that roadway overtopping will occur at the W Claire Ave culvert (O125) on reach HB035R015 during a 100-year flow event. Roadway overtopping at this location could be eliminated if the culvert capacity is increased. The channel capacity at this location is sufficient to convey flood flow without overtopping the roadway.

Recommendation: Conduct further evaluation of the culvert crossing to augment prioritization for culvert replacement. Include consideration of designing a two stage culvert at this location to accommodate the channel dominant discharge as well as flood flows.

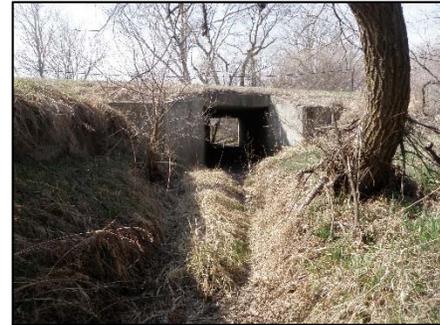
Figure 7-32: W Denton Rd Culvert (N129)

Problem description: Hydraulic analysis based on available hydrologic and as-built data, indicates that roadway overtopping will occur at the W Denton Rd culvert (N129) on reach HB035R035 during a 100-year flow event. Roadway overtopping at this location could be eliminated if the culvert capacity is increased. The channel capacity at this location is sufficient to convey flood flow without overtopping the roadway.

Recommendation: Conduct further evaluation of the culvert crossing to augment prioritization for culvert replacement.

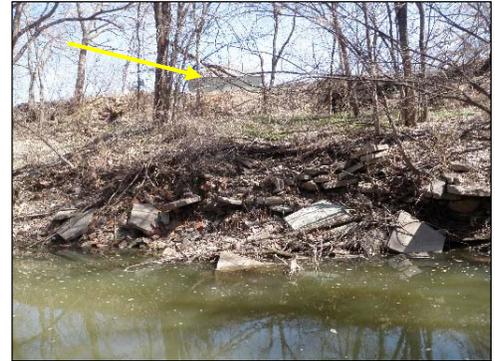
Figure 7-41: Structure on top of bank

Problem description: Eroding high bank on Haines Branch main steam HBR020 is threatening private outbuilding structure at the top of bank located 440 feet northeast of the intersection of S Coddington Ave and W Burnham St.

Recommendation: Notify the owner of the threat of bank erosion to the structure.
