Section 5

Geomorphic Evaluation

The purpose of the Haines Branch geomorphic investigation is to determine the basic geomorphic conditions of the main stem and selected tributaries. Understanding the geomorphic conditions of these streams will help determine the locations and prioritizations of interventions for managing the main stem and tributaries. Following is a brief overview of geomorphic principles with an emphasis on their application to stream and watershed management.

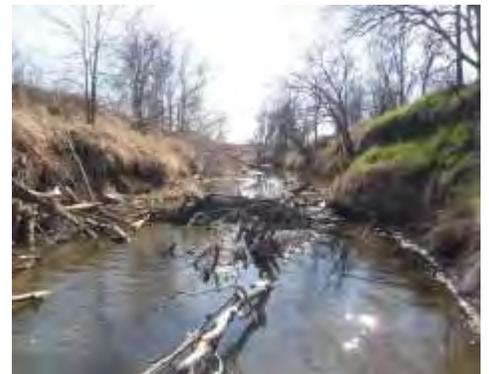
The major drivers of the poor channel scores were bank cutting, mass wasting, bar development and bed material. Bank cutting was observed as significant and frequent cutting to almost continuous cut banks. Mass wasting was also observed to be frequent and extensive on the main stem and lower tributary reaches. The poor bar development and bed material scores indicate that channel instability is ongoing and normal bar patterns are not forming. The bed material is not suitable to resist erosion and self-armor in a stable riffle pool sequence. High banks (over 12 feet tall) with steep bank slopes, overhanging vegetation with extensive root exposure were common throughout the main stem and lower tributaries. These conditions were repeatedly observed throughout the channels walked as illustrated in Figure 5-3.

Photo - Haines Branch Main Stem Mass Wasting

Grade controlling the channel will arrest the downward migration of the channel bed and will allow the reaches to adjust to a stable planform. Grade controls are recommended at existing knickpoints and at locations where projects are necessary to protect infrastructure from the channel erosion. Bank stabilization is recommended in conjunction with grade controls at locations where mass wasting and plan form adjustment are threatening infrastructure.

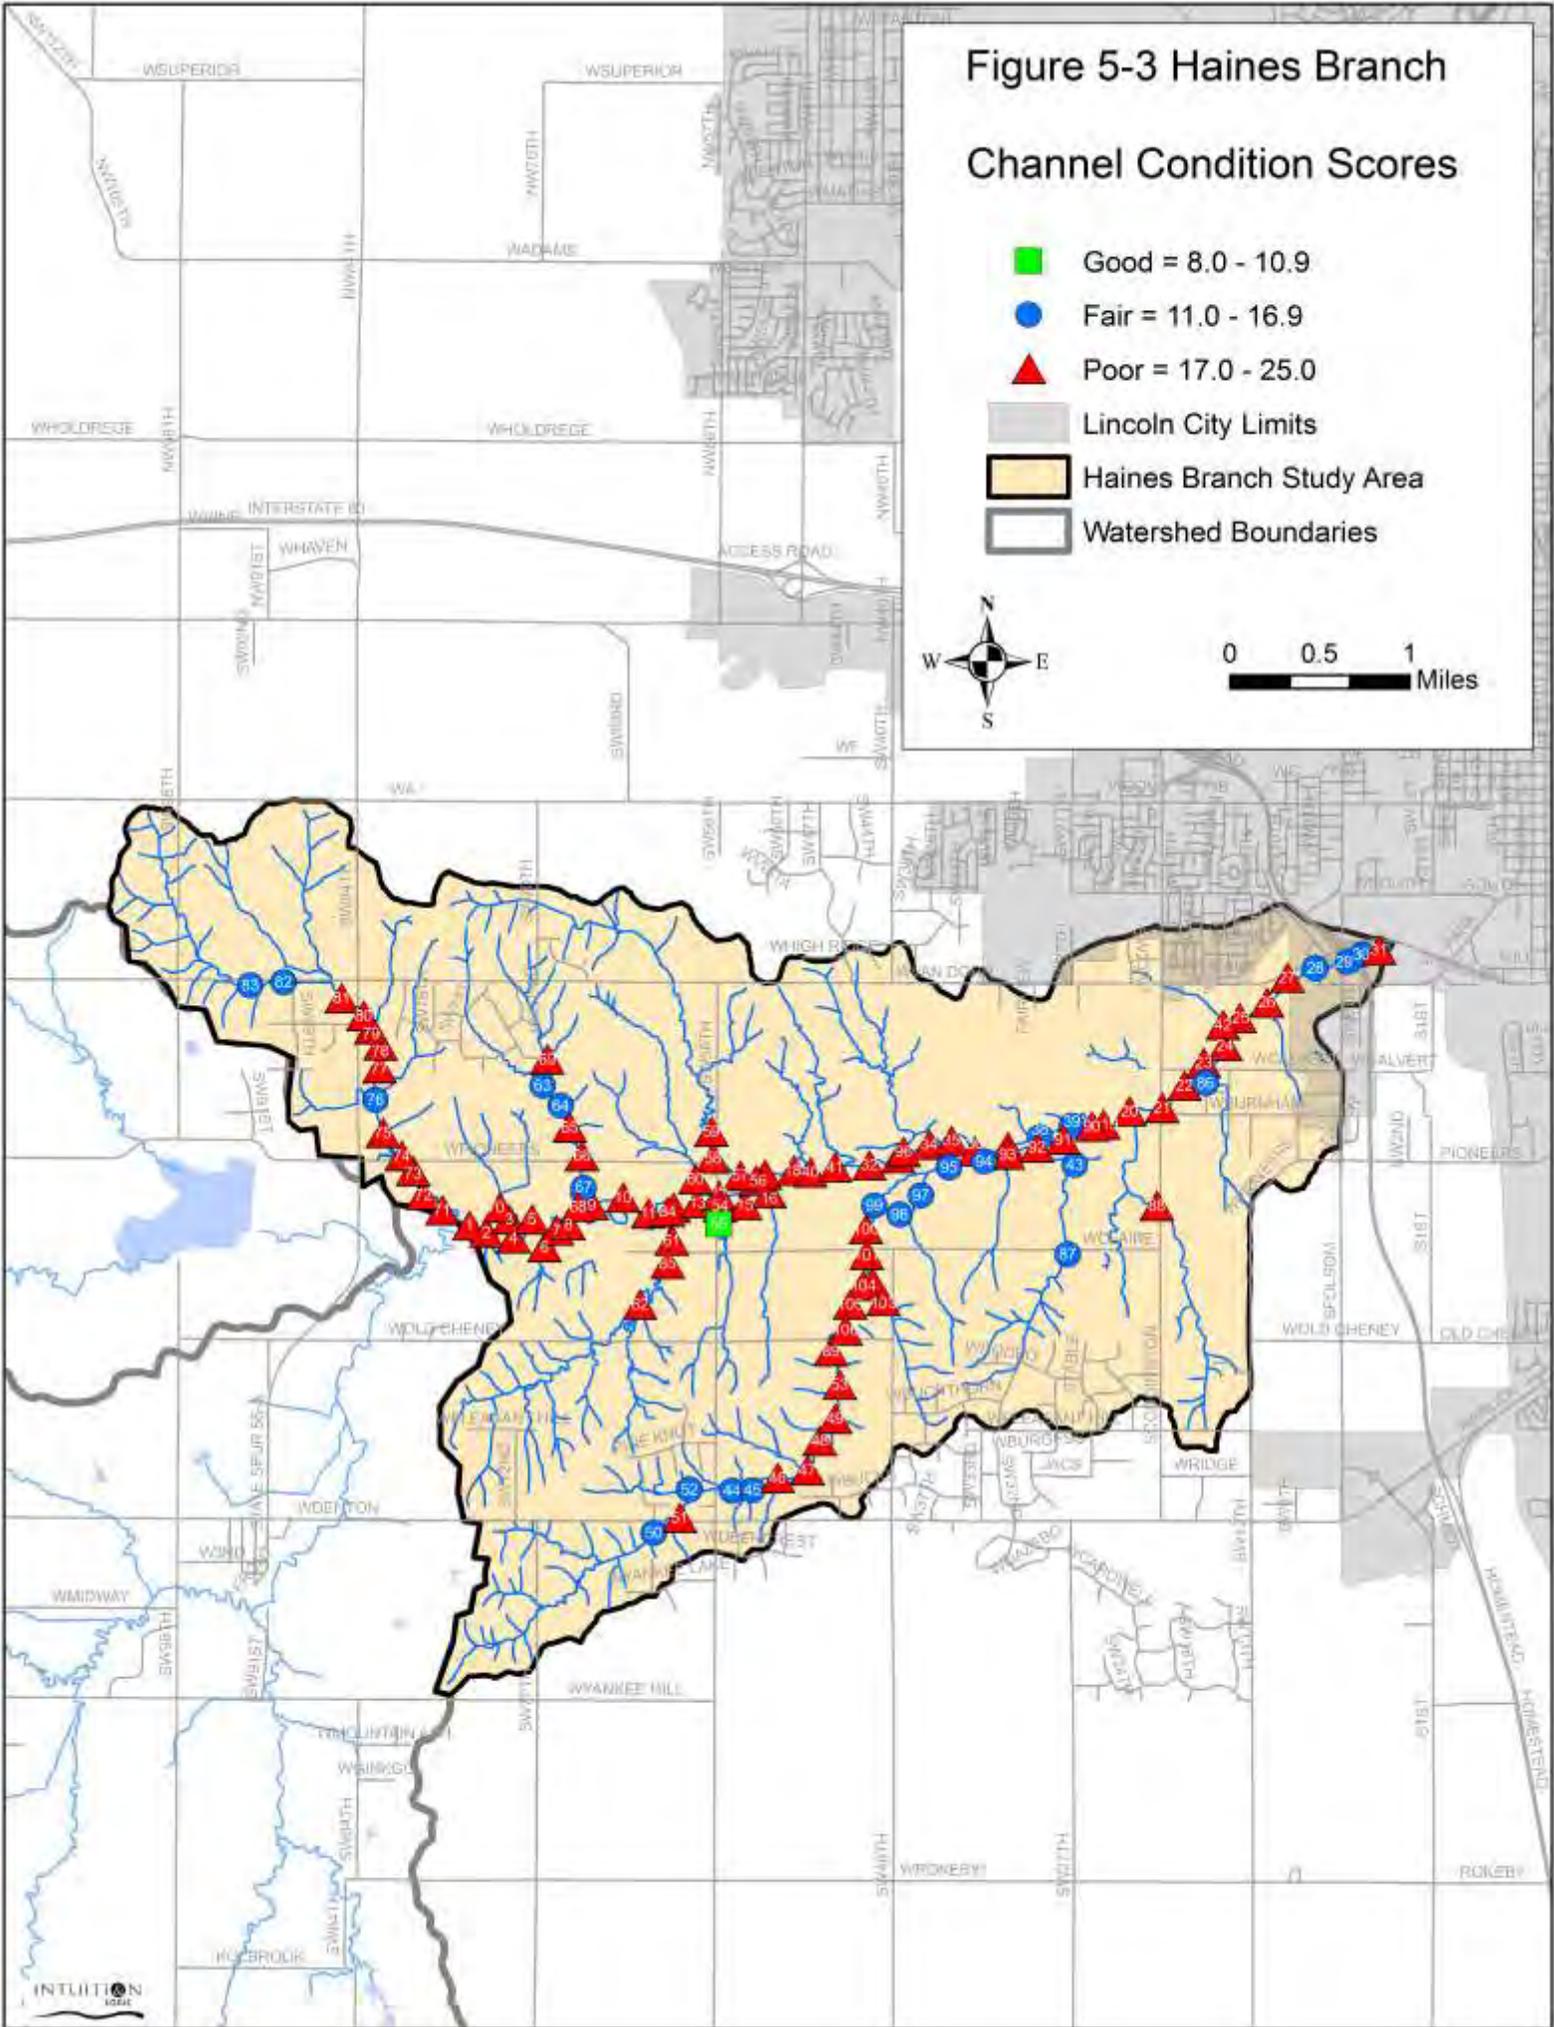
**Figure 5-3 Haines Branch
Channel Condition Scores**

Overall the Haines Branch channels walked are rated poor with an average channel condition score of 18.0. The overall score of 18 for the assessed Haines Branch channels should not be taken as a true average condition for the entirety of the study area. This score does not include the upper channels that were not walked and the upper channels were observed to be stable, managed swales or in the early stages of incision. The overall score of poor instead represents a general condition of the major channels located lower within the watershed study area.
