Aerial Photo Interpretation

Summary of Results

Appendix E

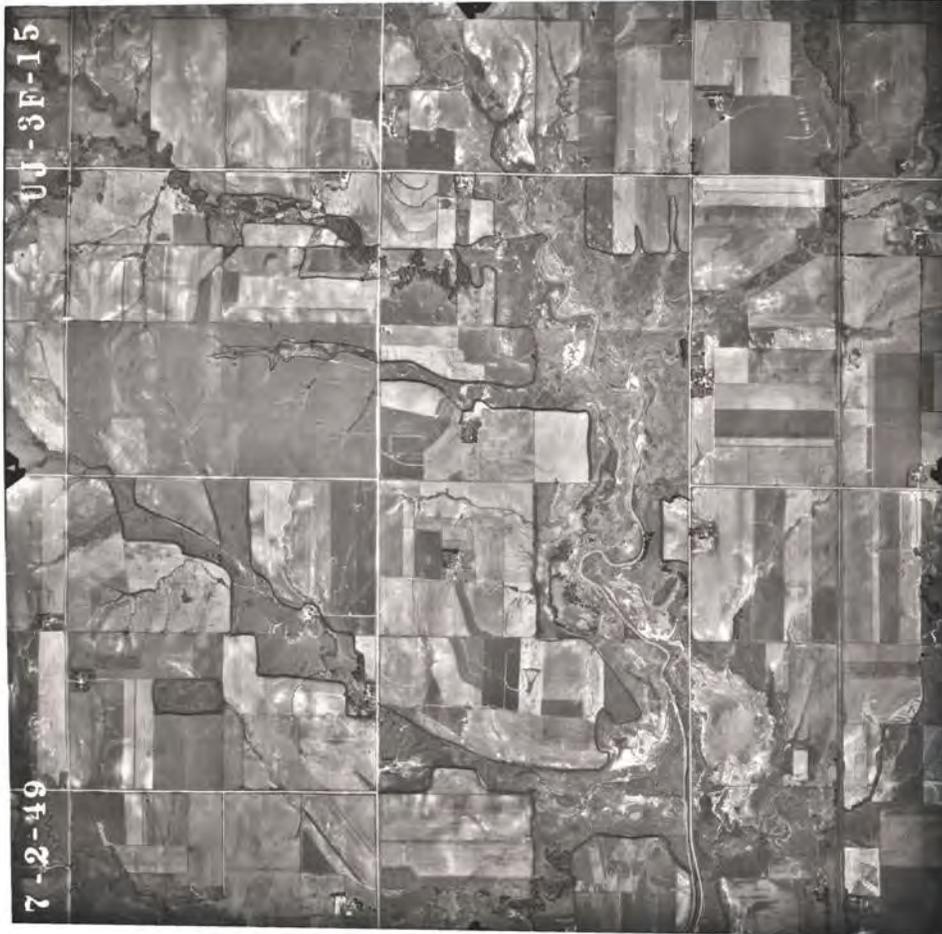
Figure E-3: 1949 Aerial Photo 15.

Photo 15 – The basin in this photo is almost entirely tilled fields with little terracing. There are a few farm houses but no other development. The woody riparian corridor appears to be poor or absent throughout the basin with the exception of the TRIB 20, eastern tributary which has a good woody corridor on the left descending bank. Much of the Southwestern tributary is off the photo or in the extreme edge. A substantial tributary evident in the 1949 photo which joins the TRIB 15, southwestern tributary just west of the confluence is much less discernable in 2005 owing in part to an impoundment about 2000 feet to the west of the tributary confluence. In the southern part of the study main channel, open water, bright white features and sinks are at least as evident as in later years. Proceeding upstream near present-day Bluff Road there is another concentration

of white features, sinks and bank retreat near the top of bank. Two western tributaries between Bluff Road and Waverly Road that were not impounded in 1949 are much more pronounced than in the more recent photographs. The channel sinuosity has changed very little between 1949 and 2005 and the major features of channel form are not significantly changed.

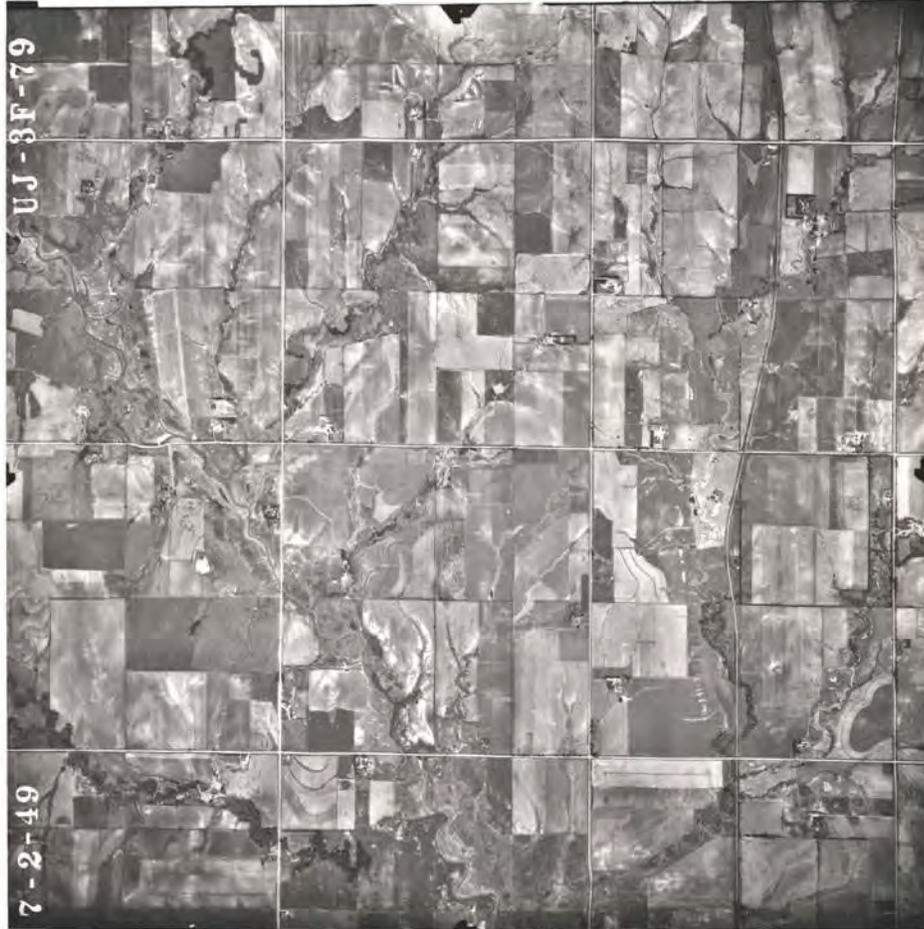
Figure E-4: 1949 Aerial Photo 79.

Photo 79 – This photo depicts the main channel north of Bluff Road to just south of the crossing at Raymond Road. The channel is incised with steep banks and poor or absent riparian corridor. The channel has some notable differences in alignment from 2005. The area just north of Waverly Road on the left descending bank appears slightly marshier than in later years and there are more isolated seeps and sinks near the stream. At Mill Road, the channel has a pronounced, tight meander the alignment of which causes a slight bend in Mill Road. In this photo there appears to be a freshly constructed cut-off channel and a dam across the natural meander. North of Mill Road there are extensive indicators of sinks, abandoned channels and isolated open water.

The confluence with the major eastern tributary and the main channel is not shown on this photo. It seems that some channel manipulation has already occurred towards the bottom of the tributary where meanders appear truncated and confined by tilled fields. The TRIB 220, eastern sub-tributary shows signs of channelization where it parallels Waverly Road, near its confluence with the main tributary. North of Waverly Road, the sub-tributary is highly sinuous with abandoned channels, oxbows and seeps evident. These features are more clearly seen than in the 2005 photo. There is a reach of narrow woody corridor adjacent to the fields and the path of about a dozen now plowed over tributaries particularly on the right descending bank. Beginning about halfway between Waverly and Mill Roads and extending north of Mill Road, the isolated surface water and white features become more pronounced and numerous. The channel also seems to be more deeply set into the landform with wide areas of retreat at the top of bank.

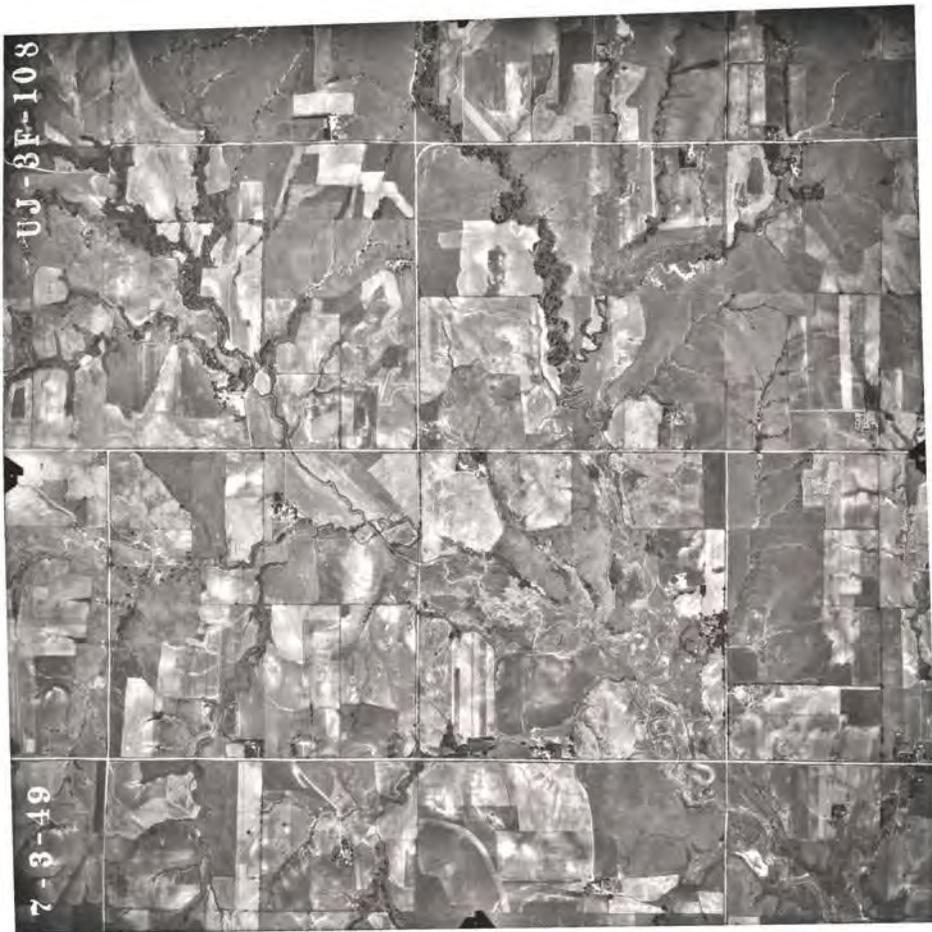
Figure E-5: 1949 Aerial Photo 108.

Photo 108 – This photo depicts the main channel from south of Raymond Road to the northwest to Davey Road. The large sinks and open water features between Raymond Road and NW 12th Street are less obvious but still discernable. West of NW 12th Street there is an apparent channelized reach with a large meander cut off on the right

descending bank and a horseshoe bend with another meander on the left descending bank cut off. The channel manipulation continues across present-day Branched Oak Road. The condition of the woody corridor improves and the degree of channel manipulation decreases approaching Davey Road.

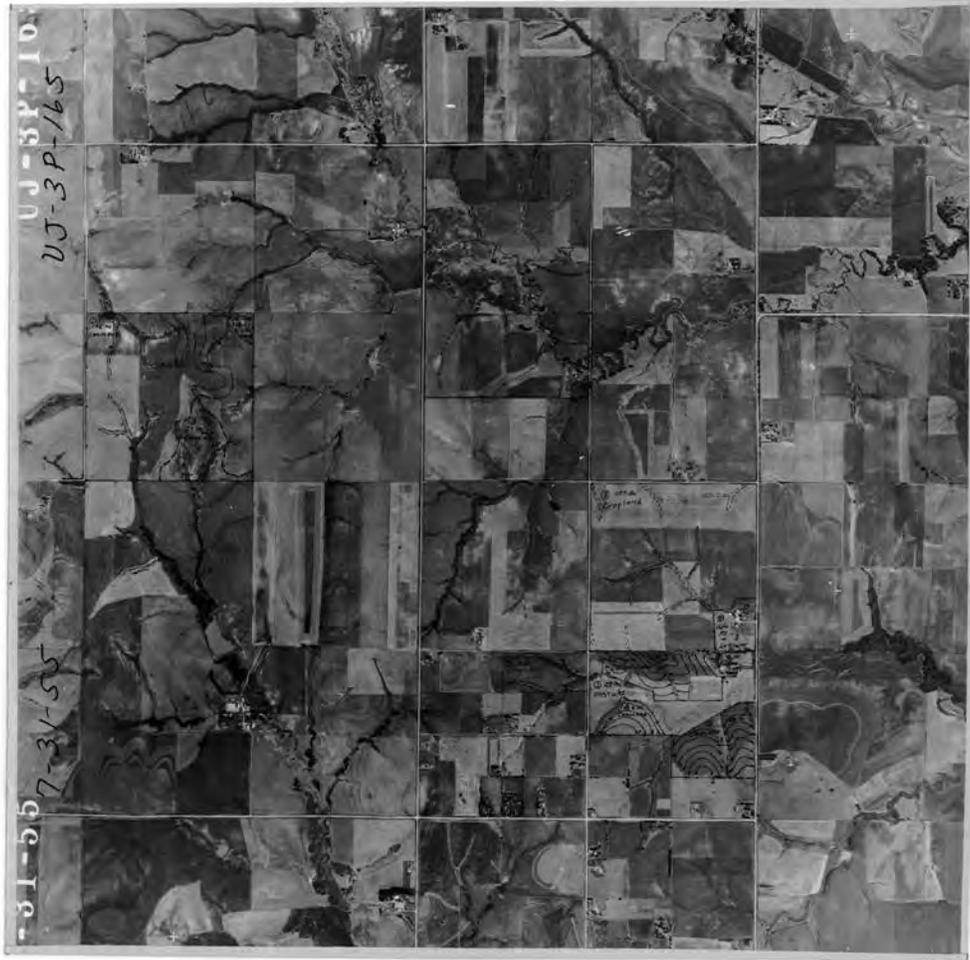
Figure E-6: 1955 Aerial Photo 165.

Photo 165 – This photo does not depict the main channel but does show much of TRIB 15, the southwest tributary. The tributary alignment is roughly that seen in 2005 though abandoned oxbows, abandoned channels and plowed over sub-tributaries are more obvious and the channel is slightly more sinuous. The tributary is mobile and has meandered across its floodplain. The meander amplitudes and frequency have changed considerably over time.

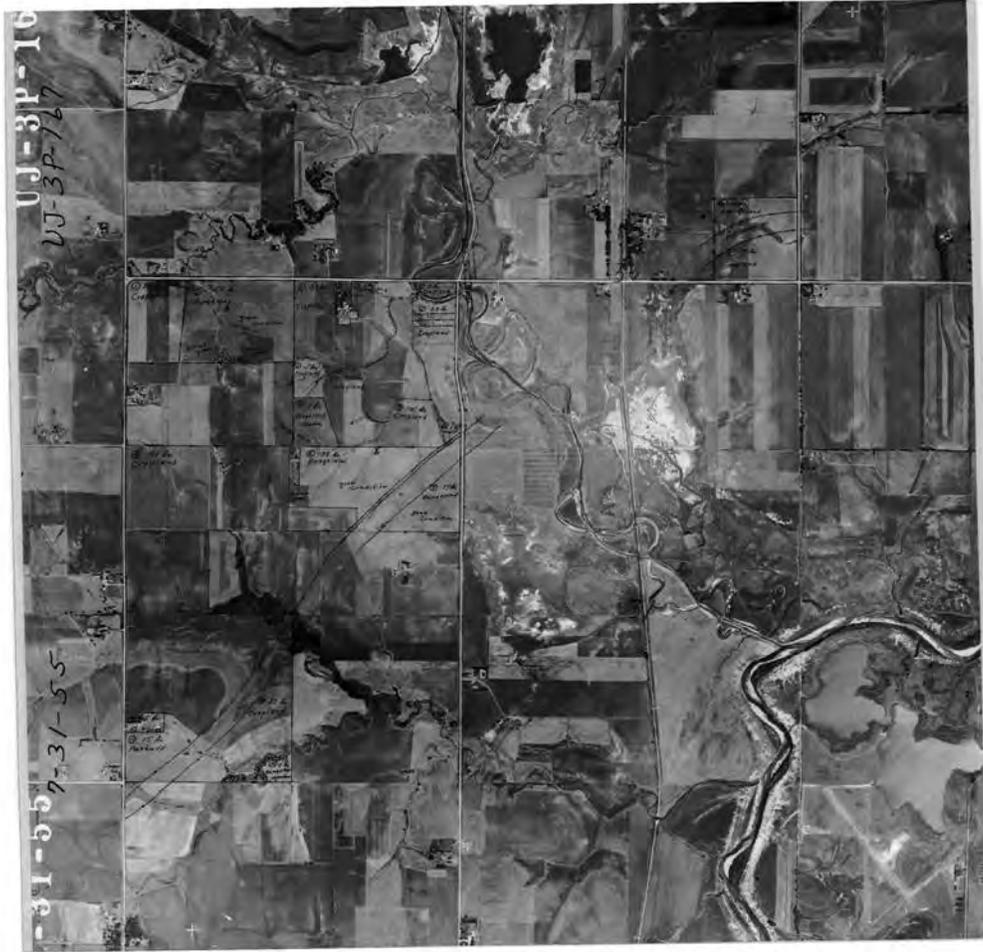
Figure E-7: 1955 Aerial Photo 167.

Photo 167 – This photo depicts the confluence of Little Salt Creek with Salt Creek, the lower reaches of TRIB 15, the southwestern tributary and the main channel north of Arbor Road but south of Bluff Road. The land use is both rangeland and tilled crop land. The degree to which the stream has been shortened and realigned to accommodate roadways and agriculture is striking. The channel sinuosity in the photographs is reduced by over 60% relative to the historical alignment. Some of the channelization appears recent or ongoing; there is a plug in the downstream limb of a meander just south of Arbor Road and the photo is annotated with a proposed realignment cutting off a major meander at Arbor Road and N 27th Street. Channel incision is apparent as is bank retreat. The extensive channelization left abandoned oxbows and isolated areas of marsh that had previously been connected by surface flow. The southern part of the main channel is bounded by large to massive white features flanking open water.

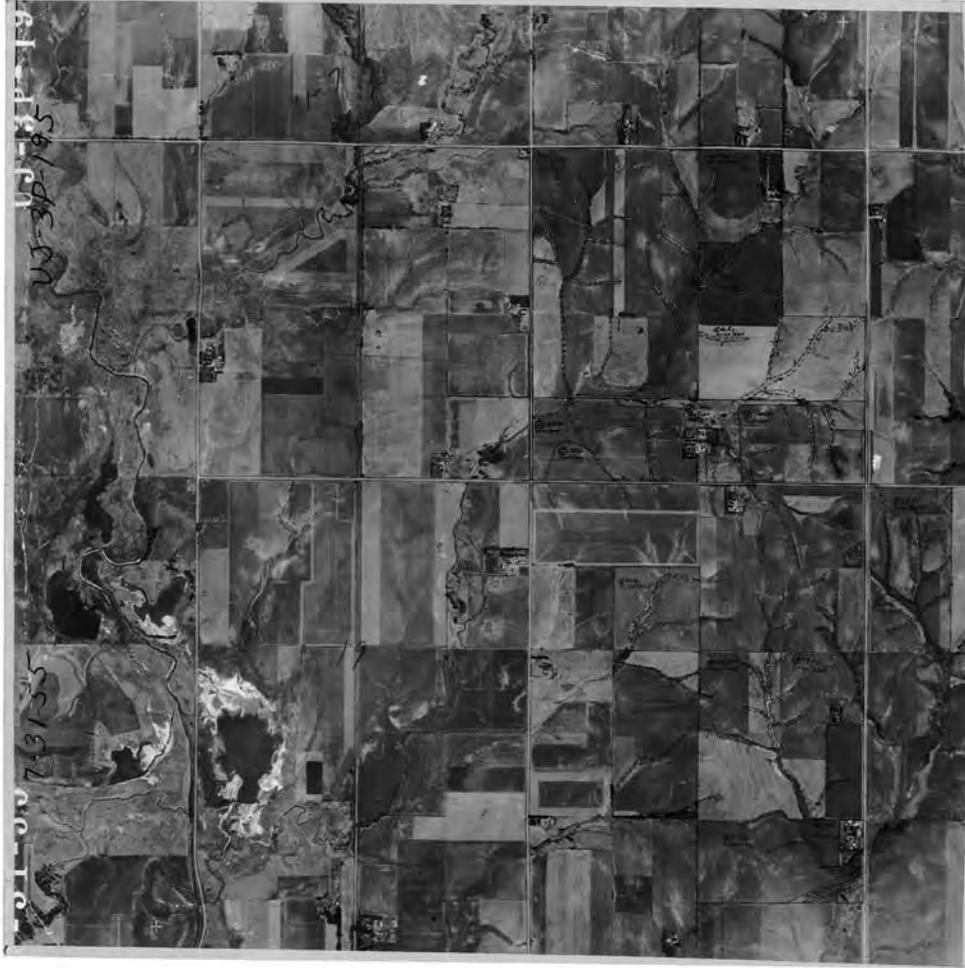
Figure E-8: 1955 Aerial Photo 195

Photo 195 – This photo depicts the main channel from the channelized reach to Mill Road. The open water features and white features surrounding them dominate the downstream reach of this photo field. The channel appears deep with very steep sides. The toes of bank appear ragged and some center bars are apparent near present-day Arbor Road. Bank retreat is especially notable near the mouths of gullies and tributaries. Sinks and isolated gullies are most prominent in the lower reaches of the stream and decline somewhat approaching Mill Road.

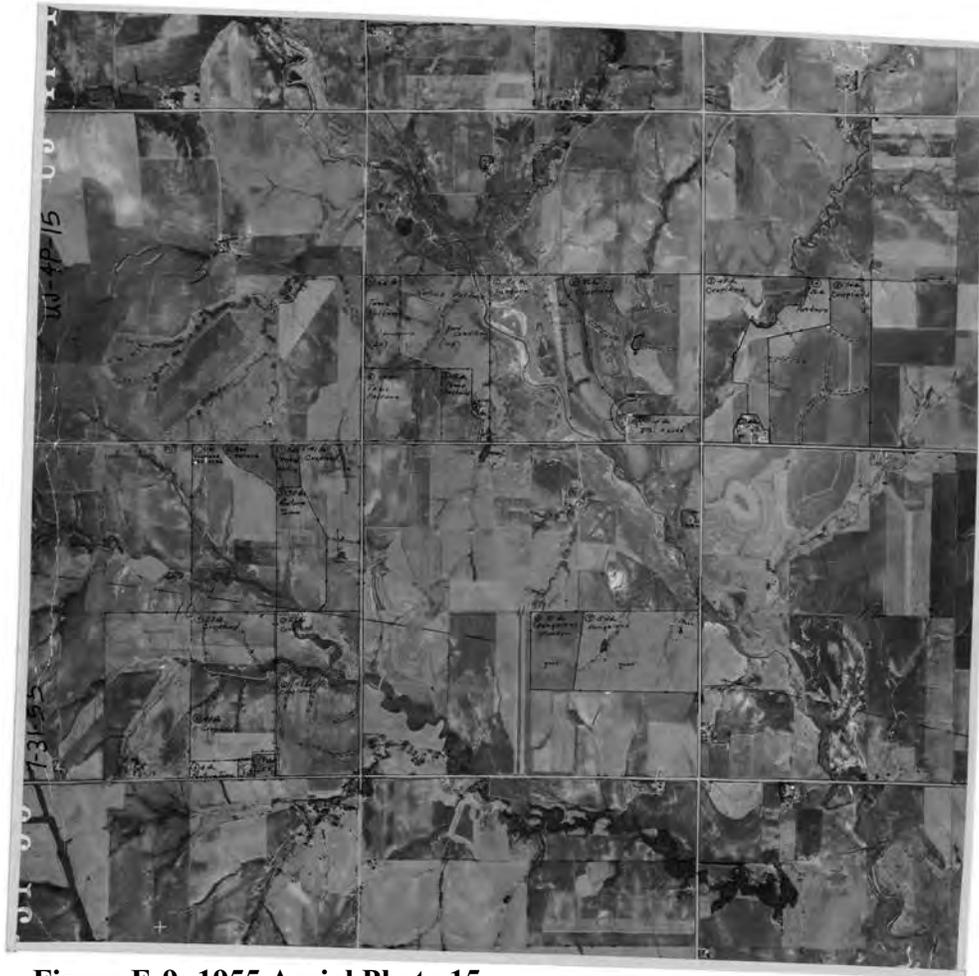
Figure E-9: 1955 Aerial Photo 15.

Photo 15 (1955) – This photo depicts the main channel from south of Bluff Road to north of Raymond Road. Most of TRIB 30 is also visible here. The main channel appears almost completely devoid of woody vegetation. Tilled fields, rangelands or marsh flank the channel with no apparent riparian corridor. Several hundred feet upstream of the confluence with the main channel, TRIB 30, has a woody corridor but all other tributaries are as denuded as the main channel. Between Mill and Raymond Roads, abandoned channels are especially notable and are delineated with white features. Approaching Raymond Road, the white features again increase in frequency.

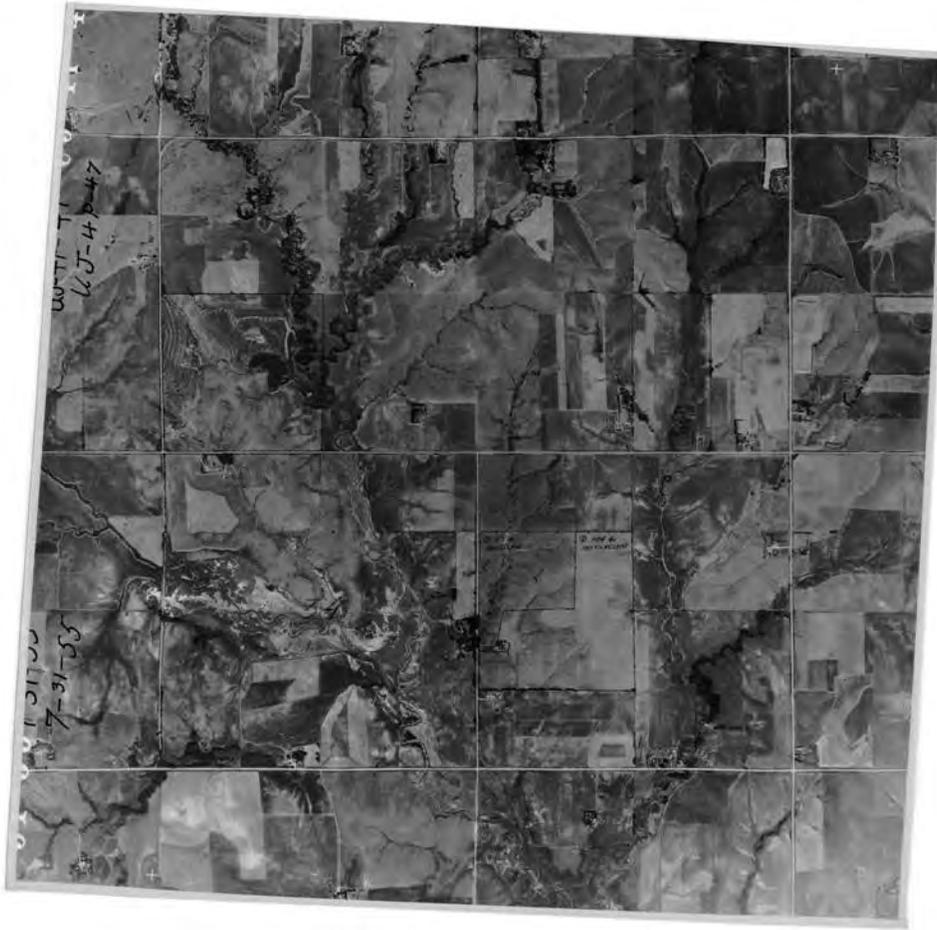
Figure E-10: 1955 Aerial Photo 47.

Photo 47 – This photo depicts the main channel from south of Raymond Road north to an area east of the Branched Oak Road crossing as well as TRIB 65, the eastern tributary from its confluence with the main channel to north of Davey Road. Just north of Raymond Road and south of the confluence, there are two substantial meanders that were eliminated by 2005. There are sinks, marshes and white features near the confluence and both streams have virtually no woody corridor. Upstream of the confluence on the main channel, the alignment is generally similar to that of 2005. West of NW12th Street the main channel appears to have been straightened. Approaching Branched Oak Road, center bars are common. The eastern tributary has an alignment similar to that of 2005 though the downstream-most major meander has migrated downstream noticeably by 2005. The impoundment south of Branched Oak Road is not evident in 1955 but a large meander just north of Branched Oak Road is. There is an active cut-off channel at the meander; the meander may have been recently channelized. About 600 feet north of Branched Oak Road, a sub-tributary that was impounded by 2005 still flows unimpeded. The sub-tributaries that meet north of Branched Oak Road have exceptionally tight meanders with roughly the same pattern as in 2005. There is some woody corridor, largely on the eastern sub-tributary extending beyond Davey Road.

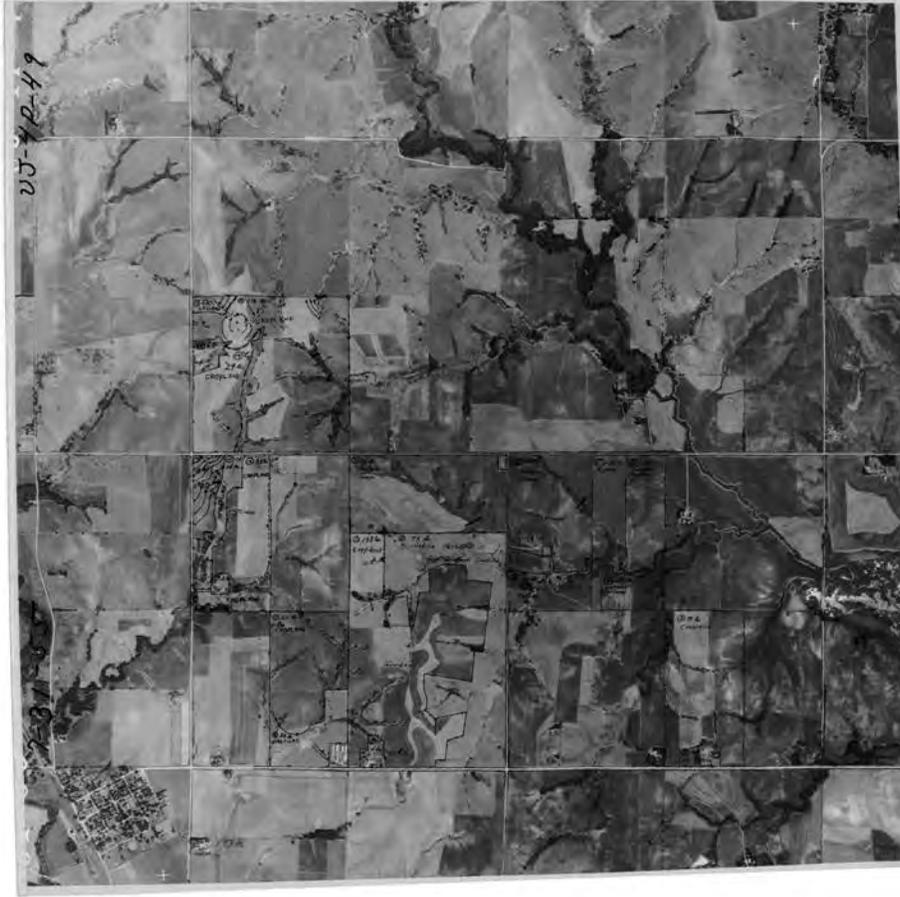
Figure E-11: 1955 Aerial Photo 49.

Photo 49 – This photo depicts the main channel from south of Branched Oak Road to north of Davey Road. This photo depicts a more dense drainage network than is apparent in the 2005 photo. Tributaries impounded by farm ponds in 2005 are revealed in 1955 as dense, dendritic drainage features. There are center bars in the main channel south of Branched Oak Road. There appears to be considerable retreat at top of bank, especially along the right descending bank. North of Branched Oak Road, the stream has some woody corridor on at least one bank though the stream still appears deeply incised. The headwaters of the small tributaries are dendritic gullies with deep, steep head ends. This is particularly noticeable in the western tributary immediately south of Davey Road.
