# Section 5

## Geomorphic Evaluation

The purpose of the South Salt Creek geomorphic investigation is to determine the basic geomorphic conditions of the main stem and selected tributaries. Understanding the geomorphic conditions of these streams will help determine the locations and prioritizations of interventions for managing the main stem and tributaries. Following is a brief overview of geomorphic principles with emphasis on their application to stream and watershed management.

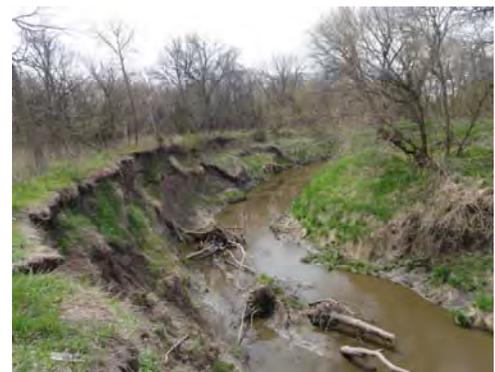
The major drivers of the poor channel scores were bar development, bed material, sediment movement, bank cutting, average bank slope and mass wasting. Excess material in the channel from frequent and extensive bank cutting and mass wasting was observed almost continuously along the South Salt Creek Main Stem and lower tributaries. Steep bank slopes, overhanging vegetation with extensive root exposure were common. Center bars, bars extending  $\frac{3}{4}$  across the channel and unconsolidated bed material were a manifestation of excessive amount of sediment being generated. These conditions were repeatedly observed throughout the channels walked as illustrated in Figure 5-3.

**Photo – South Salt Creek Main Stem Mass Wasting and material in channel**

Grade controlling the channel will arrest the downward migration of the channel bed and will allow the reaches to adjust to a stable planform. Grade controls are recommended at existing knickpoints and at locations where projects are necessary to protect infrastructure from the channel erosion. Bank stabilization is recommended in conjunction with grade controls at locations where mass wasting and plan form adjustment are threatening infrastructure.

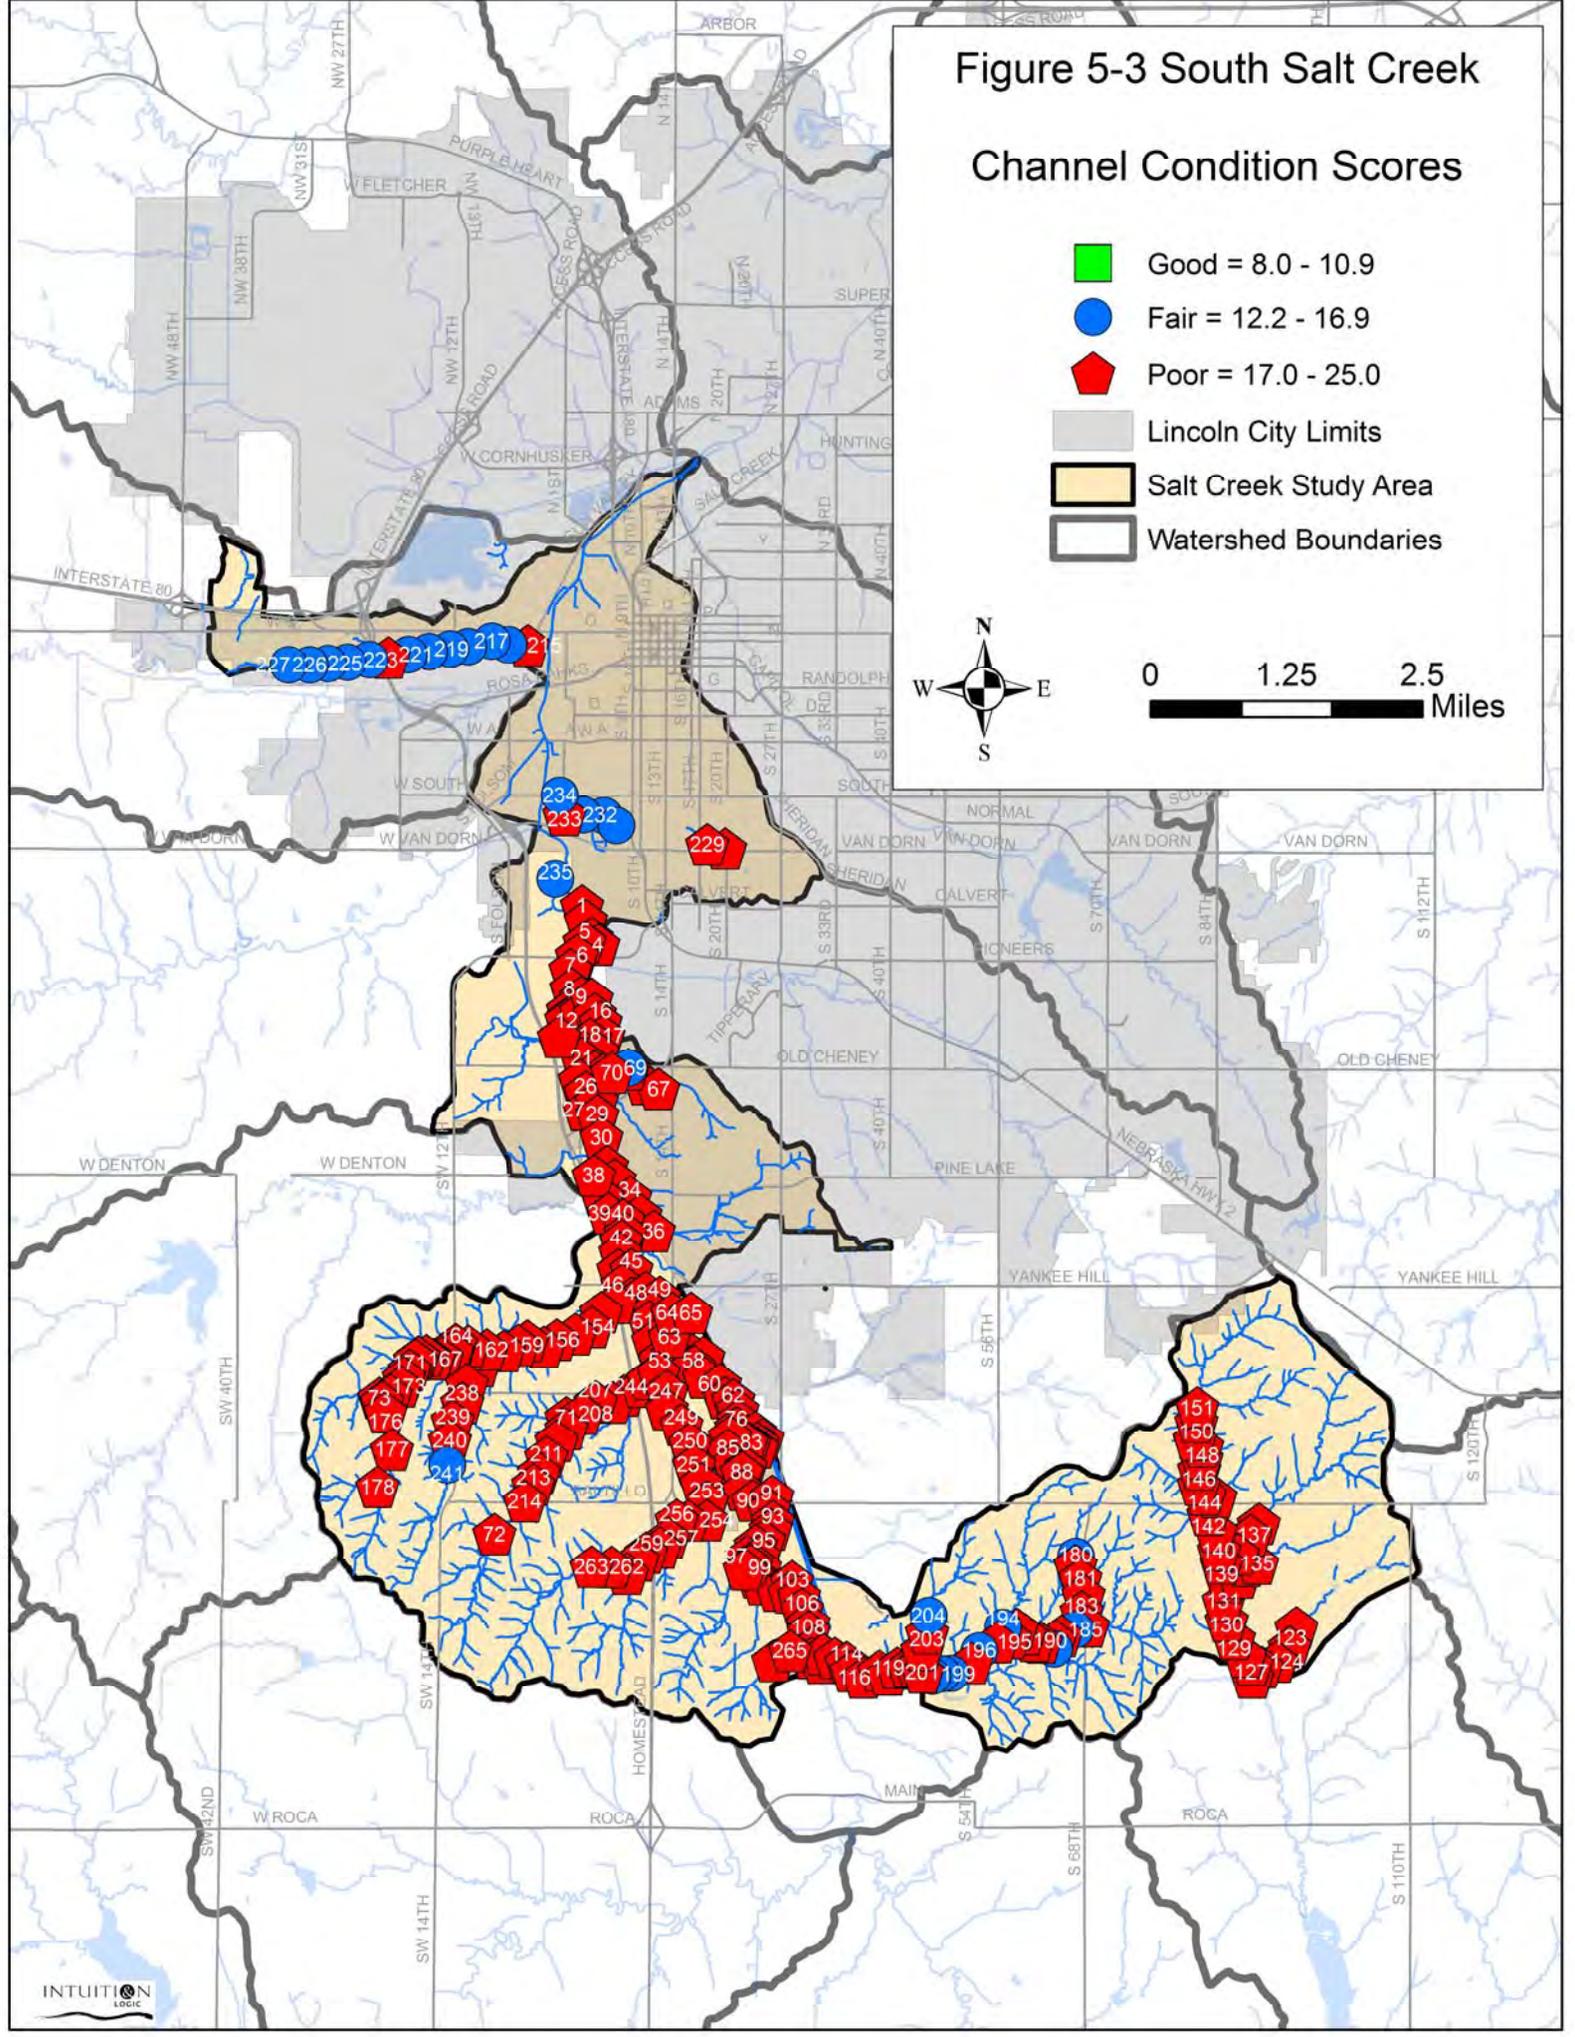
Figure 5-3 South Salt Creek

Overall the South Salt Creek channels walked are rated poor with an average channel condition score of 18.9. The overall score of 18.9 for the assessed South Salt Creek channels should not be taken as a true average condition for the entirety of the study area. This score does not include the upper channels that were not walked and the upper channels were observed to be stable, managed swales or in the early stages of incision. The overall score of poor instead represents a general condition of the major channels located lower within the watershed study area.

Channel Condition Scores

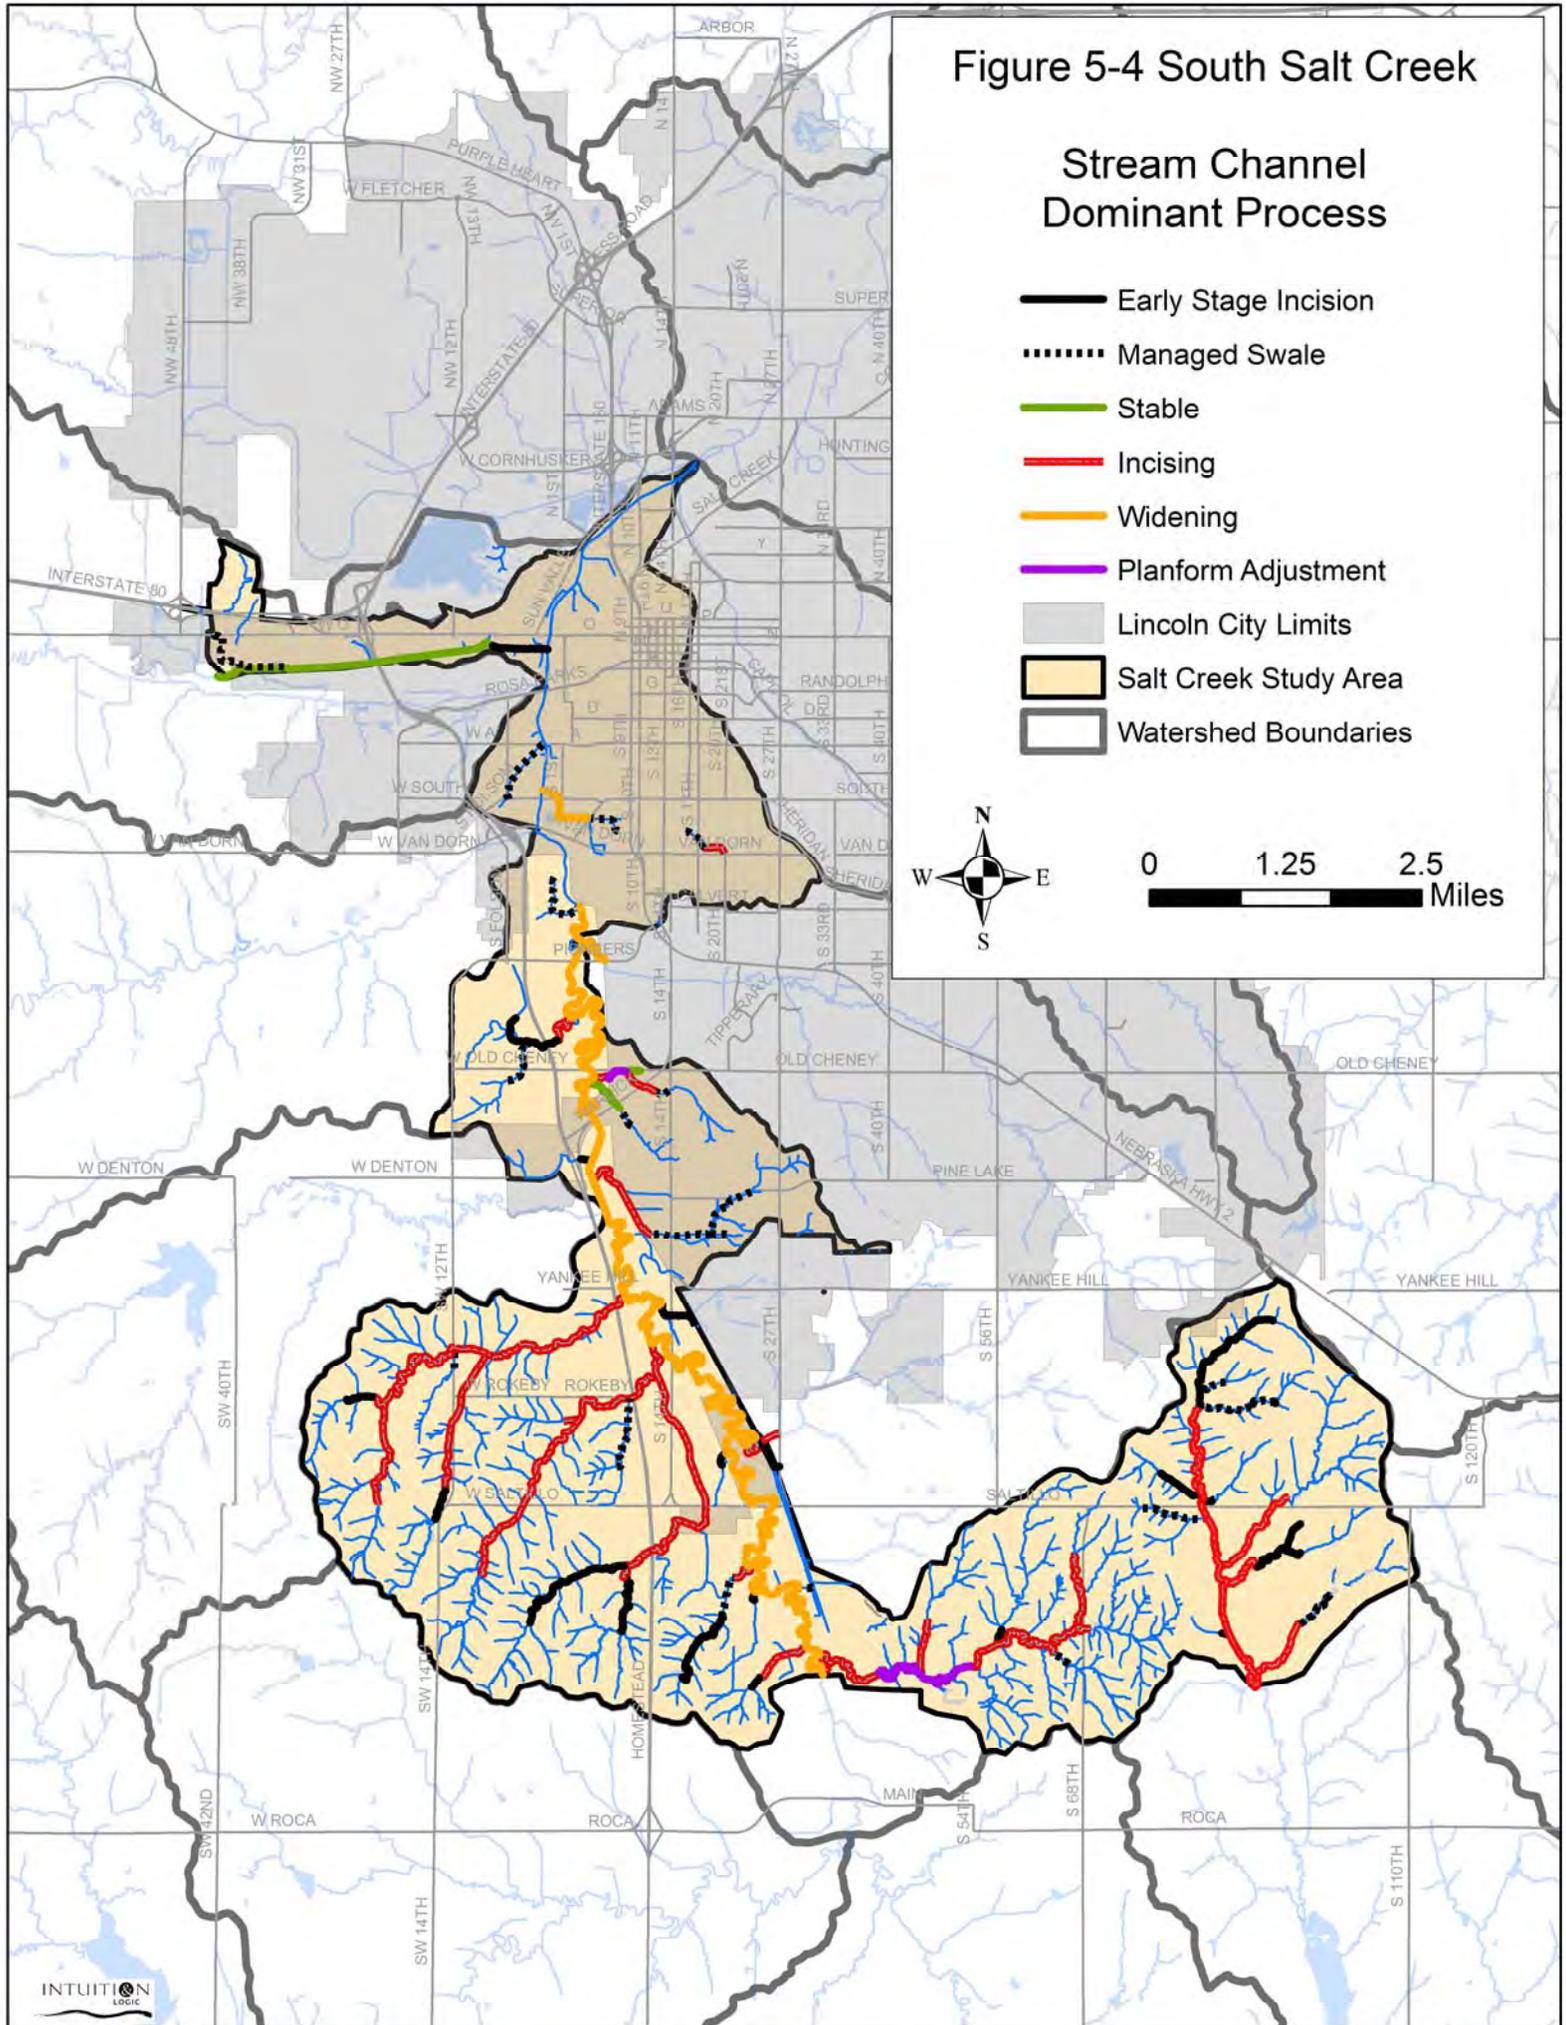
Figure 5-4 South Salt Creek

42 key indicators of dominant process were evaluated and recorded for each of the 108 South Salt Creek reaches walked. The resulting diagnosis for dominant process driving instability in the South Salt Creek main stem is widening. The dominant process for the tributaries was primarily incision, which is logical as the tributaries adjust and incise to match the main stem flowline. Figure 5-4 illustrates the dominant process by reach.

**South Salt Creek Main Stem Widening** – The dominant process driving instability along the entire length of the South Salt Creek main stem is widening. The dominant indicators of widening in the main stem include:

**Tributary Incising Reaches** - The dominant process driving instability in the South Salt Creek tributaries is incision. Over 64% of the tributary reaches are diagnosed as either incising (45%) or in the early stages of incision (19%). The dominant indicators of incision in the tributaries include:

**Wagon Train Main Stem Incision** – The dominant process driving instability along the main stem of the Wagon Train portion of the South Salt Creek Watershed Study Area is incision.

In general, the recommended approach to stabilizing South Salt Creek Watershed Study Area is to stop the process of widening on the main stem and incision in the tributaries and in the Wagon Train portion of the South Salt Creek Watershed Study Area. In the widening process, the channel is managing large amounts of material generated by bank erosion and mass wasting. This is one of the most difficult stages to manage because virtually every component of the channel is changing. At several locations on the tributaries, active incision is threatening upstream reaches that are in relatively good shape. In general, each of these processes is attempting to lower the stream slope and reduce energy in the system in response to changes in the watershed.
