Section 3

Water Quality Assessment

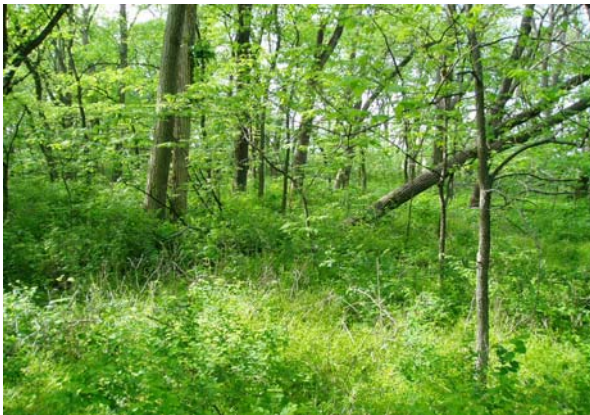
**High quality riparian woodland vegetation
downstream of SW 12th Street**

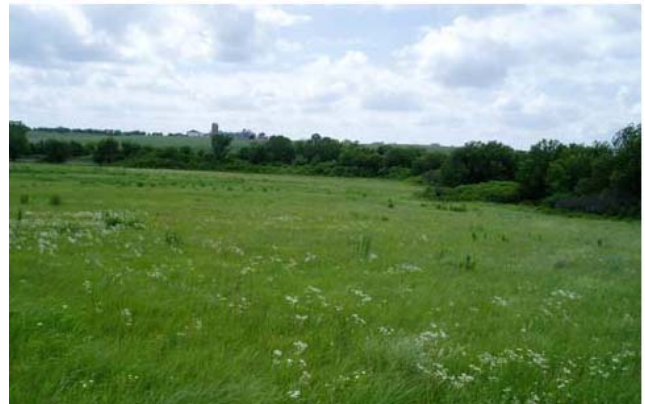
Native prairie located north of Rokeby Road

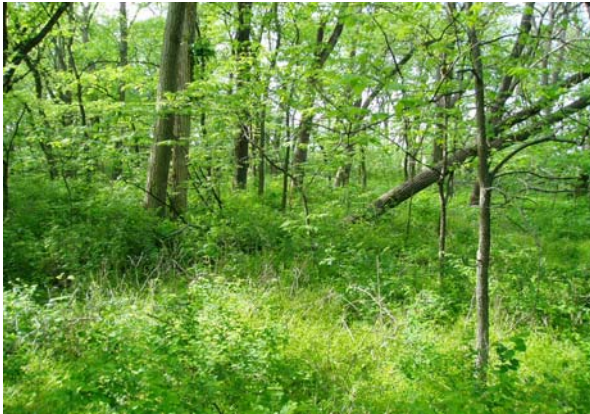
**High quality riparian woodland vegetation
downstream of SW 12th Street**

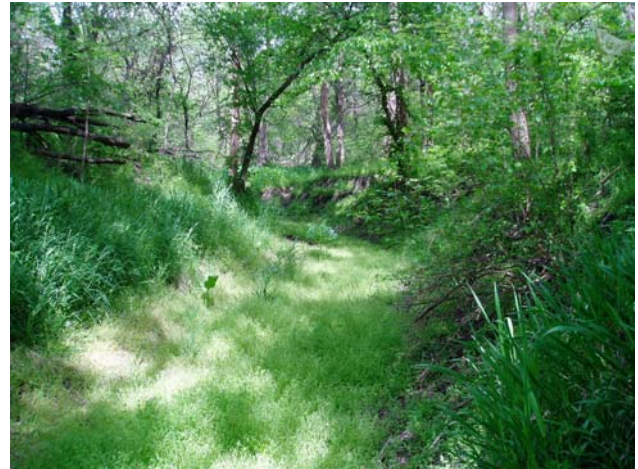
Type II stream reach located adjacent to the Cardwell Woods residential development

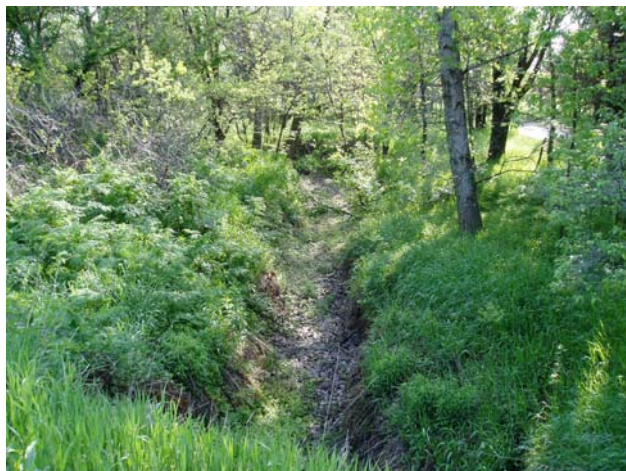
Type III stream reach located downstream of Rokeby Road

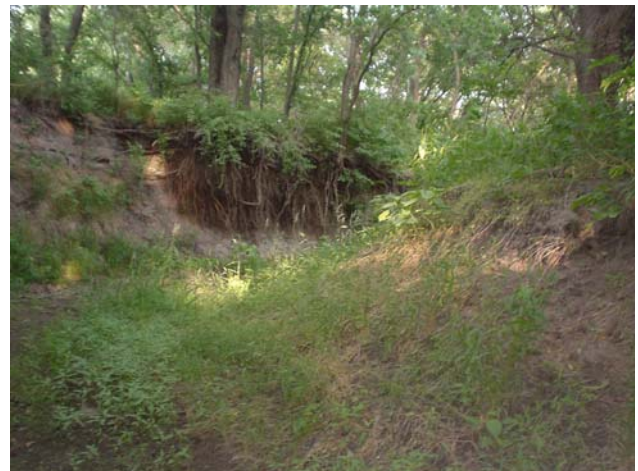
Type IV stream reach located upstream of SW 12th Street

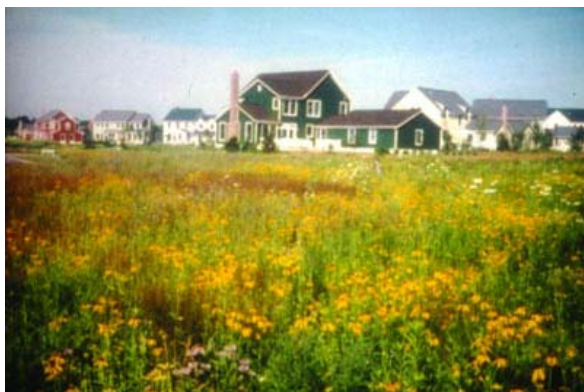
Conservation development example
