Section 2

Data Collection and Development

2.2 Hydraulic Structure Field Survey

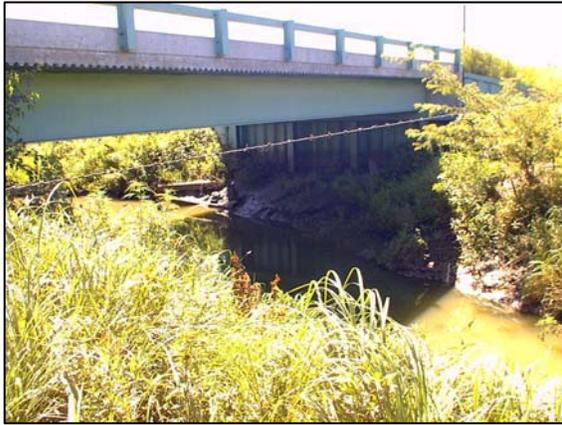
Figure 2-1: North 1st Street Bridge

Bridges – The types of information collected for each bridge included size and shape of the opening, upstream and downstream channel invert elevations, entrance conditions (i.e. wingwalls, vertical abutments), bridge deck thickness, low steel elevation and bridge parapet, roadway embankment side-slope rate, type and width of roadway pavement, and spot top of road elevations.

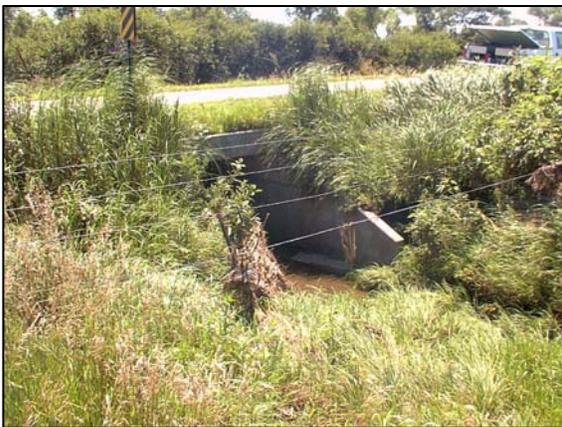
Figure 2-2: Concrete box culvert under Waverly Road

Culverts – The types of information collected included size and shape, upstream and downstream channel invert elevations, entrance conditions (i.e. headwall, wingwalls, mitered to slope, projecting), roadway embankment side-slope rate, type and width of roadway pavement, and spot top of road elevations.
