Section 6

Water Quality and Bio-Assessment

6.1 Water Quality

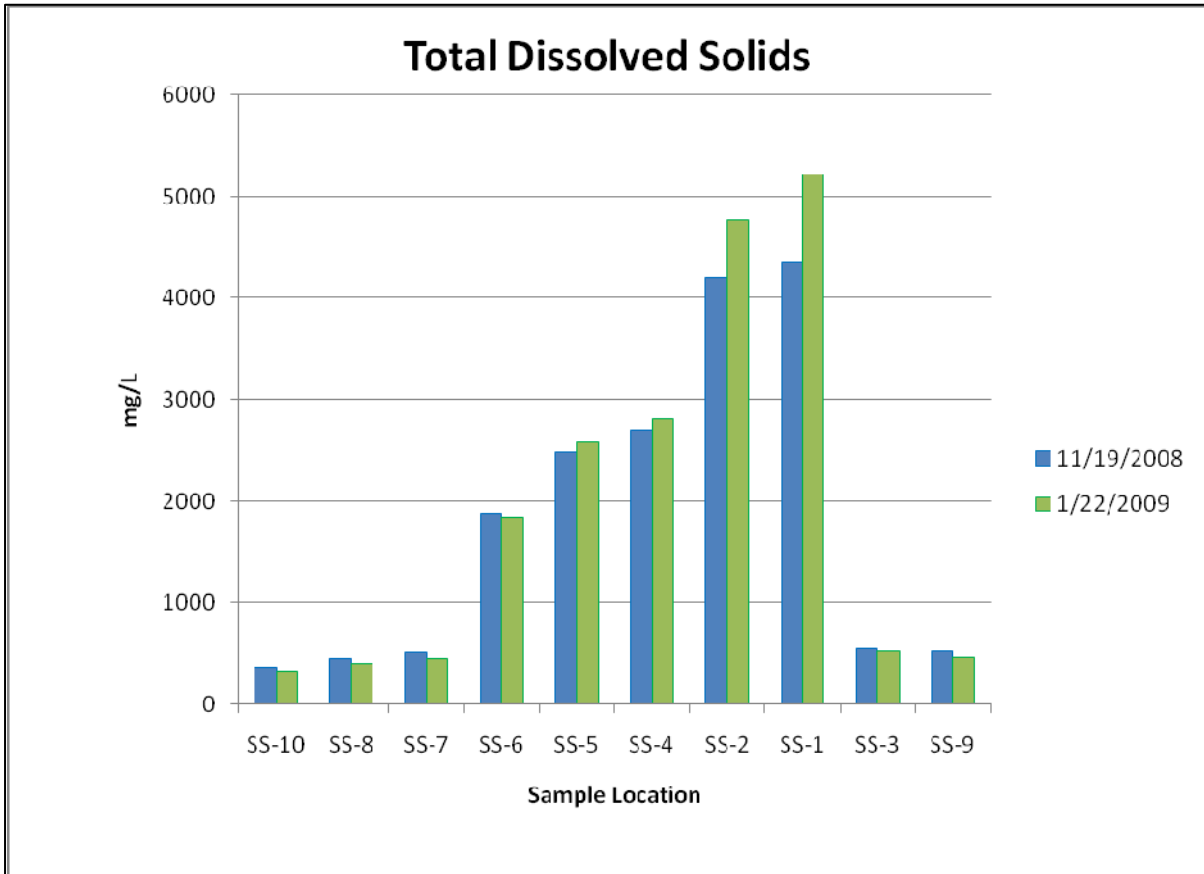
The results of these tests are depicted in Figure 6-2 below. The two series of water quality tests were consistent and demonstrated that the reaches below Raymond Road have markedly higher total dissolved solids than the upper reaches. These concentrations, over 4000 mg/L in the lower reaches of the basin, approach levels that may be toxic to livestock. While at first blush this is disturbing, high TDS levels in isolation do not necessarily imply a water quality problem. *Naturally* saline water bodies may not be suited for watering livestock but that does not mean that the salinity is a pollutant. These data should be evaluated in a broader context and supported by more extensive testing.

Figure 6-2: Total Dissolved Solids Results

There are several potential causes of the high level of TDS including the stream's salinity, leachate from the soil, animal waste or agrichemicals such as fertilizer or pesticides. Given that the testing was conducted in winter when the fields were not being worked and that TDS increases lower in the watershed, it is likely that much if not most of the TDS is associated

with salt. This is generally consistent with the findings of Greene, et al (2008)¹ in which the authors measured the seasonal salinity of Little Salt Creek. These authors also noted that salinity was highest during periods of base flow, a condition that generally corresponds to the testing here.

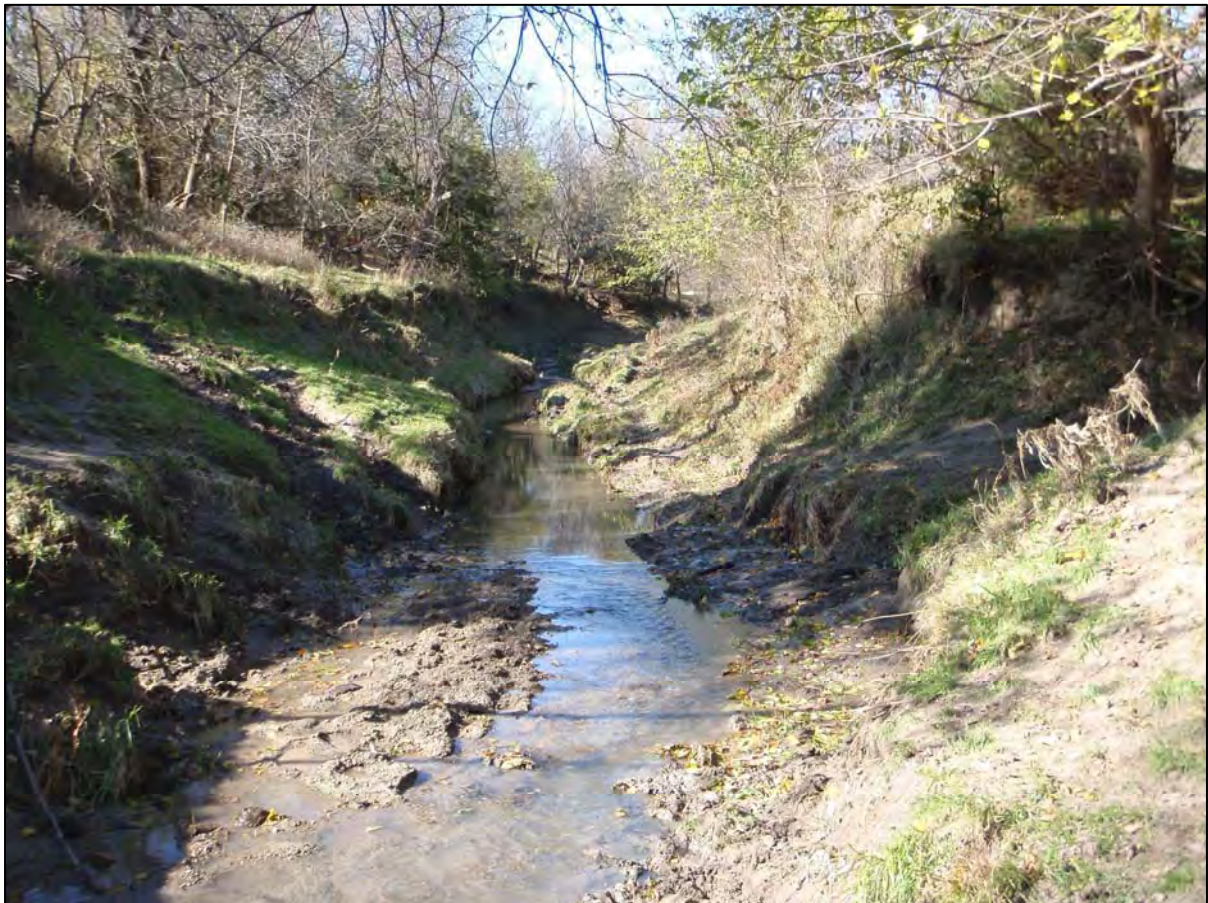
Figure 6-4: Rock Creek Road sample site facing upstream

This site had higher macro invertebrate diversity than the others and included some pollution sensitive organisms. The site includes a rocky substrate that has not silted in and is

supportive of these animals. However, the site also includes a high percentage (26%) of hemoglobin bearing species. This is indicative of hypoxic substrates. The cause of oxygen depletion in the sediment is not clear and may be due to the persistent influence of summertime high temperatures or nutrient enrichment. The possibility of high nutrient loading at the site is further suggested by the high concentrations of eutrathentic diatoms. Seventy-six percent of the diatoms sampled here require eutrophic, or nutrient enriched conditions.

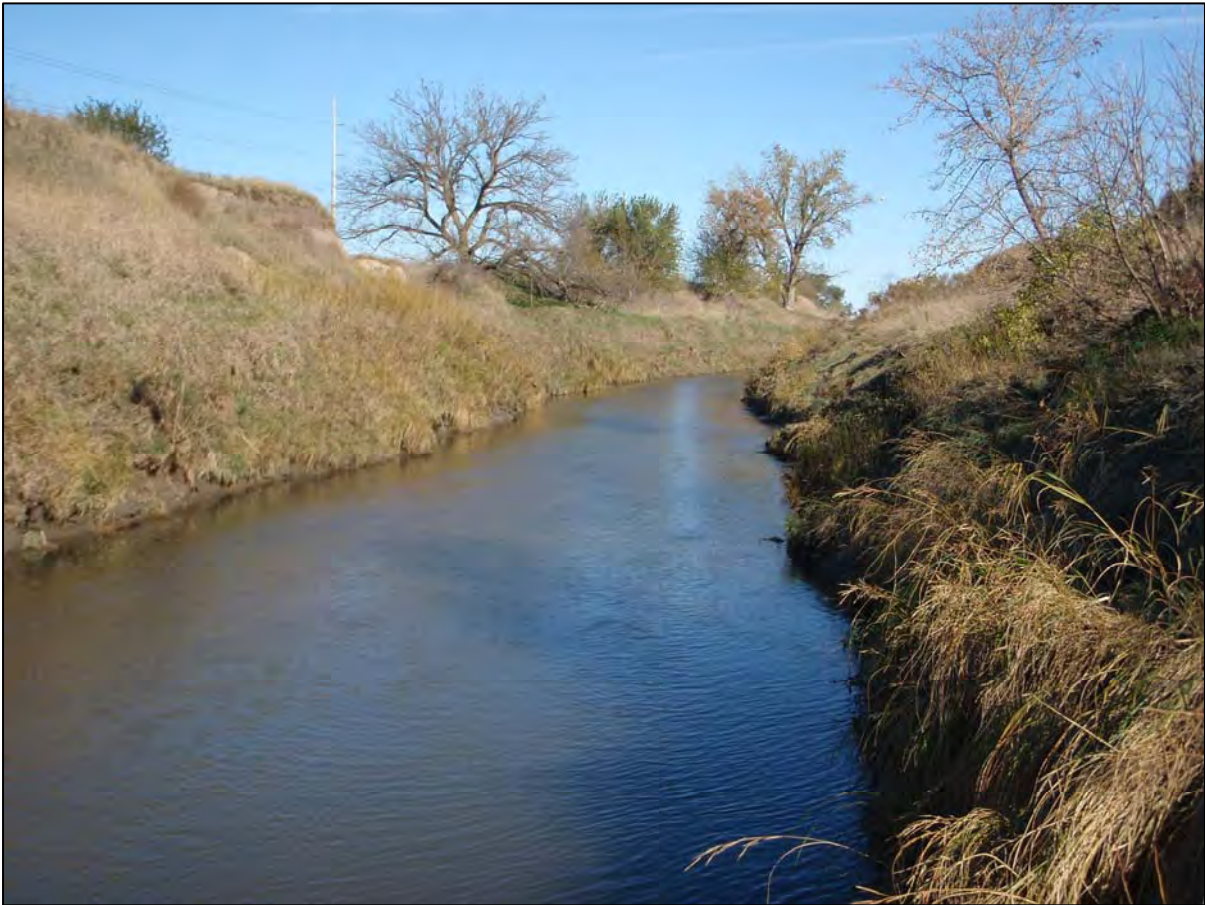
This site was overwhelmingly dominated by midges associated with filamentous algae and hypoxic substrates. High levels of filamentous algae suggest severe nutrient enrichment. Here there was also a near-complete absence of the most prominent pollution-intolerant taxa. Sixty-nine percent of the diatom taxa favored nutrient-enriched habitats. This site is depicted in Figure 6-5.

Figure 6-5: Arbor sample site facing upstream

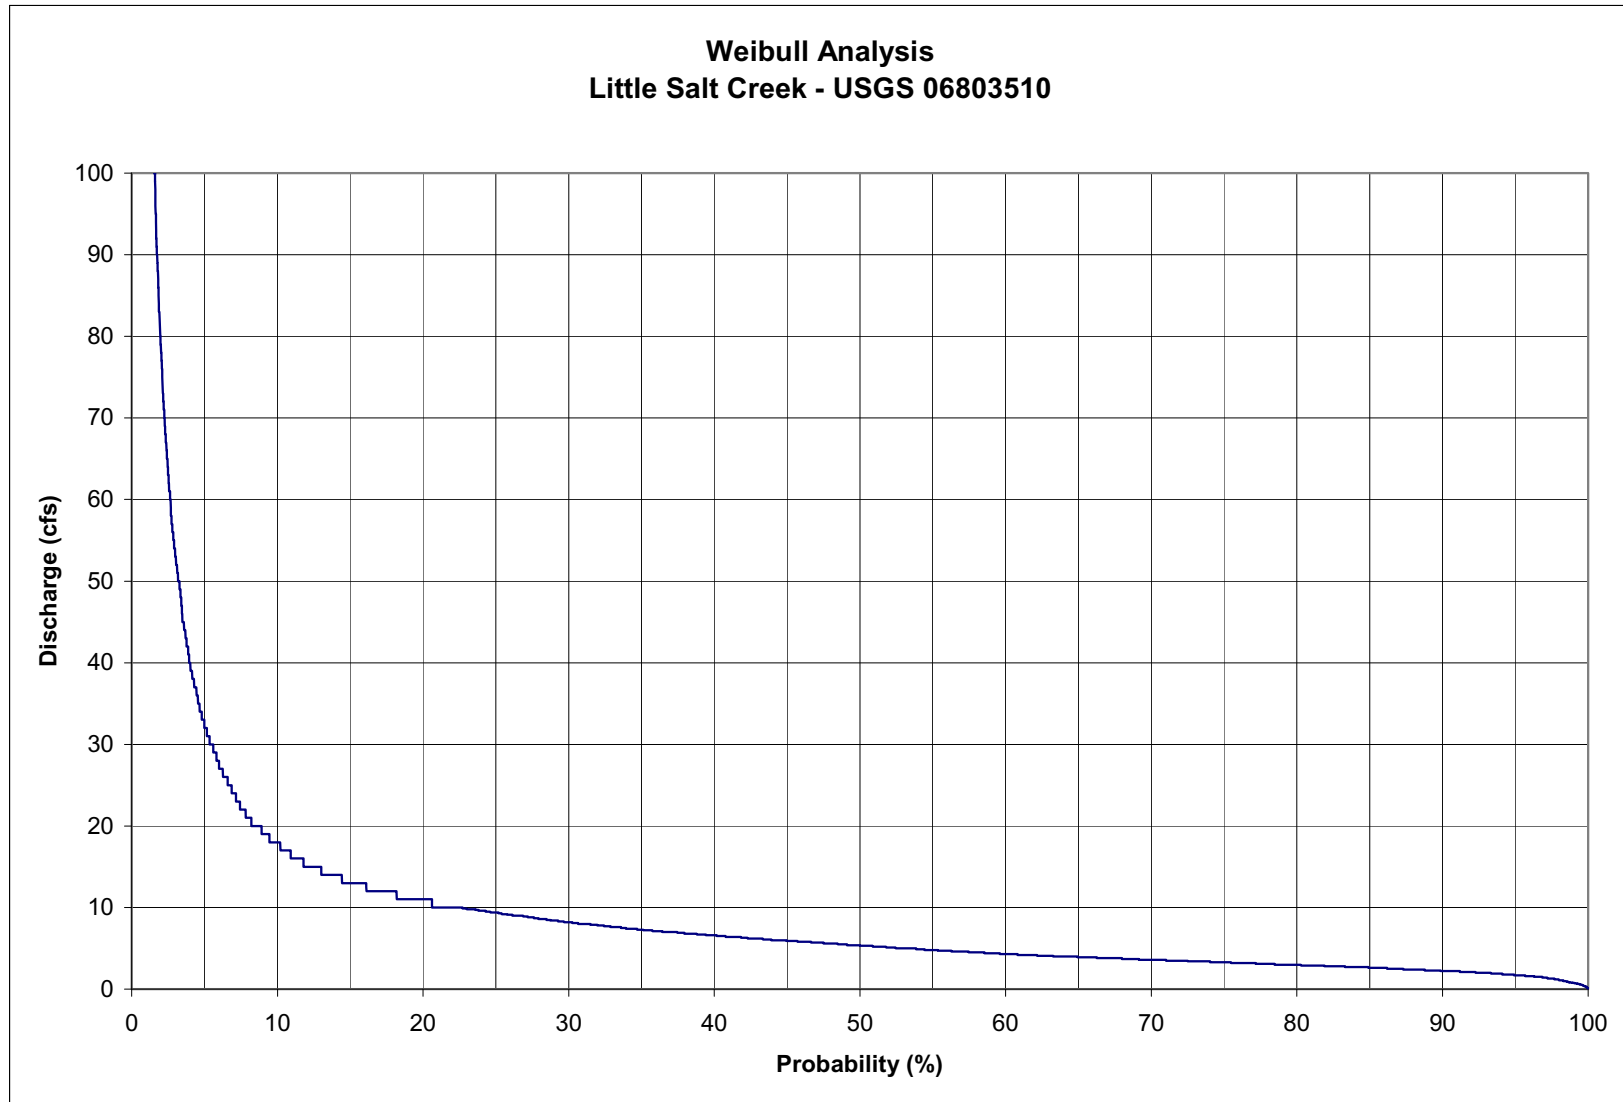
Since low flows peak discharges and volumes may be more influenced by watershed base flows, the first step in assessing low flows was to obtain an estimate for the average annual base flow for Little Salt Creek. Average daily flows for the period of record were obtained from the USGS stream gauge located at 27th and Arbor Street. These flows were then arranged from highest to lowest on a Weibull Chart. It was found that 95% of the flows were at or less than 32 cfs. Therefore a chart was developed showing the flow rankings for flows less than 100 cfs (see Figure 6-6). For the low flow analysis the flow which is approximately exceeded 50% of the time was adopted. This flow is 5.4 cfs. This flow was assumed to be distributed throughout the conveyance system based on a ratio to the contributing drainage area. At the gauge site the drainage area is 43.6 square miles. Therefore, the base flow was assumed to have a rate of 0.124 cfs/square mile of drainage area.

Figure 6-6: Weibull analysis of Little Salt Creek average daily flows at N 27th St and Arbor Rd

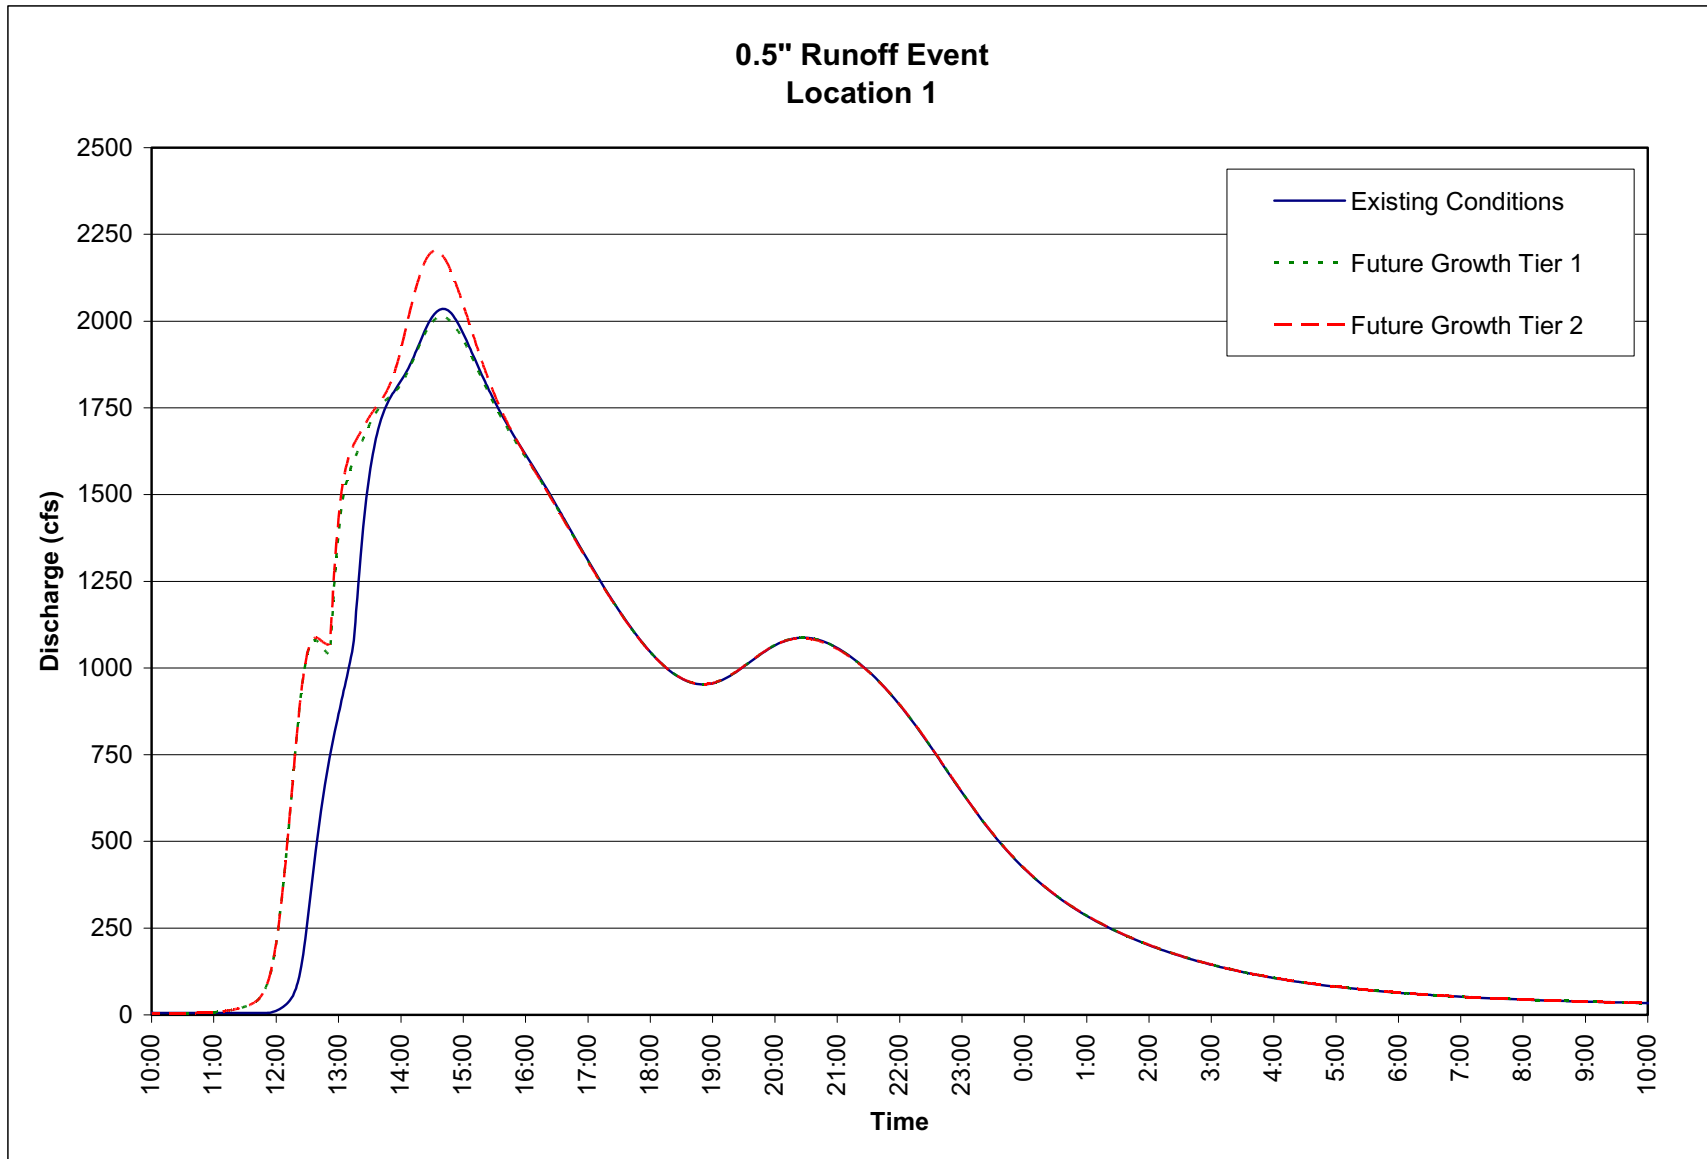
Figure 6-8: 0.5" runoff event resultant hydrographs of existing and future conditions scenarios at Location 1

Figure 6-9: 0.5" runoff event resultant hydrographs of existing and future conditions scenarios at Location 1 (first 6 hours of runoff)

It is noted that the main channel of Little Salt Creek is predicted to have a very slight lowering of peak discharge during an event producing a half inch runoff. In looking at the modeling results this was due to the peak runoff from the lower fifth of the basin becoming quicker, thus entering and leaving the main channel prior to the upper watershed contributing. This is reflected in the comparative tables above as well as displayed in Figures 6-8 and 6-9, which shows the multiple peaks due to timing differences between the upper and lower portions of the watershed for the half inch of watershed runoff. In review of Tables 6.2 and 6.4 above, the increase in future conditions storm volumes are much larger for the first six hours of runoff, with the percentage of increase dropping for the entire storm volume.

This is indeed possible, but it is noted that the design storm utilized is stationary. Storm systems that cause flooding frequently tend to be moving systems. Any storm system that would move from northwest to southeast within this watershed would allow the upper watershed to develop first, with the lower basin developing and contributing later. In this case, which is common, the predicted peak discharge at the confluence of the watershed would become higher.

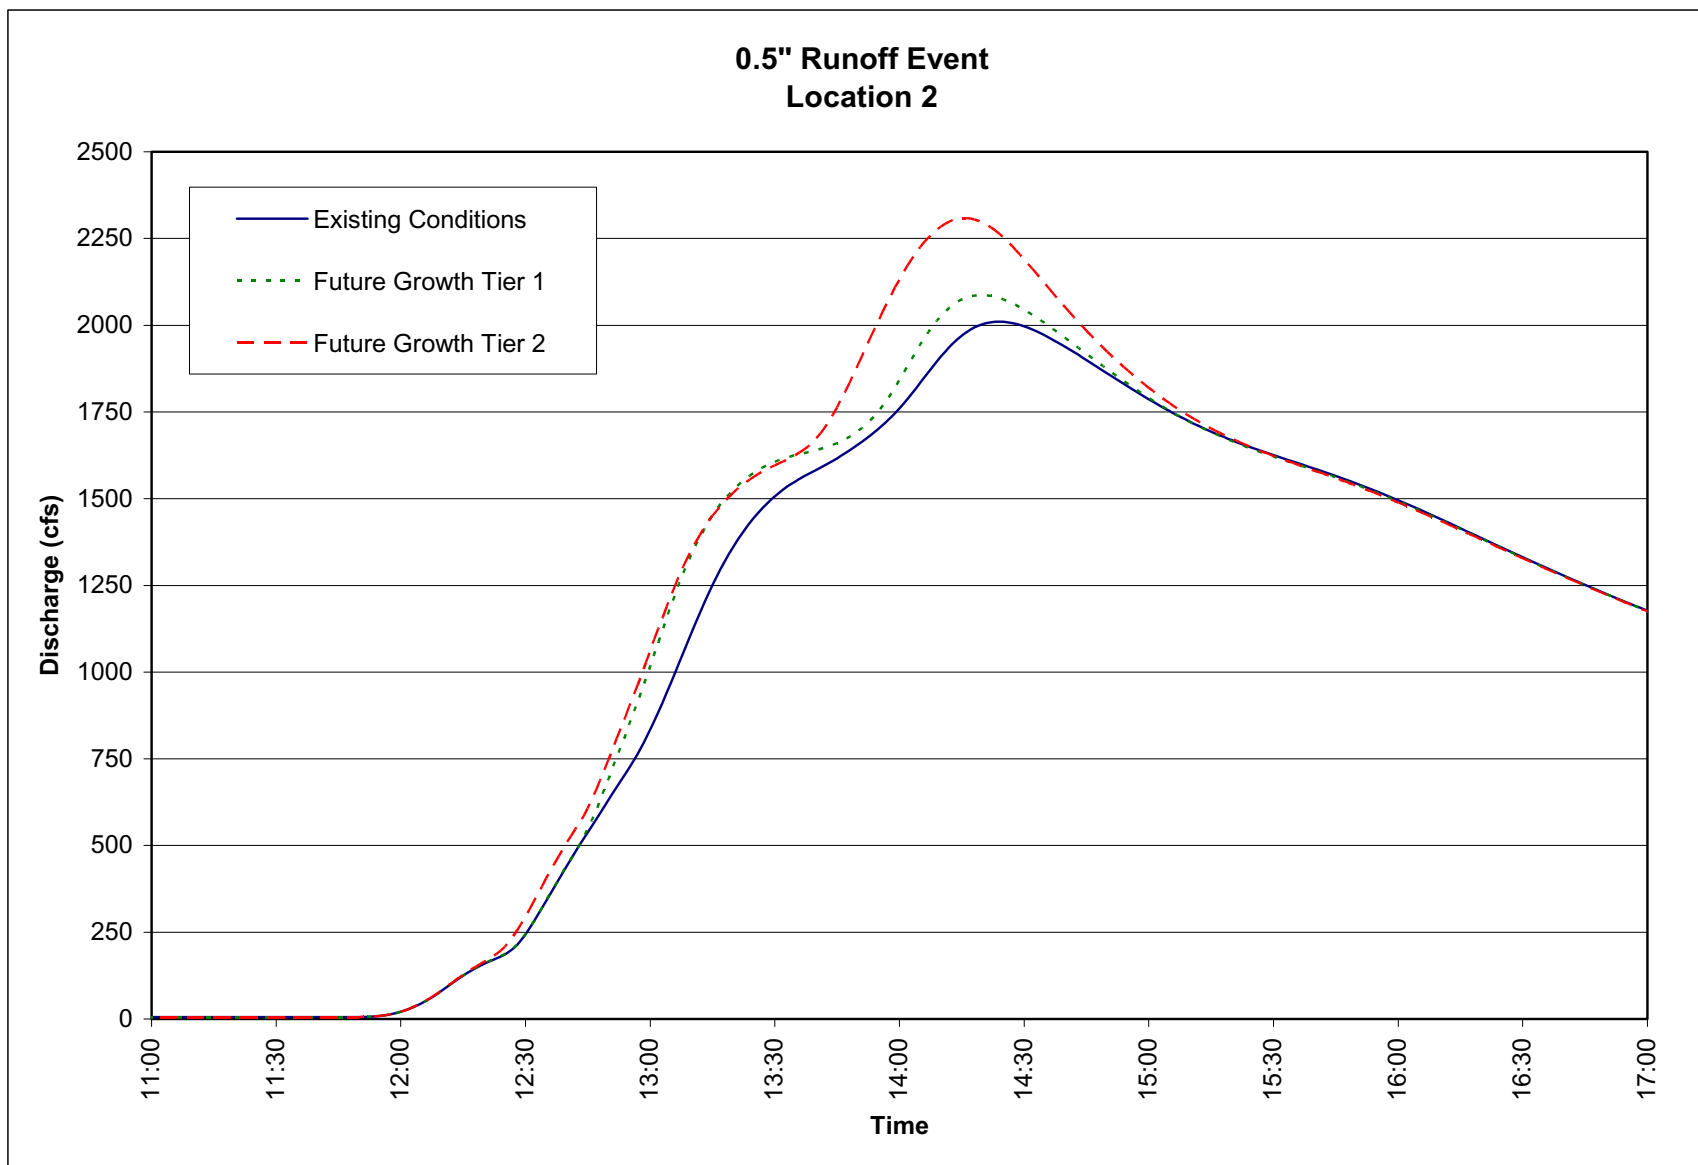
Figure 6-10: 0.5" runoff event resultant hydrographs of existing and future conditions scenarios at Location 2

Figure 6-11: 0.5" runoff event resultant hydrographs of existing and future conditions scenarios at Location 2 (first 6 hours of runoff)

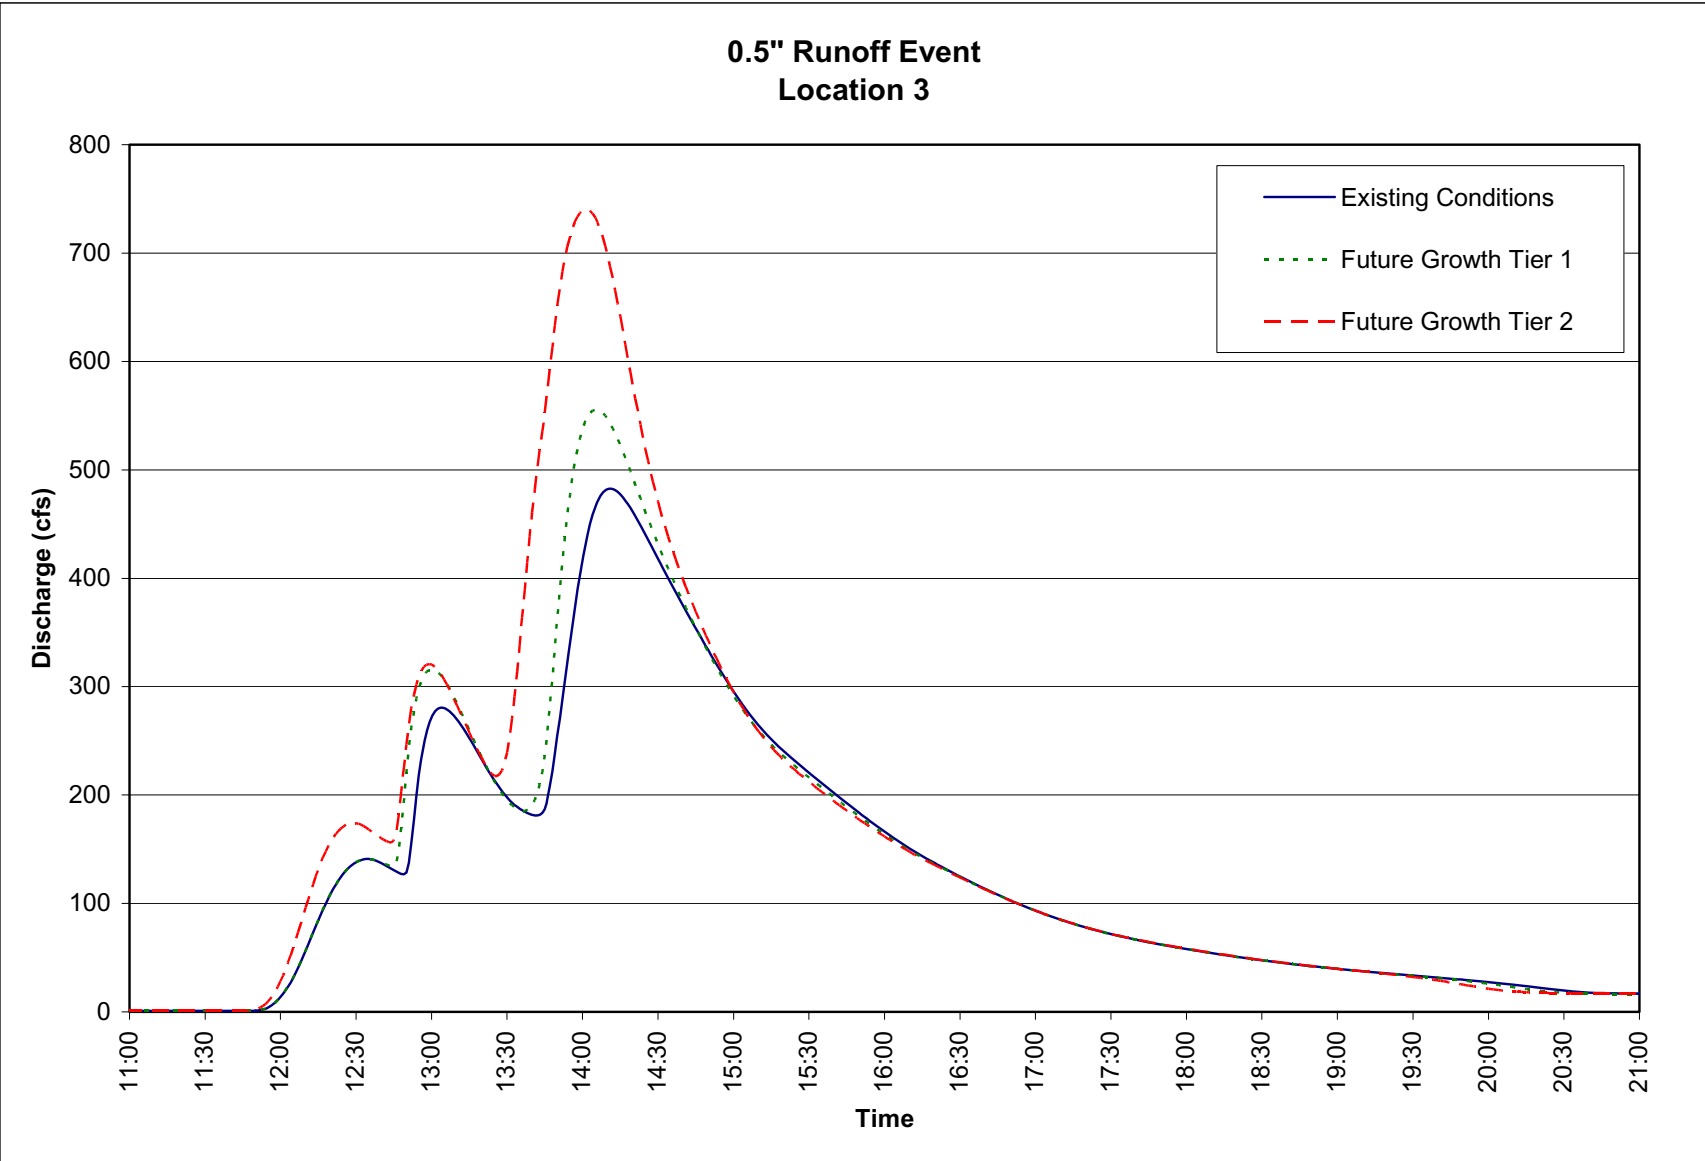
Figure 6-12: 0.5" runoff event resultant hydrographs of existing and future conditions scenarios at Location 3

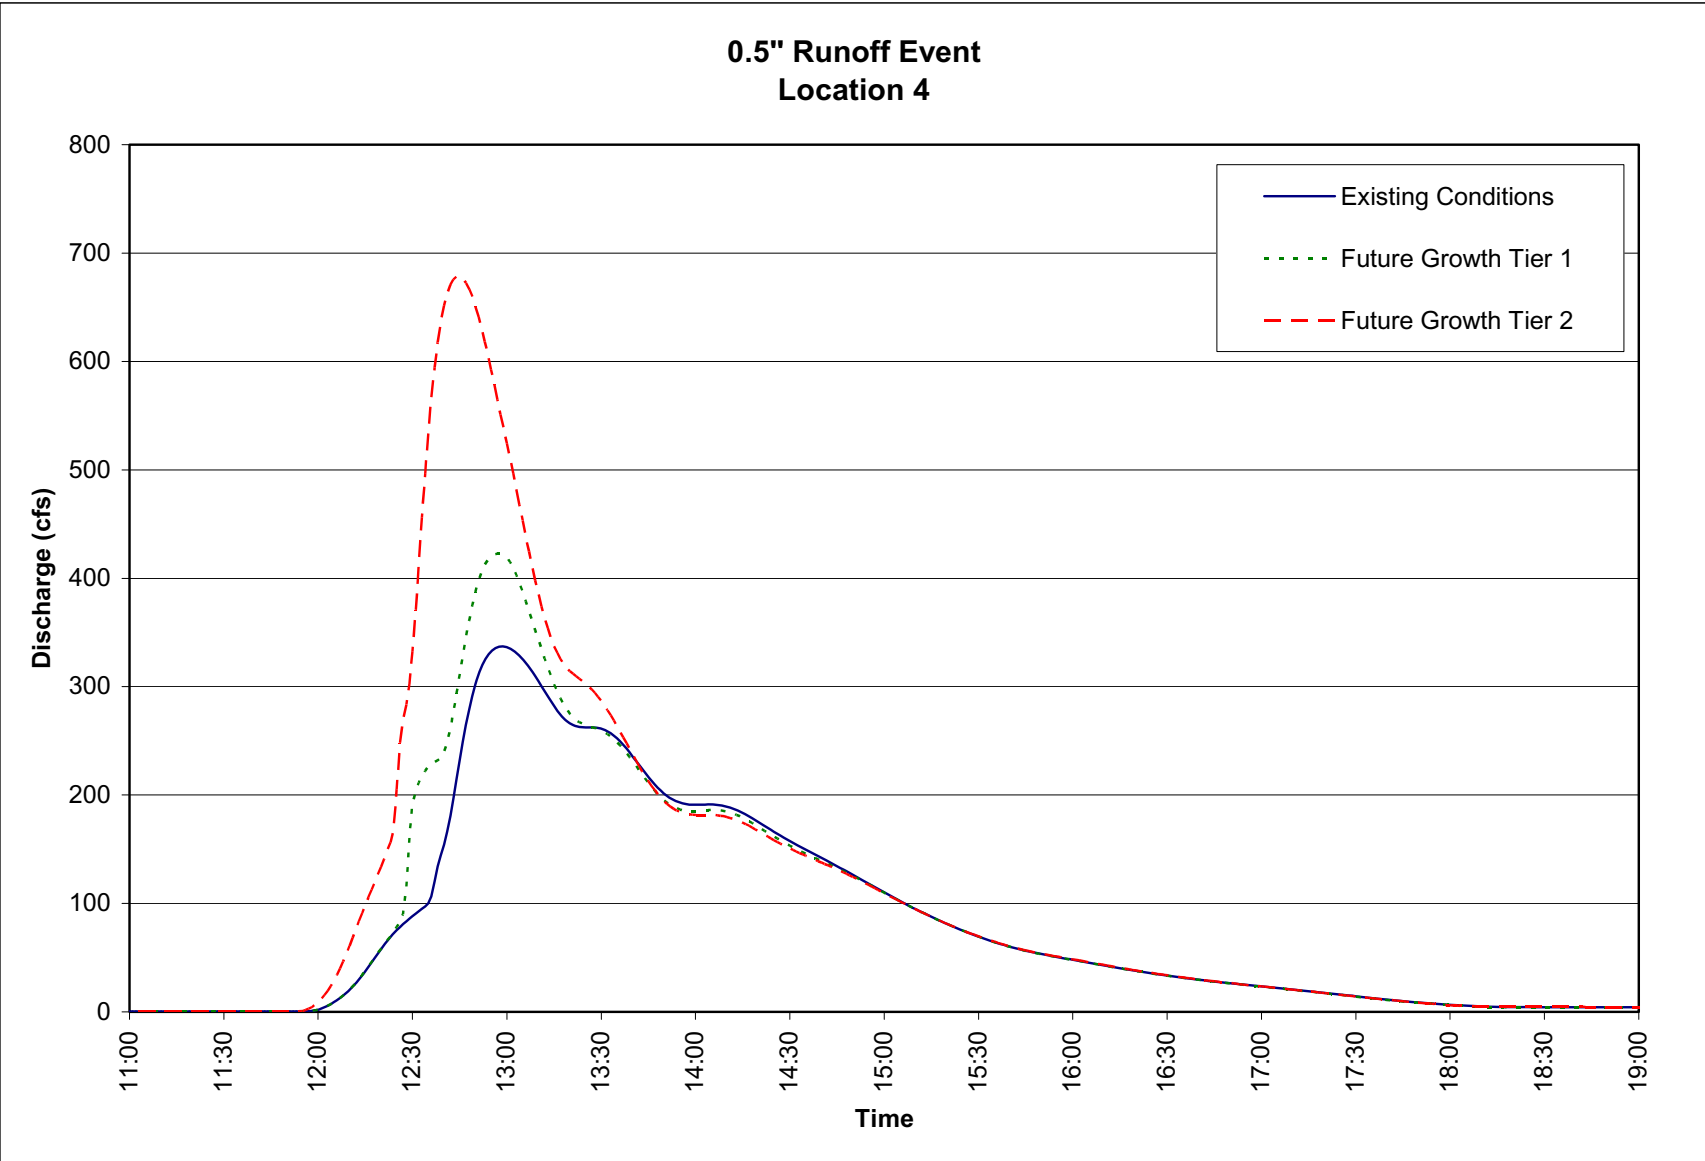
Figure 6-13: 0.5" runoff event resultant hydrographs of existing and future conditions scenarios at Location 4

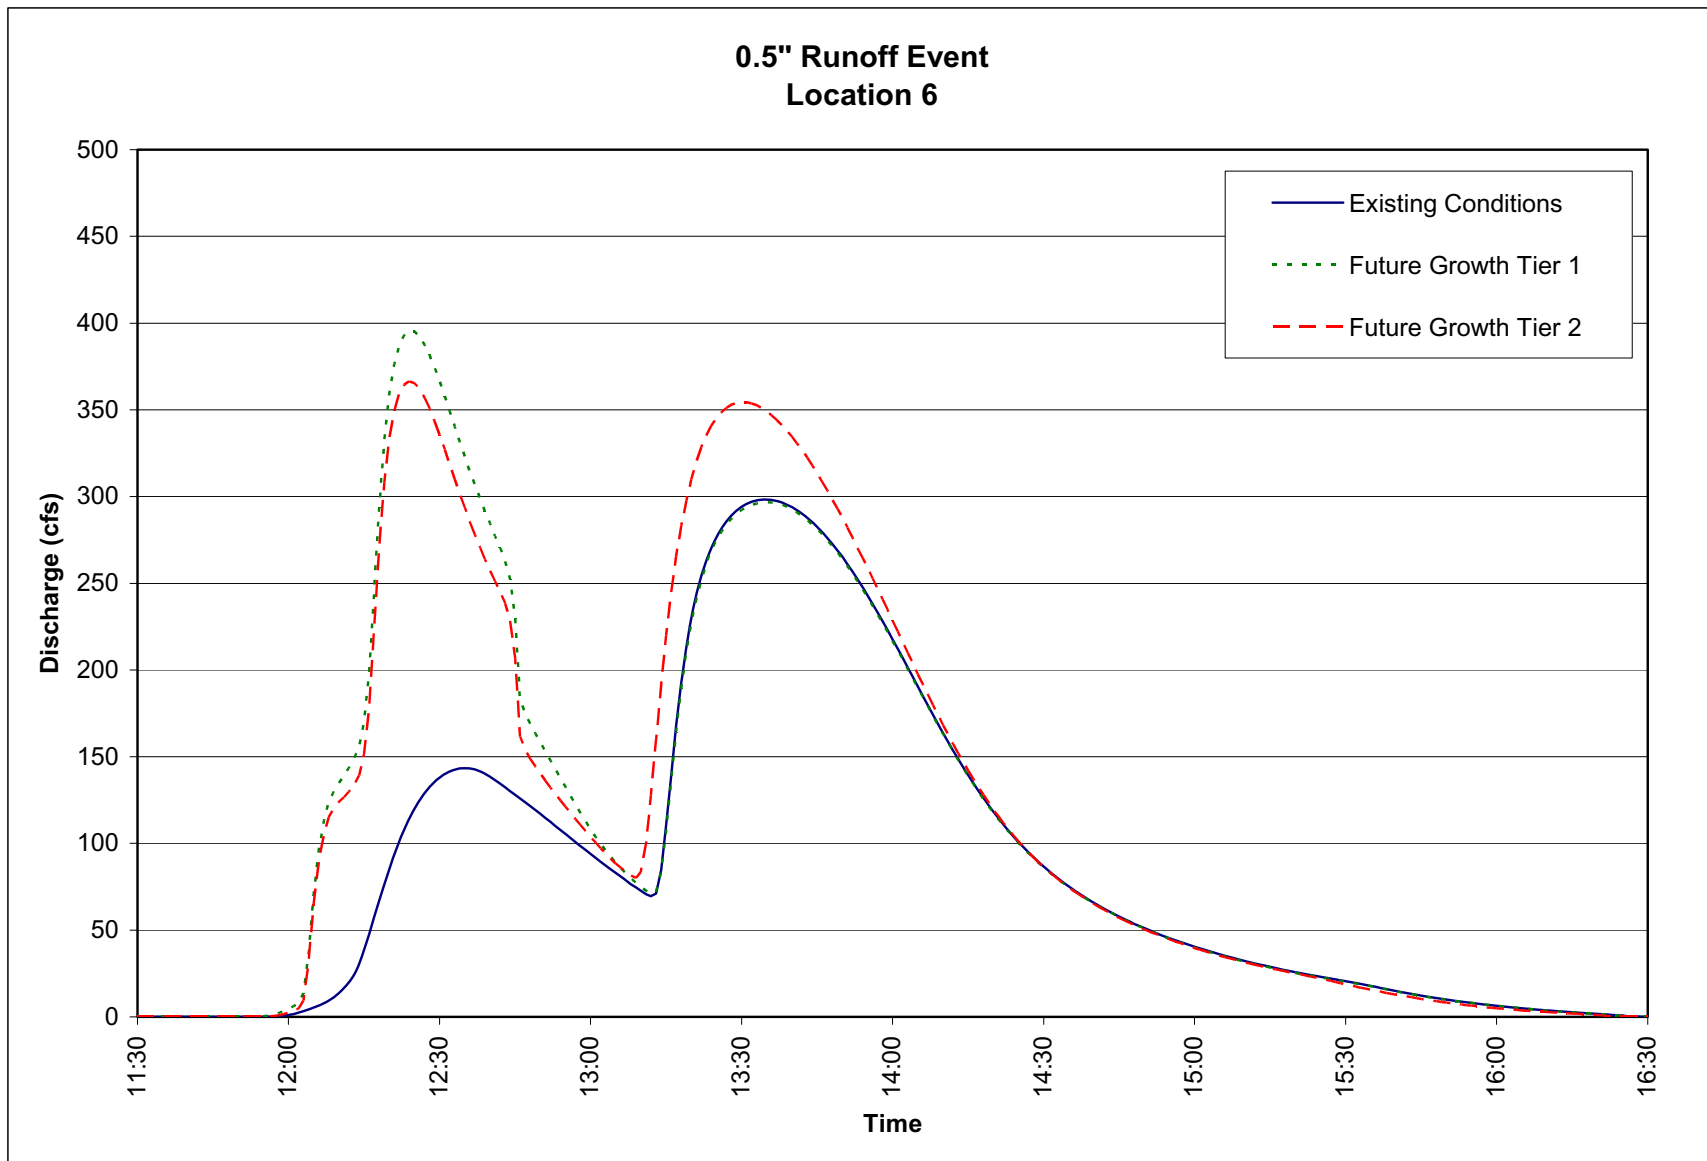
Figure 6-15: 0.5" runoff event resultant hydrographs of existing and future conditions scenarios at Location 6
