Section 2

Data Collection and Development

2.1 Watershed Inventory

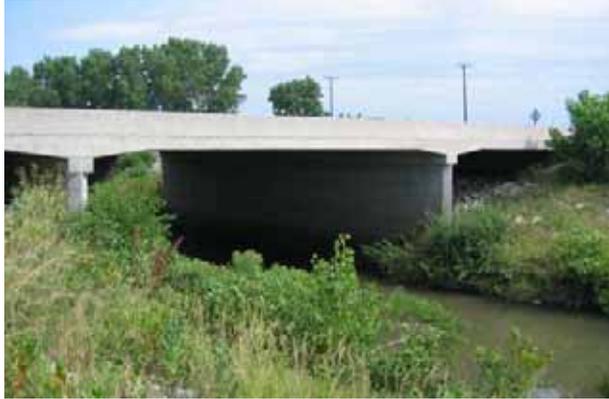
Highway 6 Bridge Crossing (SC05)

- **Bridges** – The types of information collected for each bridge included a stream cross section to define the upstream face of the bridge opening, centerline profile of the bridge decking, low chord elevation of the bridge, physical characteristics of the support system, and upstream and downstream photographs.

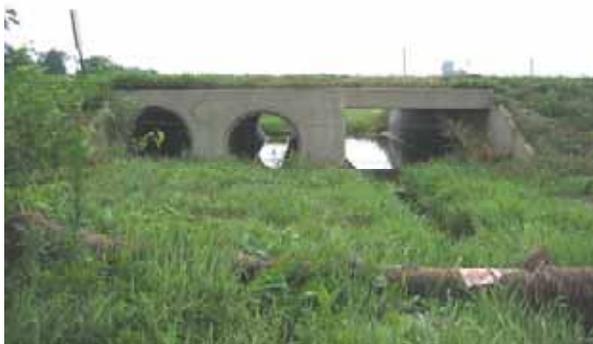
Culvert (SC040) extending beneath Havelock Avenue, just east of 70th Street

- **Culverts** – The types of information collected included a stream cross section immediately upstream of the culvert, centerline profile of the roadway crossing, upstream and downstream invert locations, opening dimensions, material type, wing-wall configuration, and upstream and downstream photographs.

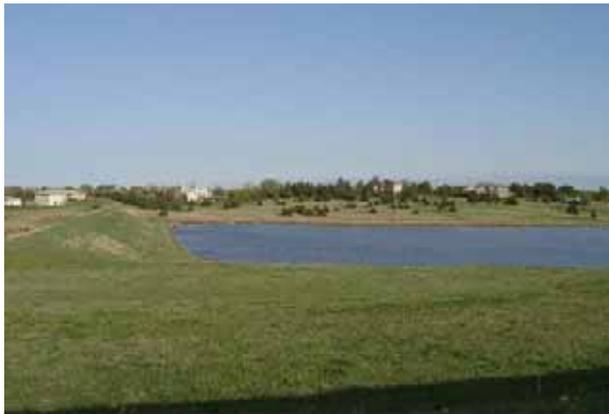
Magee Detention Facility (SC642) located near 120th and Yankee Hill Road

- **Detention Facilities** – Information was collected for detention facilities located along the stream centerlines, as shown on Figure 2-1, that provided significant watershed storage or impacted floodplain elevations. The types of information collected included the location and dimensions of the inlet and outlet structures, dimensions of the emergency spillway, centerline profile of the detention embankment, a cross section of the emergency spillway at the embankment toe and crest, and representative photographs. In addition, design drawings for regional detention facilities located upstream of the stream centerline were collected.
