Section 8

Geomorphic Evaluation

8.2 Stevens Creek Evaluation

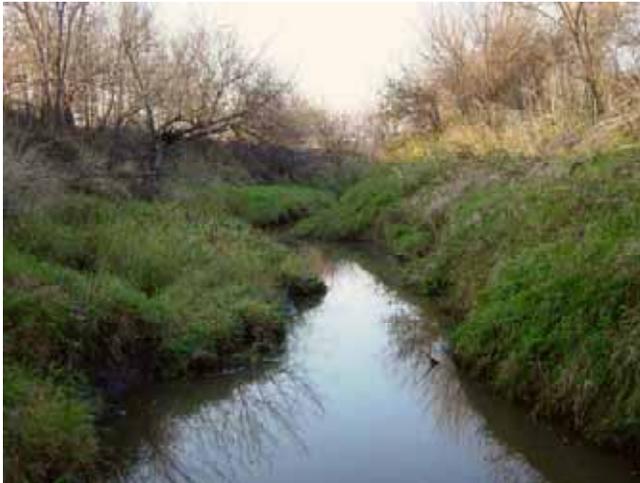
Widening followed by meander advance on the Lower Main Stem of Stevens Creek

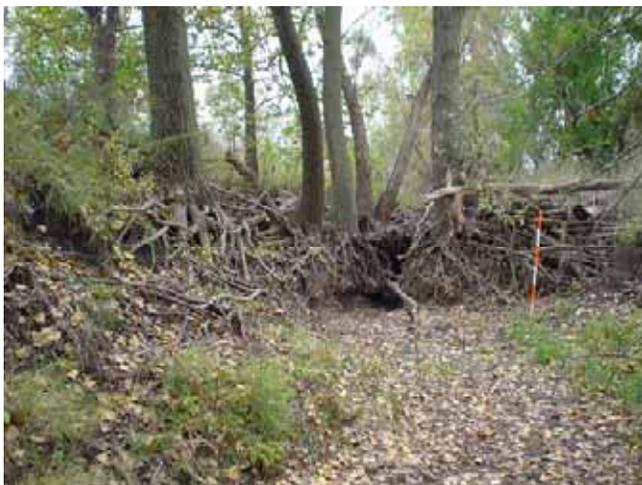
Incision arrested by tree roots on Stevens Creek (Tributary 45)

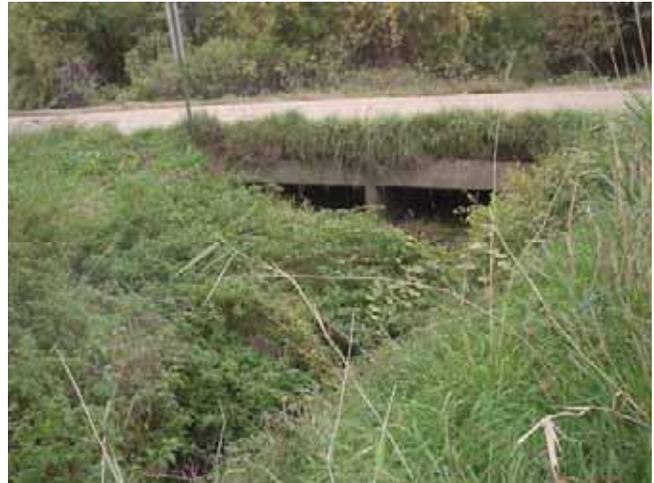
Deposition on Stevens Creek (Tributary 45)

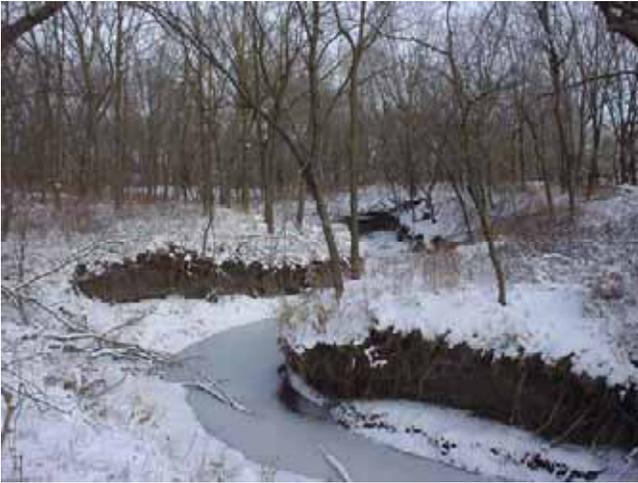
Meander advance on Stevens Creek (Tributary 96)

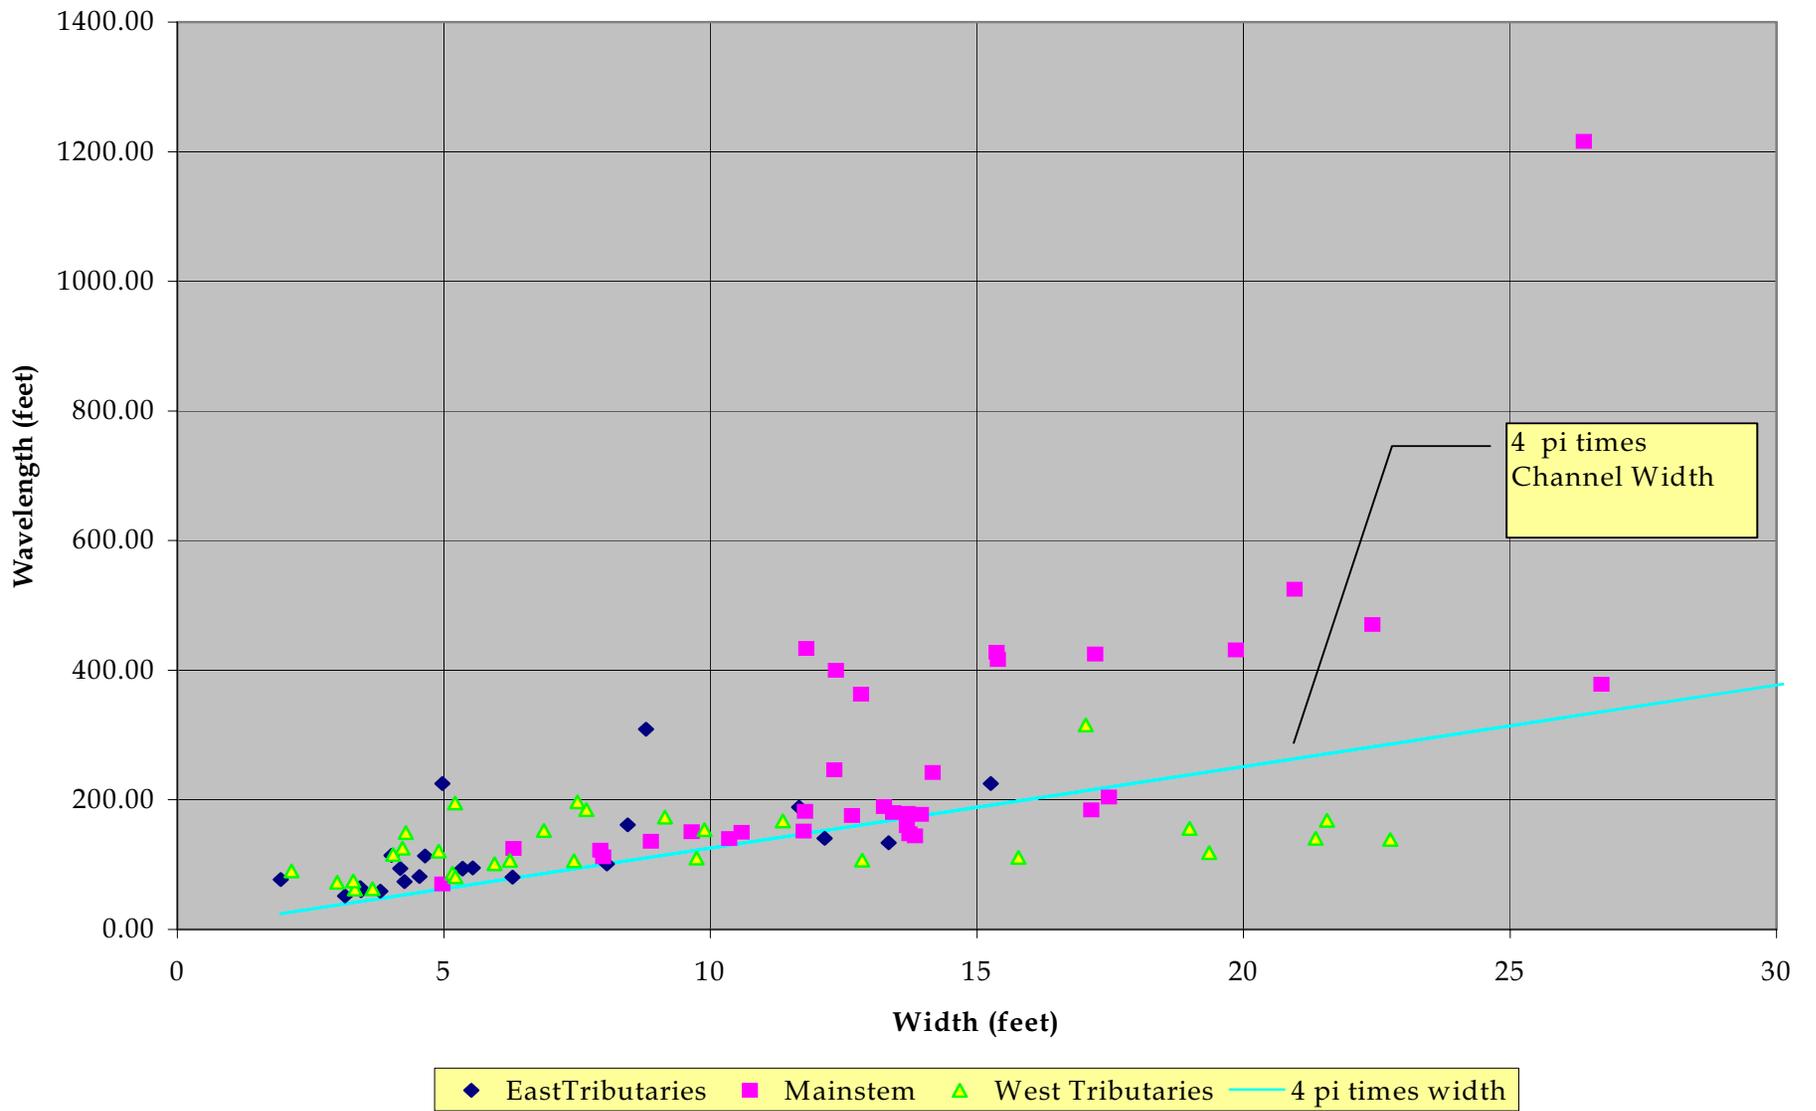
Figure 8-13
Wavelength versus Width by Location

The wavelengths appear slightly longer relative to channel width than is typical, particularly on the lower main stem (Figure 8-13). This may accurately reflect the channel conditions or may be an artifact of using the aerial two-foot contour to determine width.
