# Section 7

## Capital Improvement Projects

## 7.4 Capital Improvement Projects

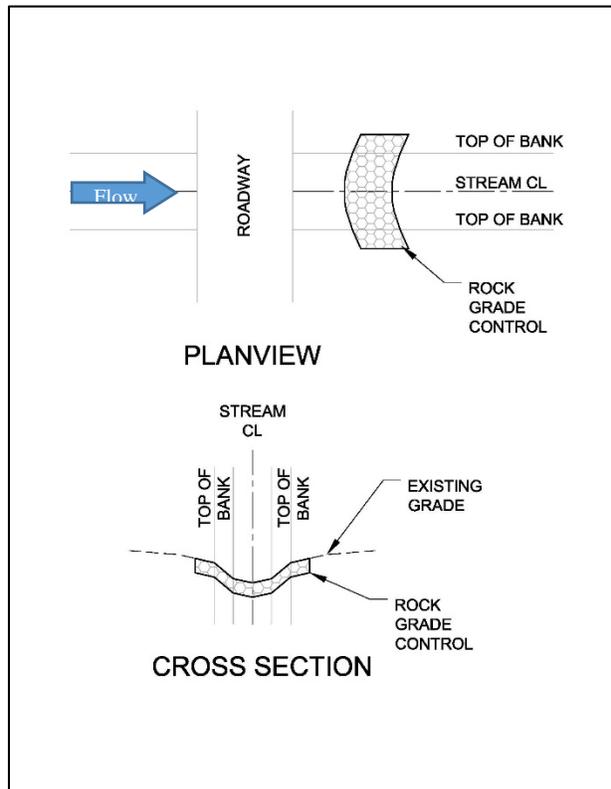
1. **Grade Control Projects** - construct grade controls along the main stem and tributaries at select locations to stop incision at these locations. The grade controls will stop incision at the site and limit the propagation and depth of incision upstream of each grade control project. Grade control projects also include any localized bank stabilization necessary to construct a stable grade control. The bank stabilization should incorporate the use of native riparian vegetation. The grade control should be placed at grade on the channel bottom and formed in a manner to mimic the elevation and stable slopes of the existing channel banks. Where stabilizing a knickpoint, a ramp slope of 20H: 1V maximum should be used. The grade control should extend to the top of each bank or the 25 year flow depth, whichever is greater. Consideration should be given to soil erodability, piping and shear stresses along the grade control and at the edges.

Figure 7-1: Rock Grade Control Structure Detail

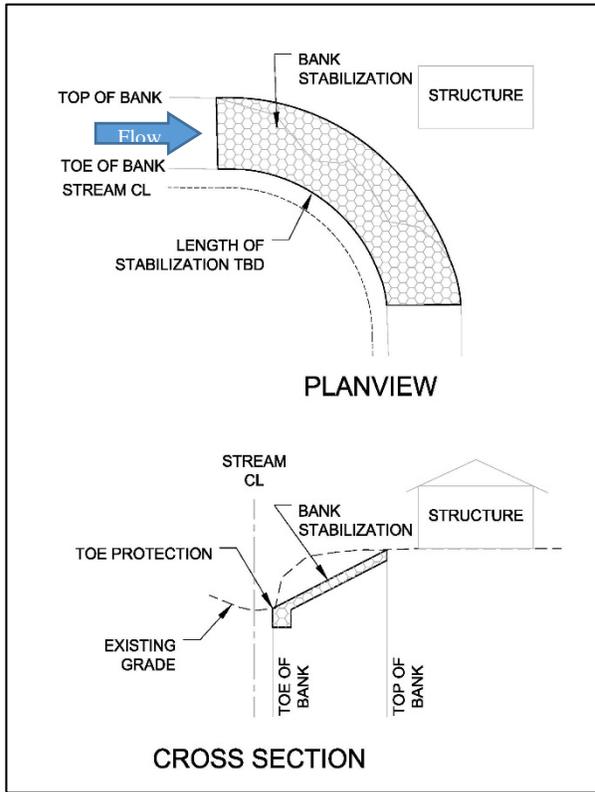
Figure 7-2: Bank Stabilization Structure Detail

2. **Bank Stabilization Projects** - construct engineered bank stabilization to protect identified infrastructure or structures from continuing bank erosion threatening the structure. The bank stabilization measures vary in size based on flow parameters, bank height, bank slope, site-conditions and other parameters. Bank stabilization should extend through the entire bend, beginning and ending at a riffle. To the greatest extent practical, bank stabilization shall be bio-engineered, incorporating the use of native riparian vegetation. Each bank stabilization project includes grade controls at the project limits to protect the stabilized bank from potential future incision and add to the systemic stability of the watershed study area.

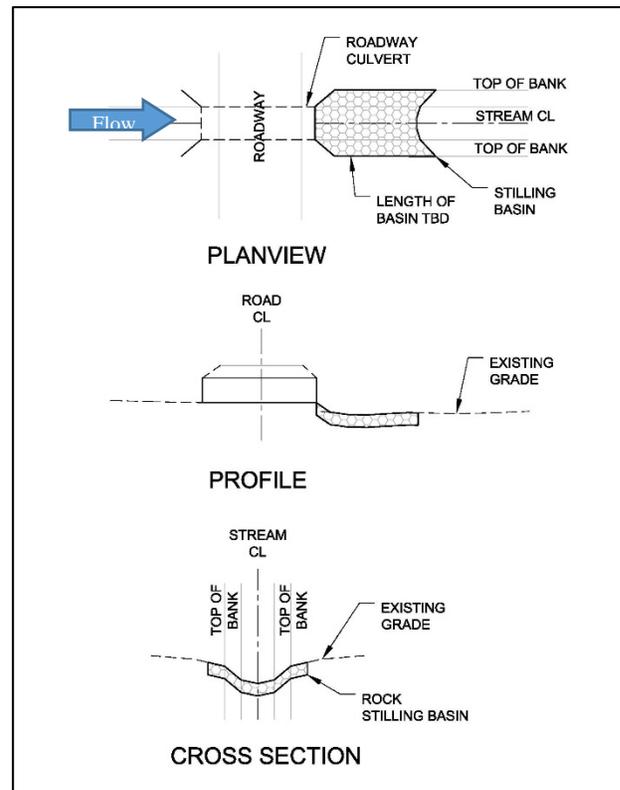
3. **Outlet Stilling Basin and Scour Protection** – construct a stilling basin or scour protection at the pipe or culvert outfall to protect the pipe from erosion and undermining due to outfall scour. The limits of protection should extend to the top of each bank or the 25 year flow depth, whichever is greater. Consideration should be given to soil erodability, piping and shear stresses through the scour protection and at the edges. When using a stilling basin, consideration should be given to the depth of scour anticipated in the plunge pool for a variety of flow events. Due to tailwater influences, the greatest potential for scour may not occur at the largest flowrate.

Figure 7-3: Stilling Basin Structure Detail

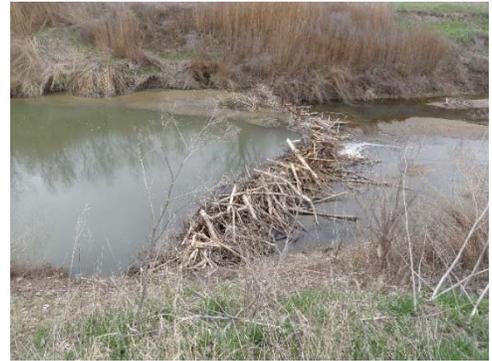
**Problem description:** An existing knickpoint in the main stem channel MCR005 approximately 600 feet northeast of the S Folsom St and Rosa Parks Way intersection.

Figure 7-5: Existing knickpoint

**Recommendation:** Recommend constructing an engineered grade control at or immediately upstream of the existing knickpoint to protect the public and private parcels contiguous to the channel at this locations. The grade control will prevent the knickpoint from propagating upstream. This project will be a joint City, NRD and State (NDOR) project and will need participation of all entities.

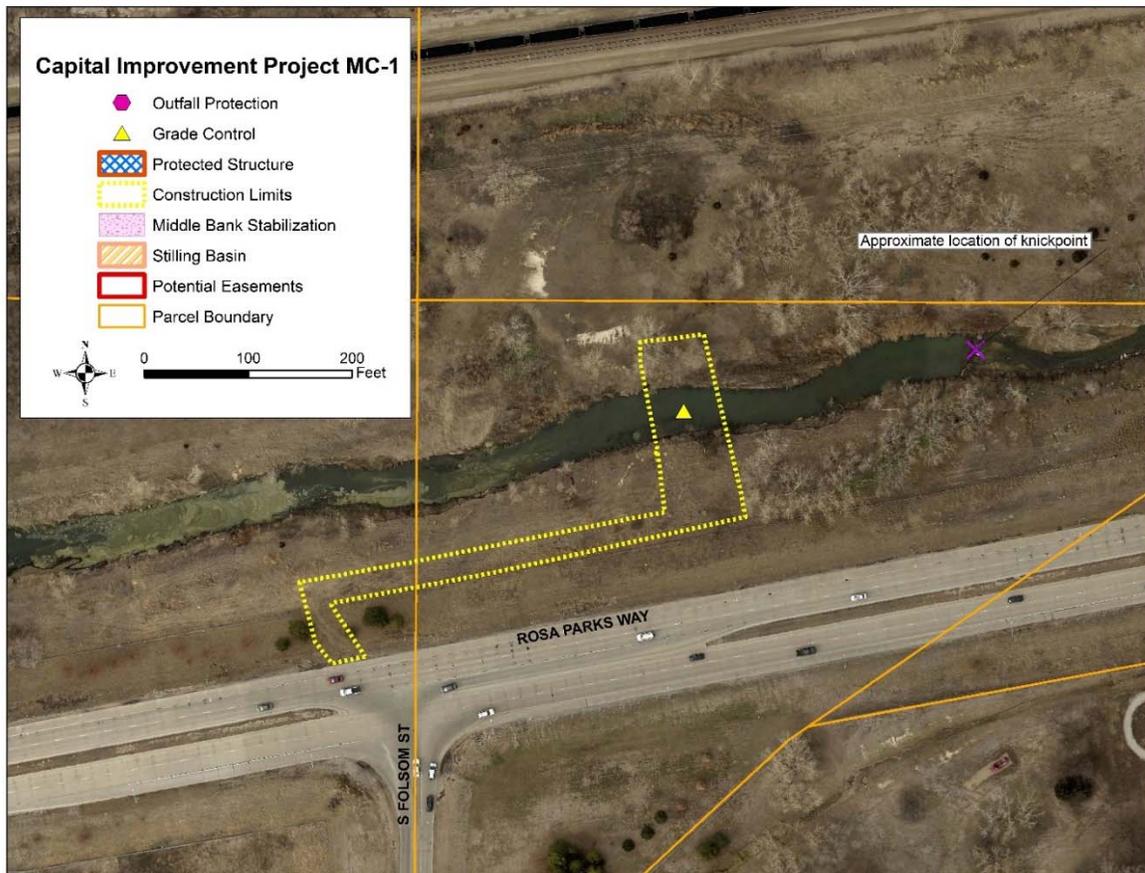
Figure 7-6: Conceptual Layout of MC-1

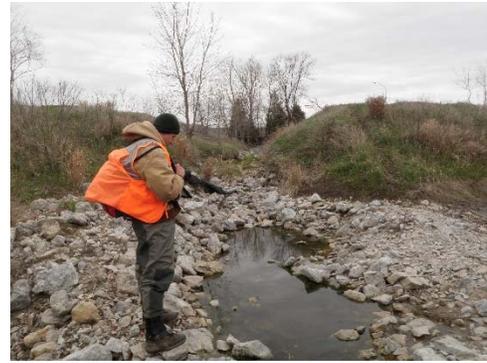
**Problem description:** The existing tributary MC005R005 grade control and bank armor along the reach immediately upstream of the confluence is failing. The rock appears to be undersized and is placed on top of geo-textile fabric. The rock is washing away and the fabric is becoming exposed. The project site is located 1,000 feet northwest of the S Folsom St and Rosa Parks Way intersection and is partially located within the existing State right-of-way. Potentially affected parcels are public property including Seacrest Park.

Figure 7-7: Failing grade control

**Recommendation:** Recommend removing the existing grade control and fabric and replacing with an engineered rock grade control to prevent further erosion. This project will be a joint City, NRD and State (NDOR) project and will need participation of all entities.

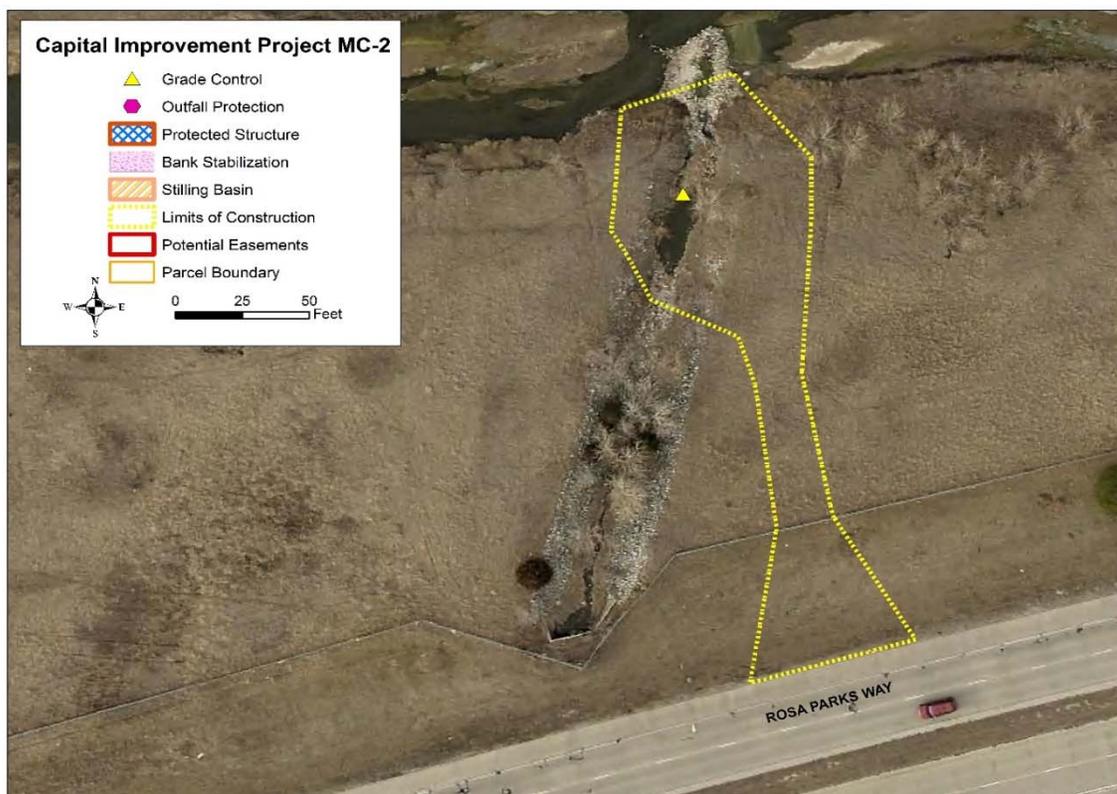
Figure 7-8: Conceptual Layout of MC-2

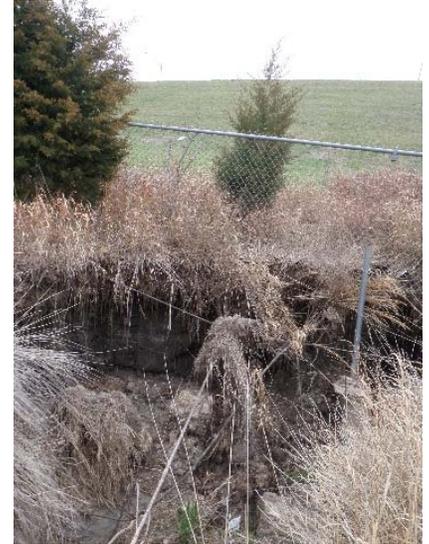
**Problem description:** Two pipe outfalls located high on the slope, away from the main stem channel MCR010 along the Rosa Parks Way ROW fence, is causing erosion on the right descending bank. The project sites are located directly northeast of the Rosa Parks Way and Homestead Parkway interchange and is partially located within the existing State right-of-way. At the east location, a large area of scour and erosion is present at the outfall, and the fence has been undermined. At the west location, the invert of a CMP culvert has rusted out and the outfall beneath the CMP is eroding. The erosion from these outfalls potentially affects parcels which are public property.

Figure 7-9: Pipe outfall erosion

**Recommendation:** Recommend replacing the CMP culvert outfalls and constructing scour protection at each location to stop the erosion. In addition, reshape and rock line the erosion from the pipe outfall to the channel and repair the fence. This project will be a joint City, NRD and State (NDOR) project and will need participation of all entities.

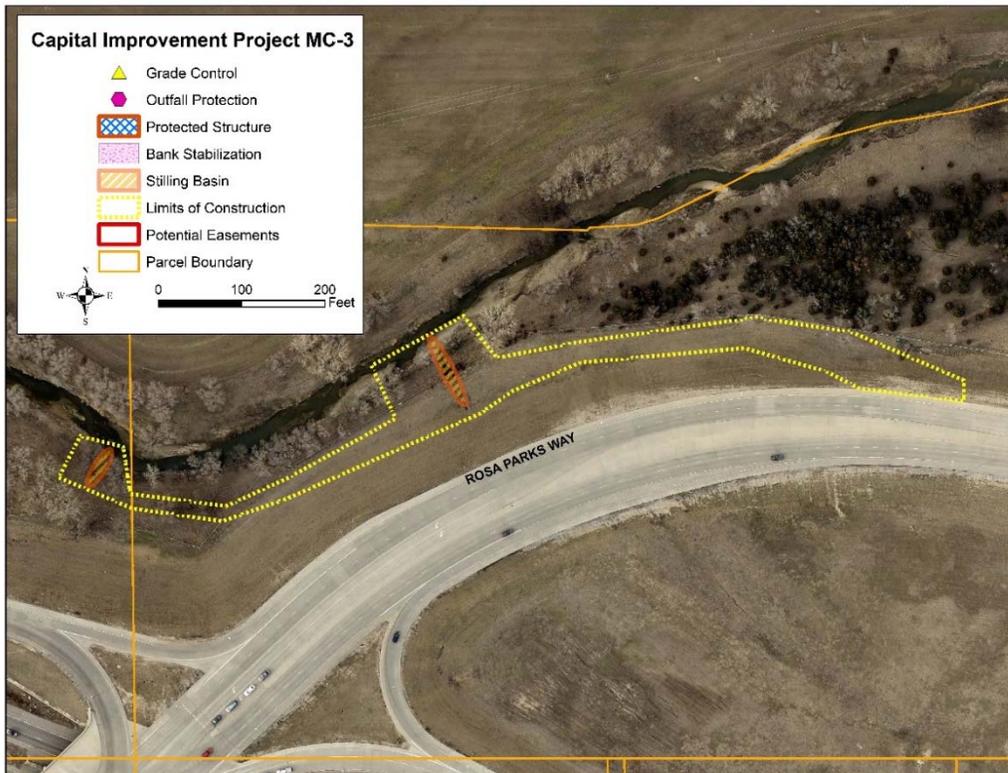
Figure 7-10: Conceptual Layout of MC-3

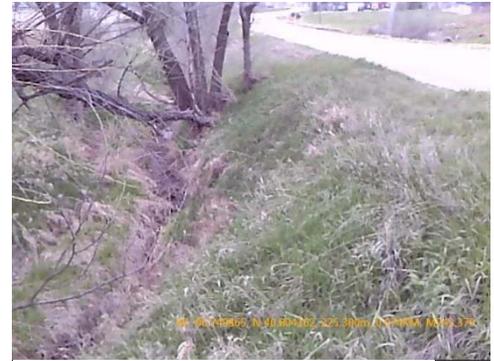
**Problem description:** Bank erosion and channel incision along tributary MC015R005 is threatening S Coddington Ave just north of the S Coddington Ave and W Millstone Rd intersection and is partially located within the existing State right-of-way. At one location, the bank erosion is within 10 feet the edge of S Coddington Ave pavement. In addition, the invert of the existing CMP culvert outfall for this tributary has rusted out and the slope under the CMP is eroding. The CMP is located on the right descending bank at the confluence with the main stem.

Figure 7-11: Bank cutting along tributary/ditch parallel to S Coddington Ave.

**Recommendation:** Recommend constructing bank stabilization with associated channel modification to stop erosion along the tributary. In addition, replace the rusted CMP outfall and reshape and rock line the erosion from the pipe outfall to the channel. This project will be a joint City, NRD and State (NDOR) project and will need participation of all entities.

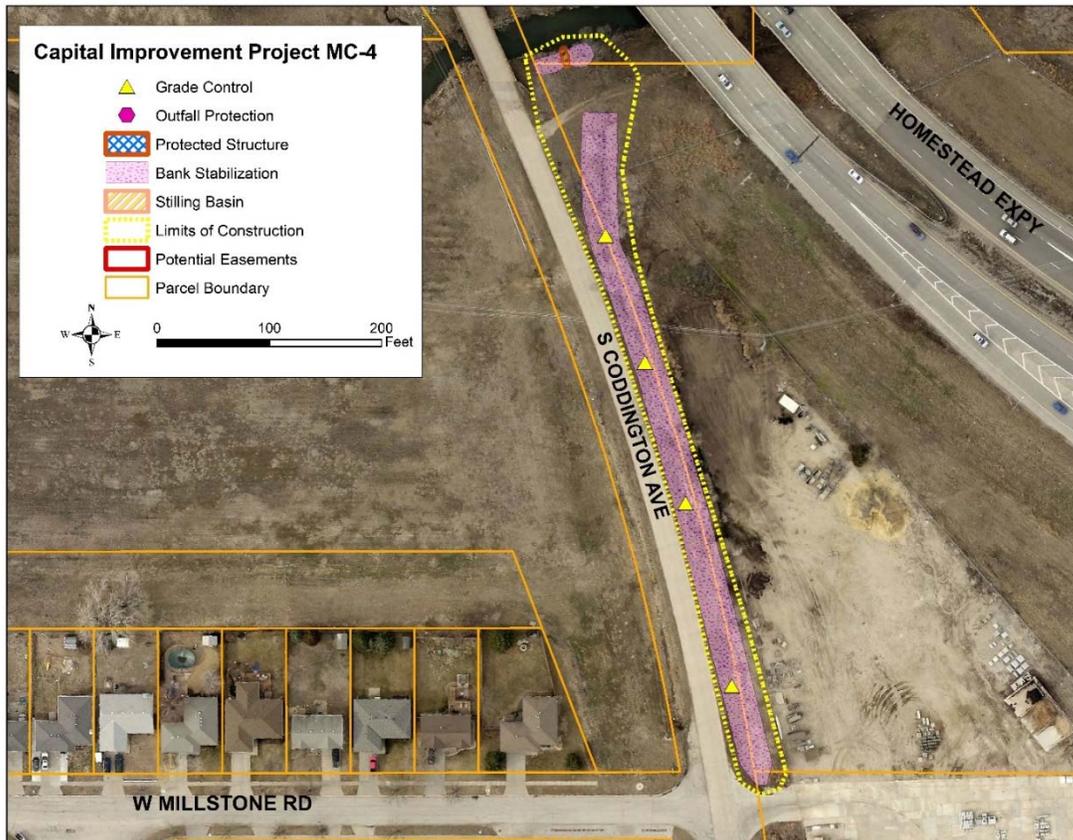
Figure 7-12: Conceptual Layout of MC-4

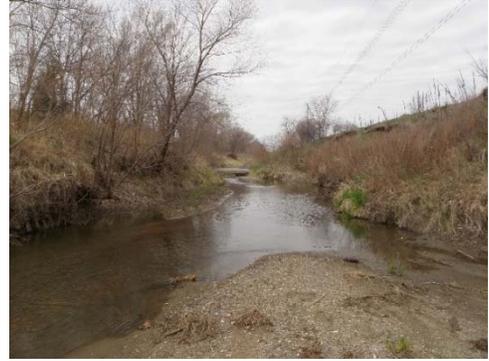
**Problem description:** The main stem MCR020 along this reach has incised and transitioned into widening. Center bars and active slumps are still present throughout this reach, however this reach also exhibits signs of transition from widening to a stable sediment transport, as indicated by the presence of riffles. The stability appears tenuous based on the presence of multiple knickpoints along the reach. Securing the

Figure 7-13: Project Reach

knickpoints with engineered grade controls will help stabilize this reach by preventing future incision caused by the knickpoints propagating upstream. The reach extends 5,400 feet east of SW 40<sup>th</sup> St. The access is approximately 0.25 miles north of SW 40<sup>th</sup> St and West F St. Potentially affected parcels are both publicly and privately owned property. The profile grade is at 1,145 feet at the upstream limits of the project reach and 1,139 feet at the downstream limits. 4 to 6 grade controls appear sufficient to accommodate this 5 feet of grade change.

**Recommendation:** Recommend installing 4 to 6 engineered grade controls along 5,400 feet of channel along the main stem to halt future incision along this reach. An additional rock grade control is recommended at the tributary on the left descending bank to provide a stabilized construction access. This project will be a joint City, Country, NRD and Burlington Northern Santa Fe Railroad project and will need participation of all parcel owners.

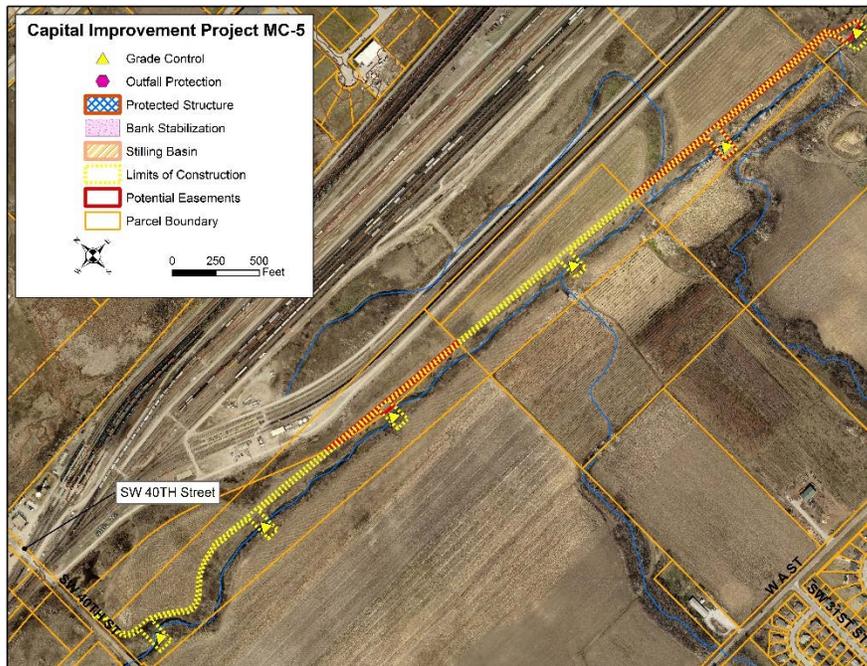
Figure 7-14: Conceptual Layout of MC-5

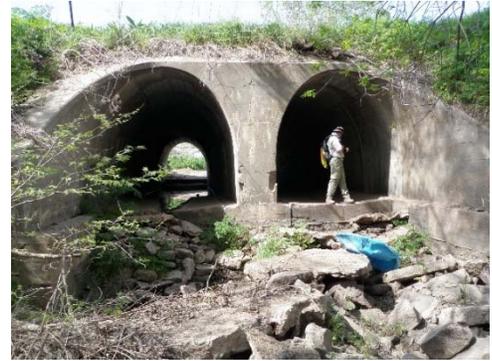
**Problem description:** The tributary MC60R015 culvert on the 7400 block of W O St is perched, and the culvert footings have been exposed. The project is located 3,800 feet east of the NW 84<sup>th</sup> St and W O St intersection and is partially located within the existing State right-of-way. Potentially affected parcels are both publicly and privately owned.

Figure 7-15: Perched W O St culvert

**Recommendation:** Recommend removing the existing dumped rubble and constructing an engineered stilling basin and rock grade control structure to protect the culvert outfall. This project will be a joint City, NRD and State (NDOR) project and will need participation of all parcel owners

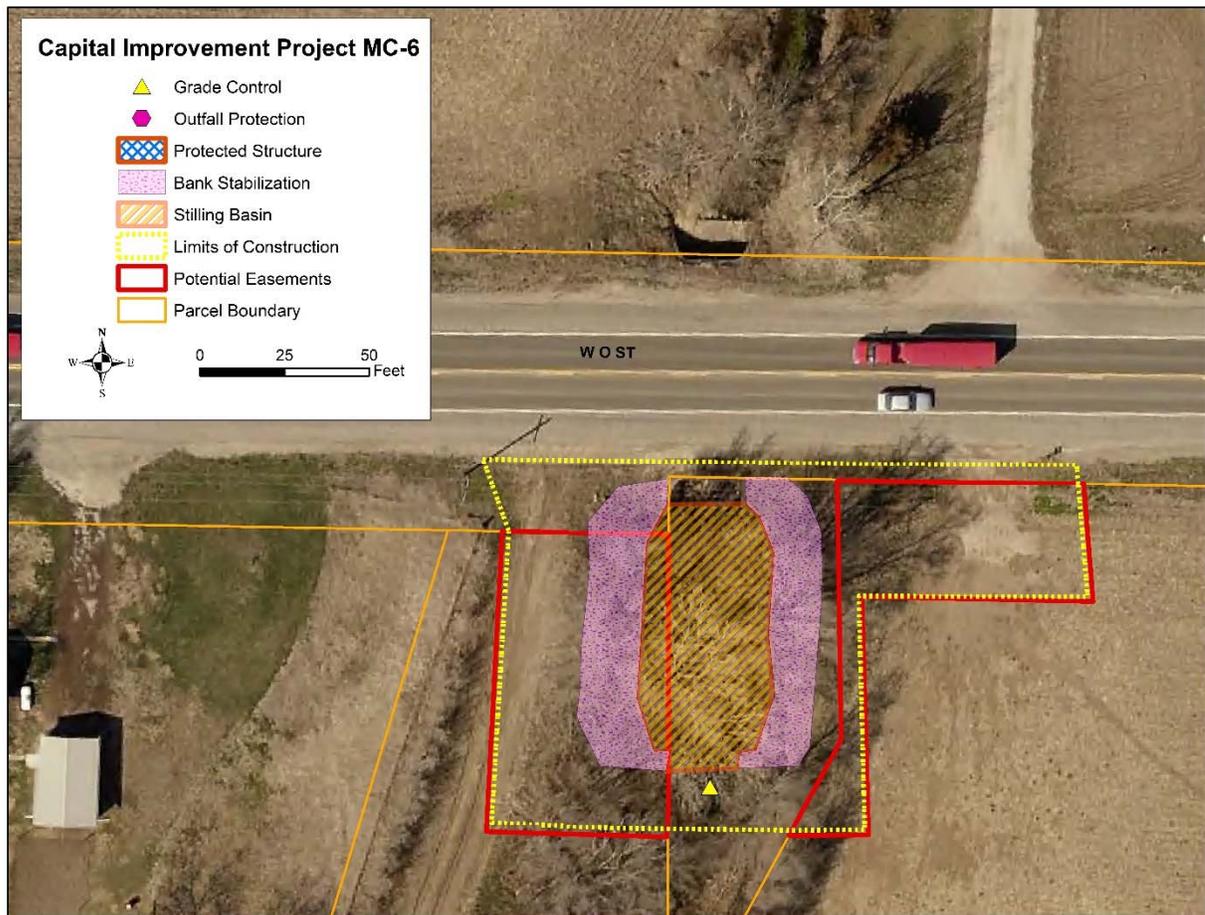
Figure 7-16: Conceptual Layout of MC-6

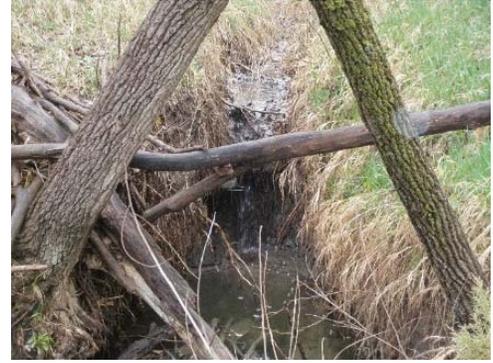
**Problem description:** A 3 foot knickpoint is located in tributary MC070R005 approximately 2,170 feet west of NW 84<sup>th</sup> St and 130 feet north of I-80 and is partially located within the existing State right-of-way. In addition, the I-80 culvert outfall at this location is perched from past incision.

Figure 7-17: 3 foot knickpoint

**Recommendation:** Recommend installing grade control structures to stop incision and installing a stilling basin and grade control structure to protect the culvert outfall. This project will be a joint City, NRD and State (NDOR) project and will need participation of all entities.

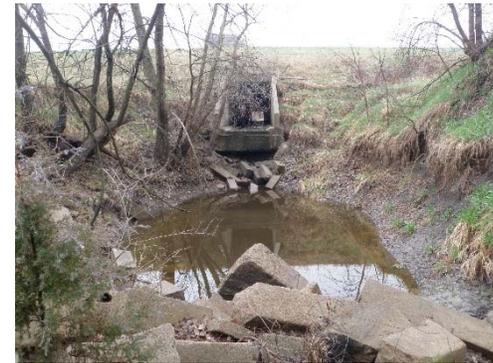
Figure 7-18: I-80 culvert outfall

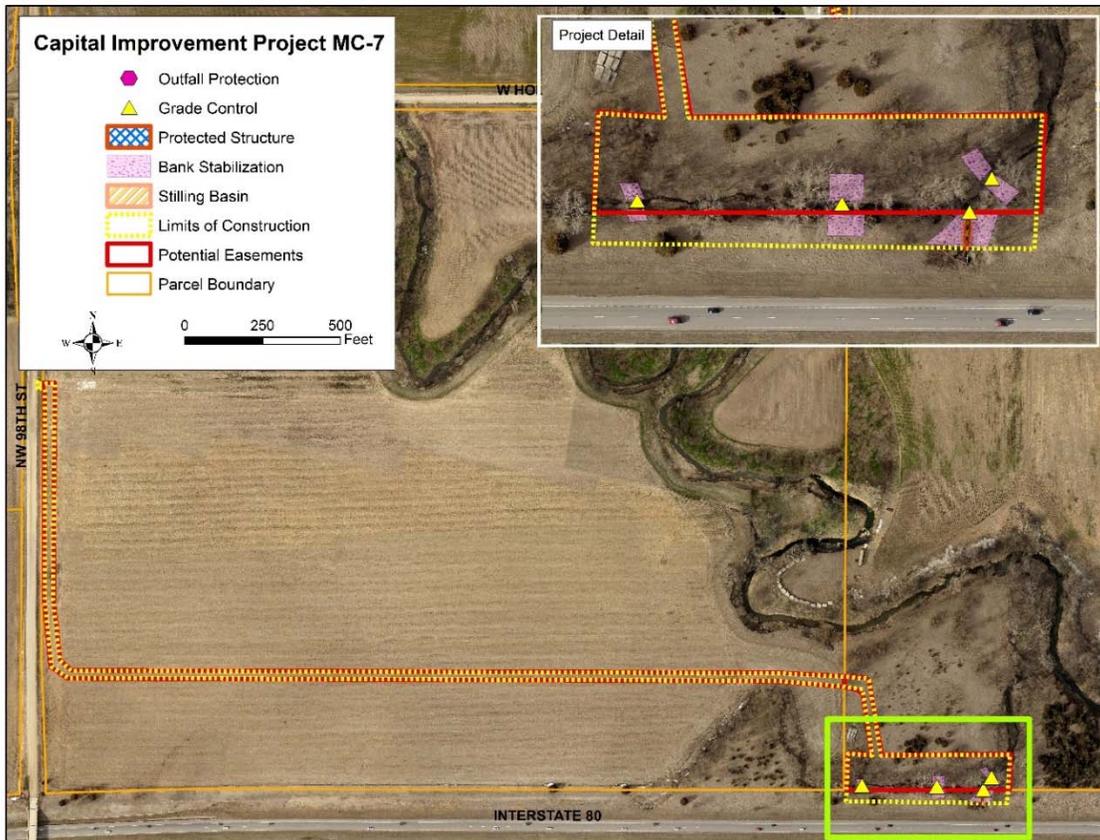
Figure 7-19: Conceptual Layout of MC-7

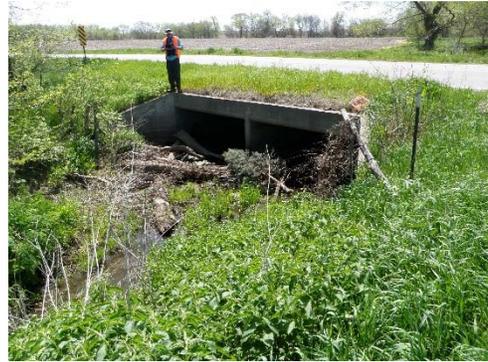
**Problem description:** Hydraulic analysis completed based upon available hydrologic and as-built data, indicates that roadway overtopping will occur during a 100-year flow event at this road crossing for tributaries MC075R015 and MC070R020. Roadway overtopping at this location could be eliminated if the culvert capacity is increased. The channel capacity at this location is sufficient to convey flood flow without overtopping the roadway.

Figure 7-21 – W Adams St culvert

**Recommendation:** Conduct further evaluation of the culvert crossing to augment prioritization for culvert replacement.

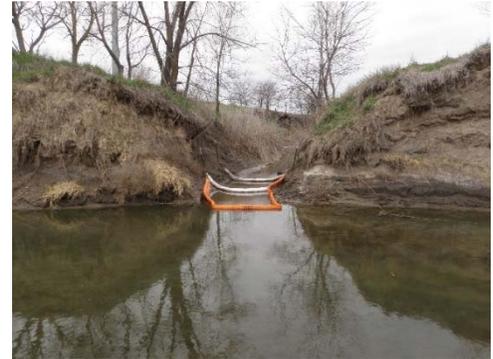
**Problem description:** Tributary MC010R005 is incised between its confluence with the Middle Creek main stem MCR010 and the railroad tracks. Incision is beginning to threaten the railroad utility road. The incised reach is about 150 feet long and located 3,000 feet downstream of Homestead and 600 feet north of Rosa Parks Way. Additionally, the erosion control measures are failing causing construction sediment to be discharged.

Figure 7-23: Incising tributary

**Recommendation:** Place grade control in the tributary to stop incision.

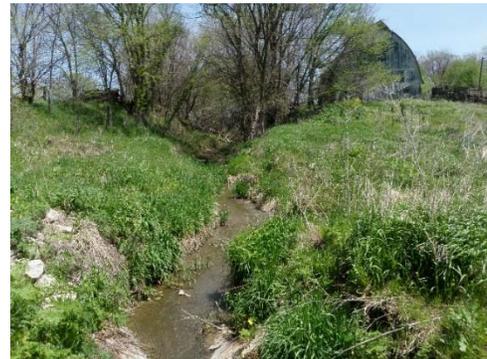
**Problem description:** At this location on tributary MC075R005 a barn is located at the top of the channel adjacent to a 1:1 bank slope and is susceptible to bank erosion. Project is located 1,000 feet upstream of W Holdrege St between NW 98<sup>th</sup> St and NW 84<sup>th</sup> St. Potentially affected parcels are private property.

Figure 7-25: Barn Near Top of bank

**Recommendation:** Recommend constructing bank stabilization in the vicinity of the barn with associated grade controls.
