NEBRASKA CAPITOL ENVIRONS COMMISSION

NEBRASKA CAPITOL ENVIRONS COMMISSION STAFF REPORT

APPLICATION NUMBER	Urban Design Record #23016
APPLICATION TYPE	Certificate of Appropriateness
ADDRESS/LOCATION	1526 K Street
HEARING DATE	February 24, 2023
ADDITIONAL MEETINGS	N/A
APPLICANT	Michelle Potts, State Building Division, michelle.potts@nebraska.gov
STAFF CONTACT	Collin Christopher, 402-441-6370, cchristopher@lincoln.ne.gov

NDAS FNAB 1526 Exterior Renovations
Capitol Environs Review

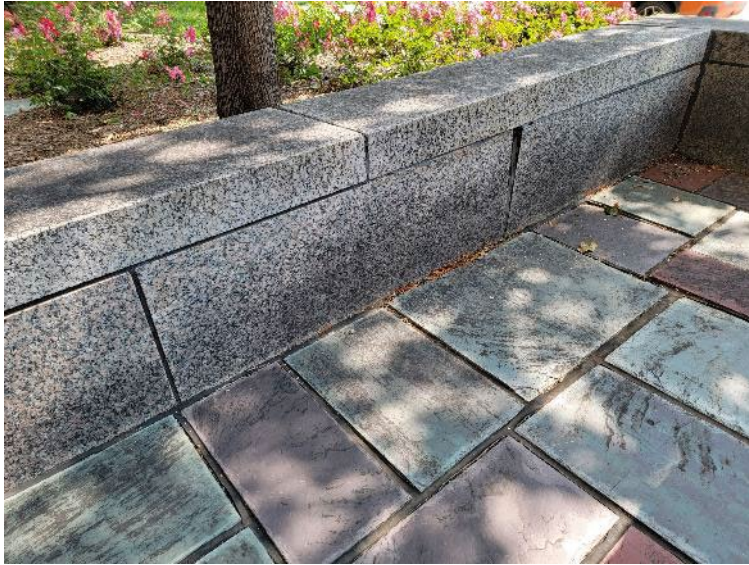
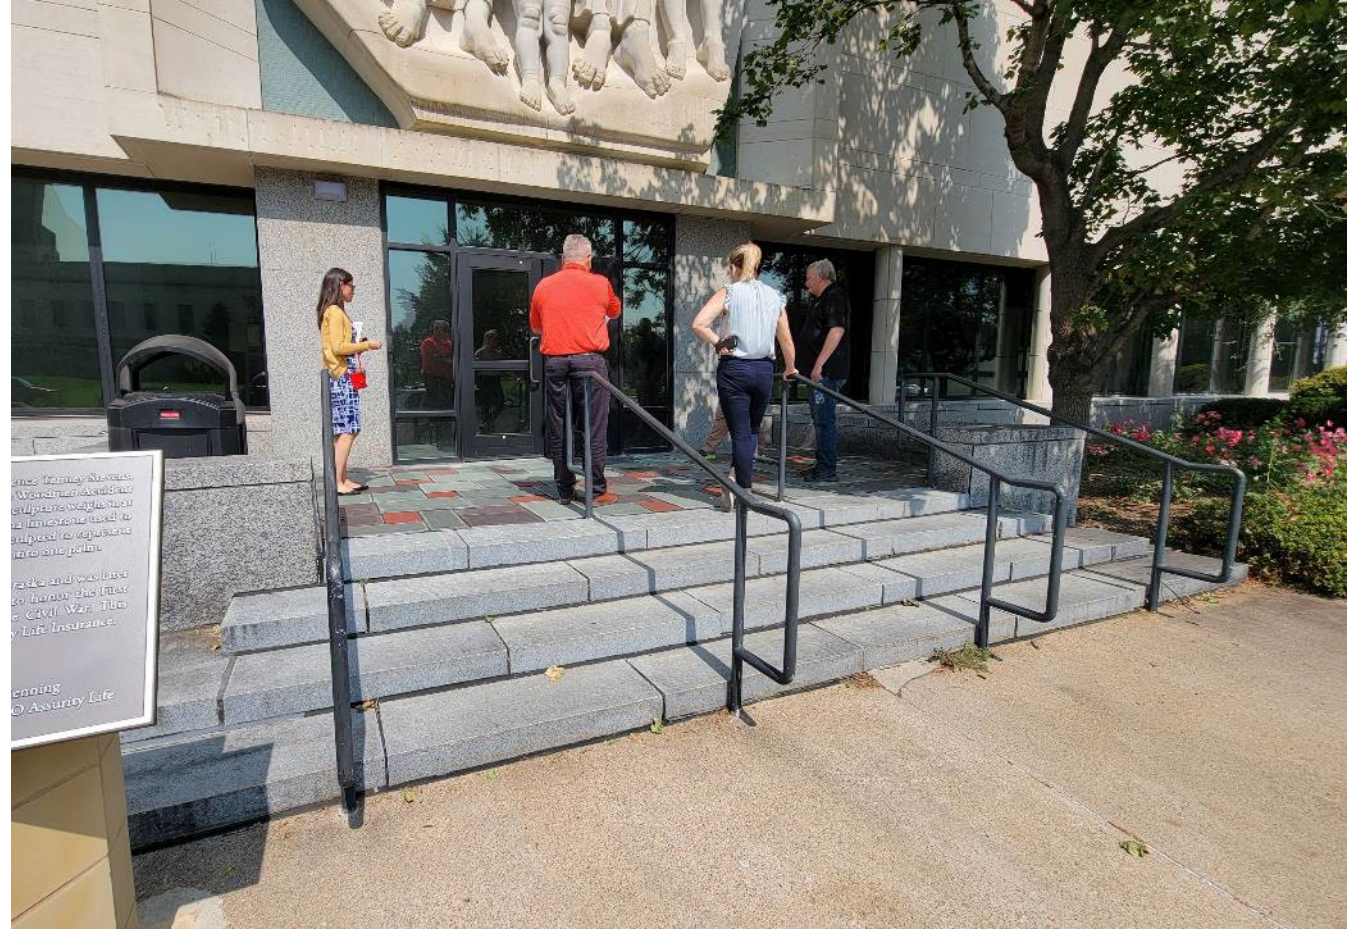
South Stair/Entrance Existing Conditions

Uneven steps and walking surface, damaged stone at wall/landing/steps, no structural stoop at entrance, non-ADA-compliant joints/gaps

South Side – New ADA ramp, steps, railings, and landings at main entrance to the building. There is a need to provide a longer ramp than exists today to meet required rise/slope tolerances for ADA. This will involve demolishing the existing steps, walls, and landings, pushing the new steps closer to K Street and providing new stem walls at either end of the steps. The design intent for the new stem walls is to remove the existing granite clad walls, which are only found on this façade, and at one location on the east, and come back with colored concrete walls with reveals that align with the overall character of existing concrete walls found on the other primary facades of the building (east/north/west). This intent is two-fold: to align the facades in a consistent design language, and to control costs. The improvements to this entrance approach will also remove the existing fragmented slate entrance landing, which currently creates an uneven and non-ADA-compliant walking surface, with a new concrete landing and steps. The new railings will maintain the overall intent of the existing design while meeting current standards.

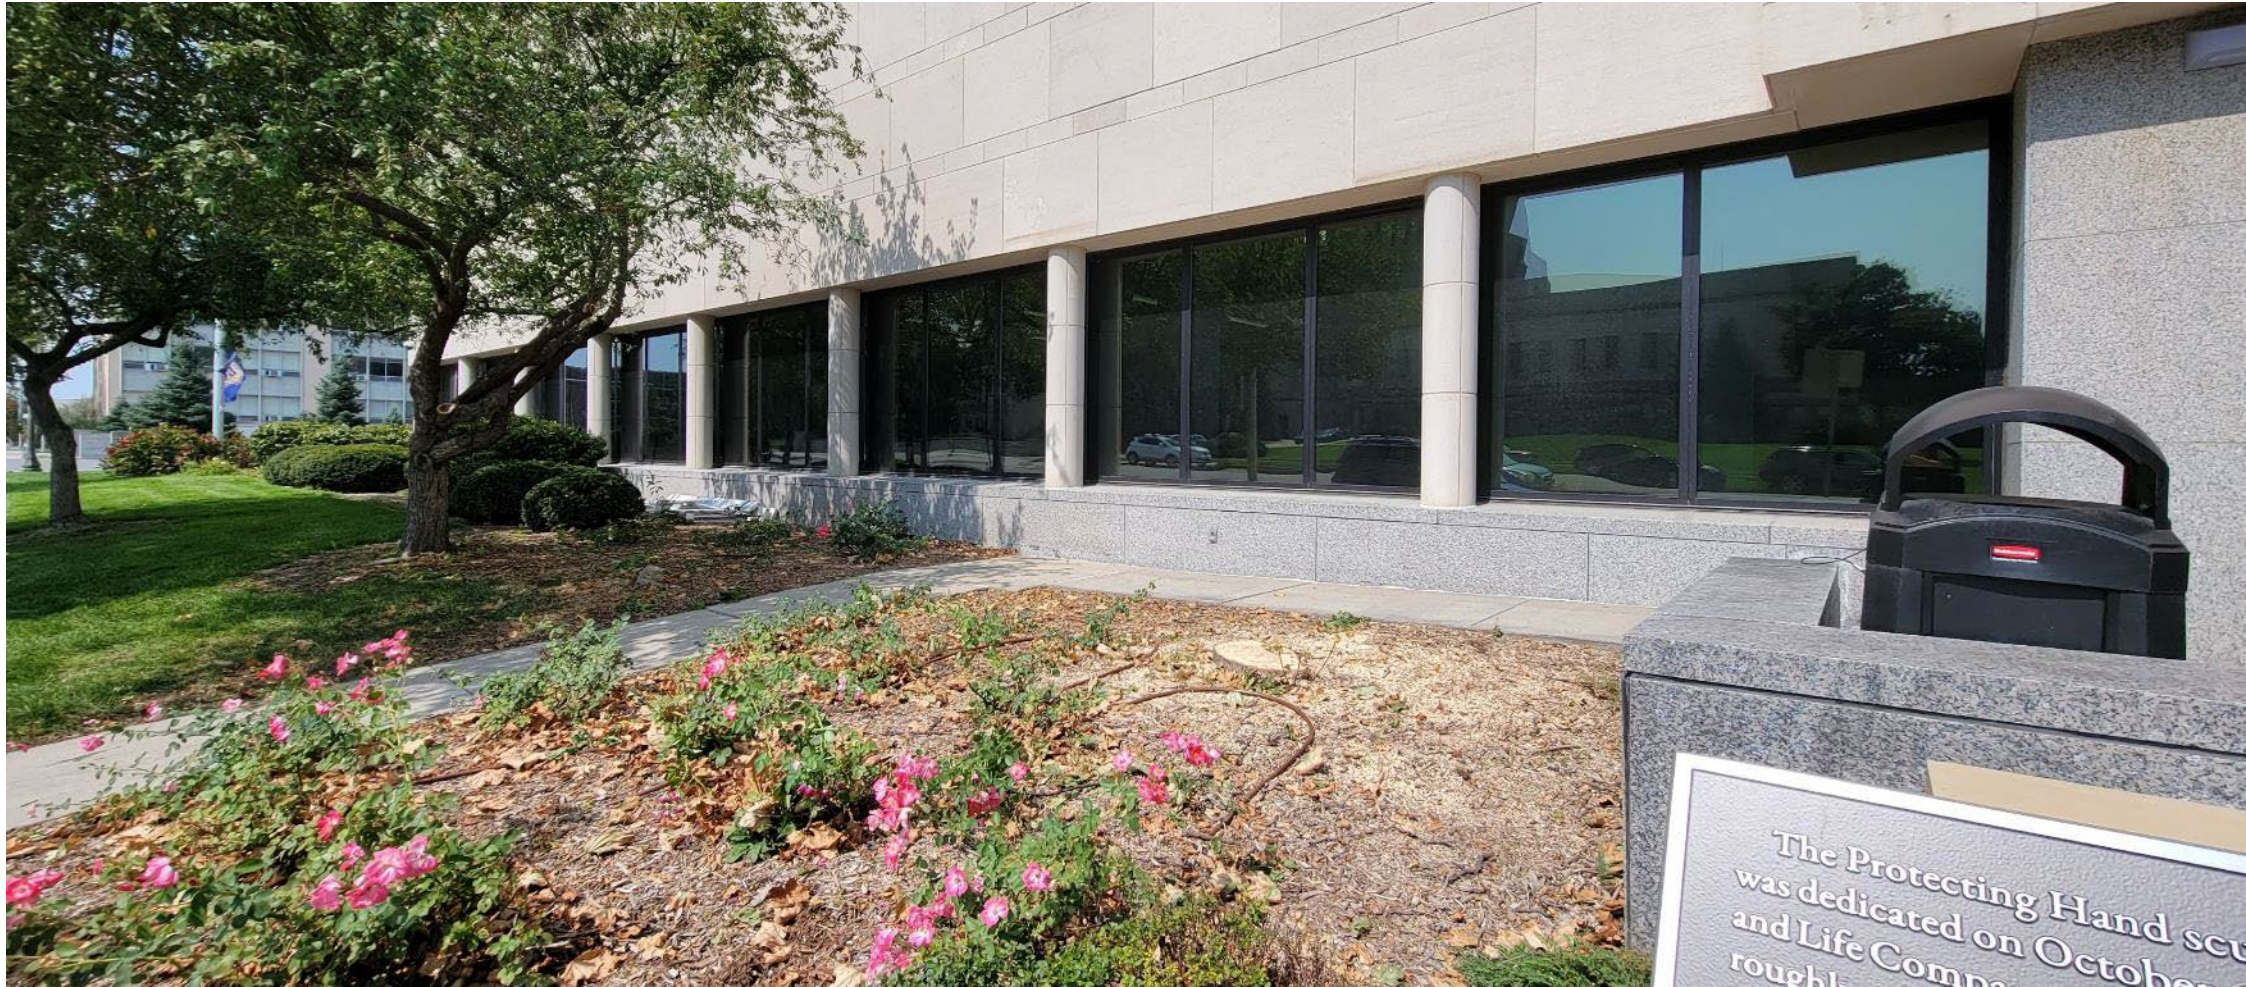
South Stair/Entrance Existing Conditions

Non-ADA-compliant ramp slope/length, insufficient egress lighting

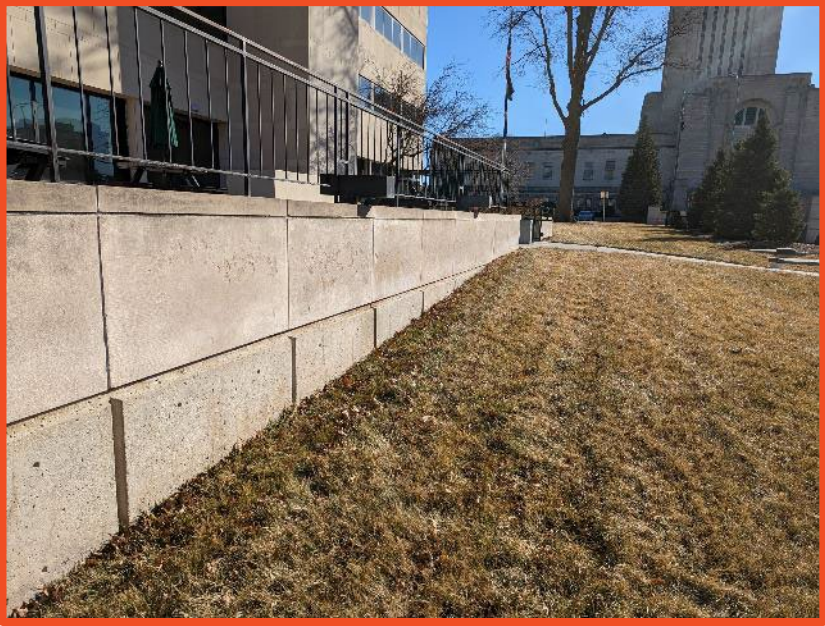
Existing cast-in-place concrete walls with reveals along Centennial Mall adjacent to project

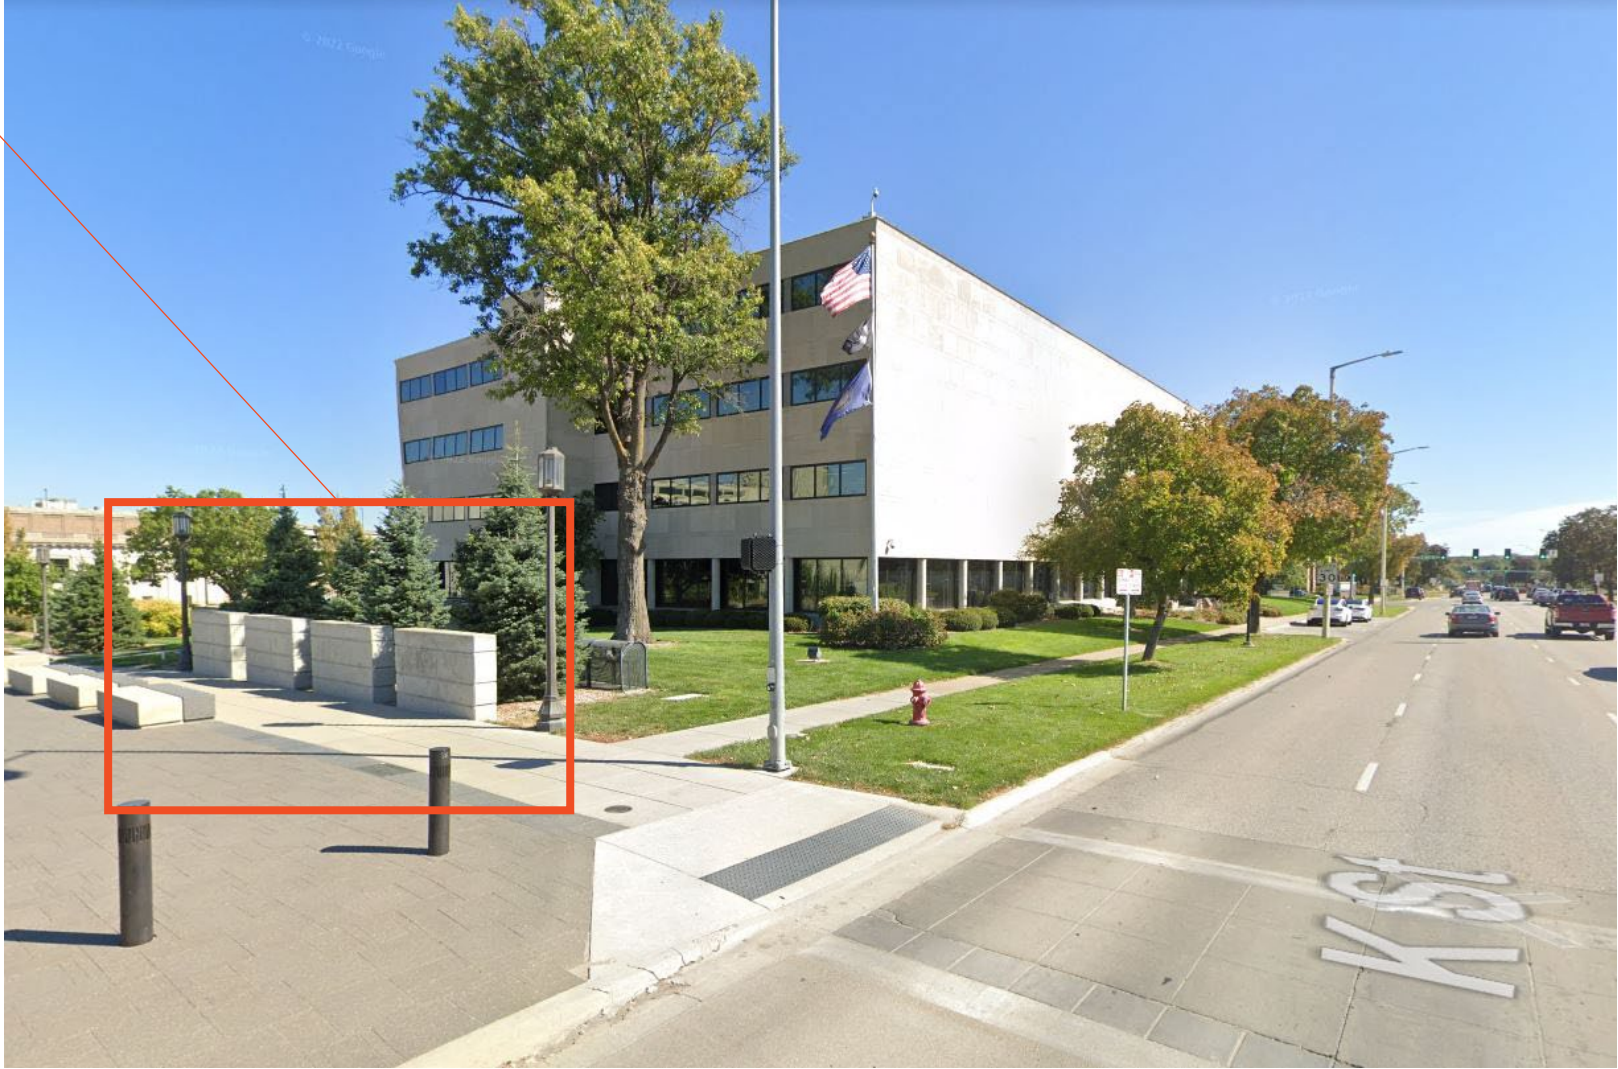
Existing cast-in-place concrete walls with reveals on project

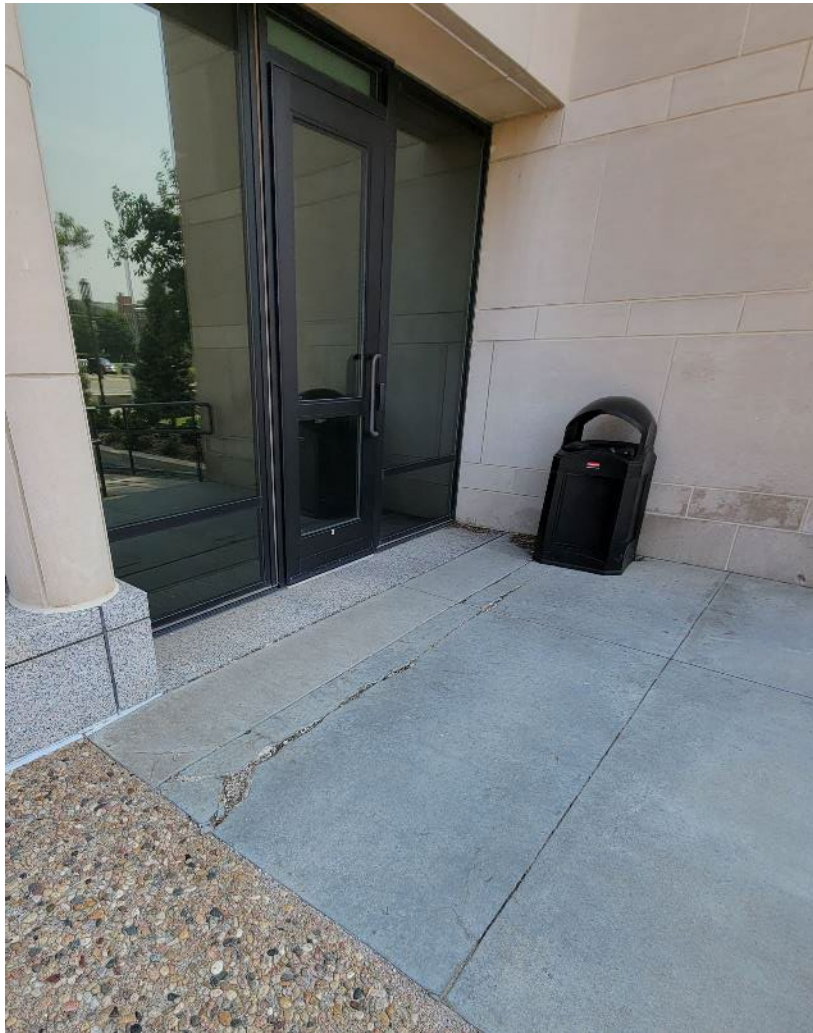
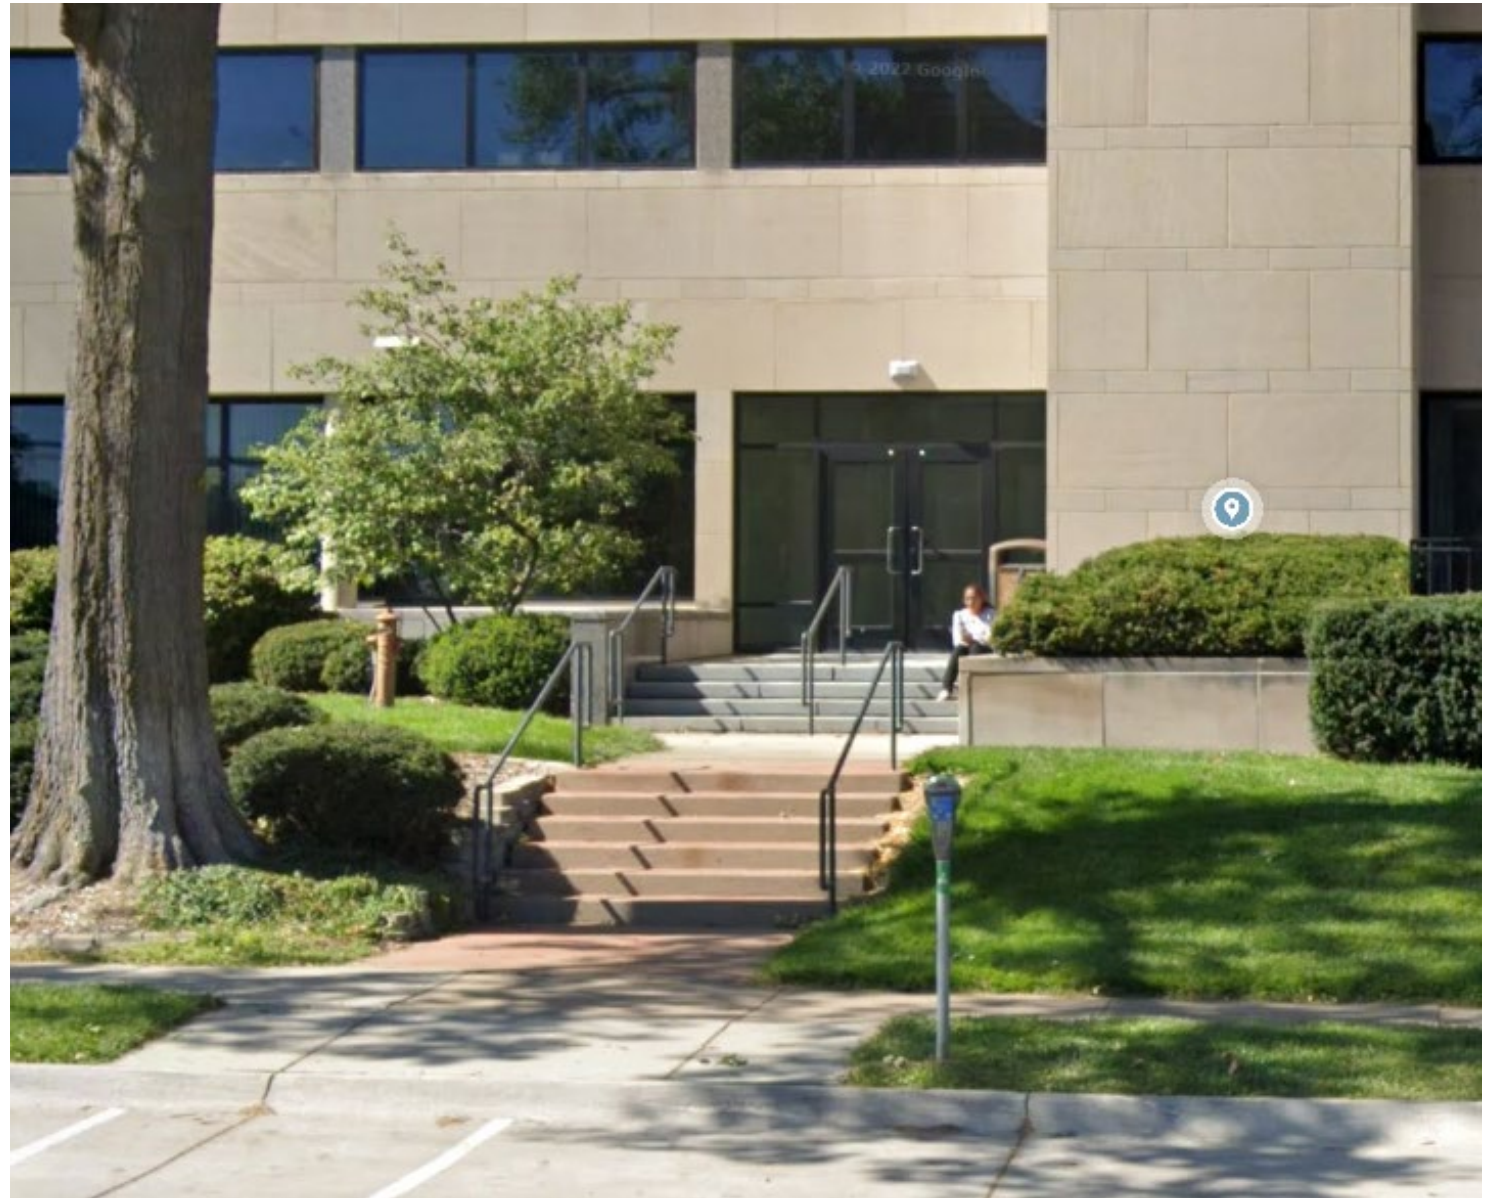
Site – East Entry – Existing Conditions

Damaged Granite Walkway & Non-ADA-Compliant Aggregate Surface

East Side – Replace the existing walk and steps with new concrete walk and steps to improve accessibility and egress safety. Repair damaged limestone and concrete on exterior plaza wall. Replace existing non-ADA compliant concrete aggregate plaza surface with flat concrete surface. Replace existing plaza guardrail. Clean existing stone and concrete plaza walls.

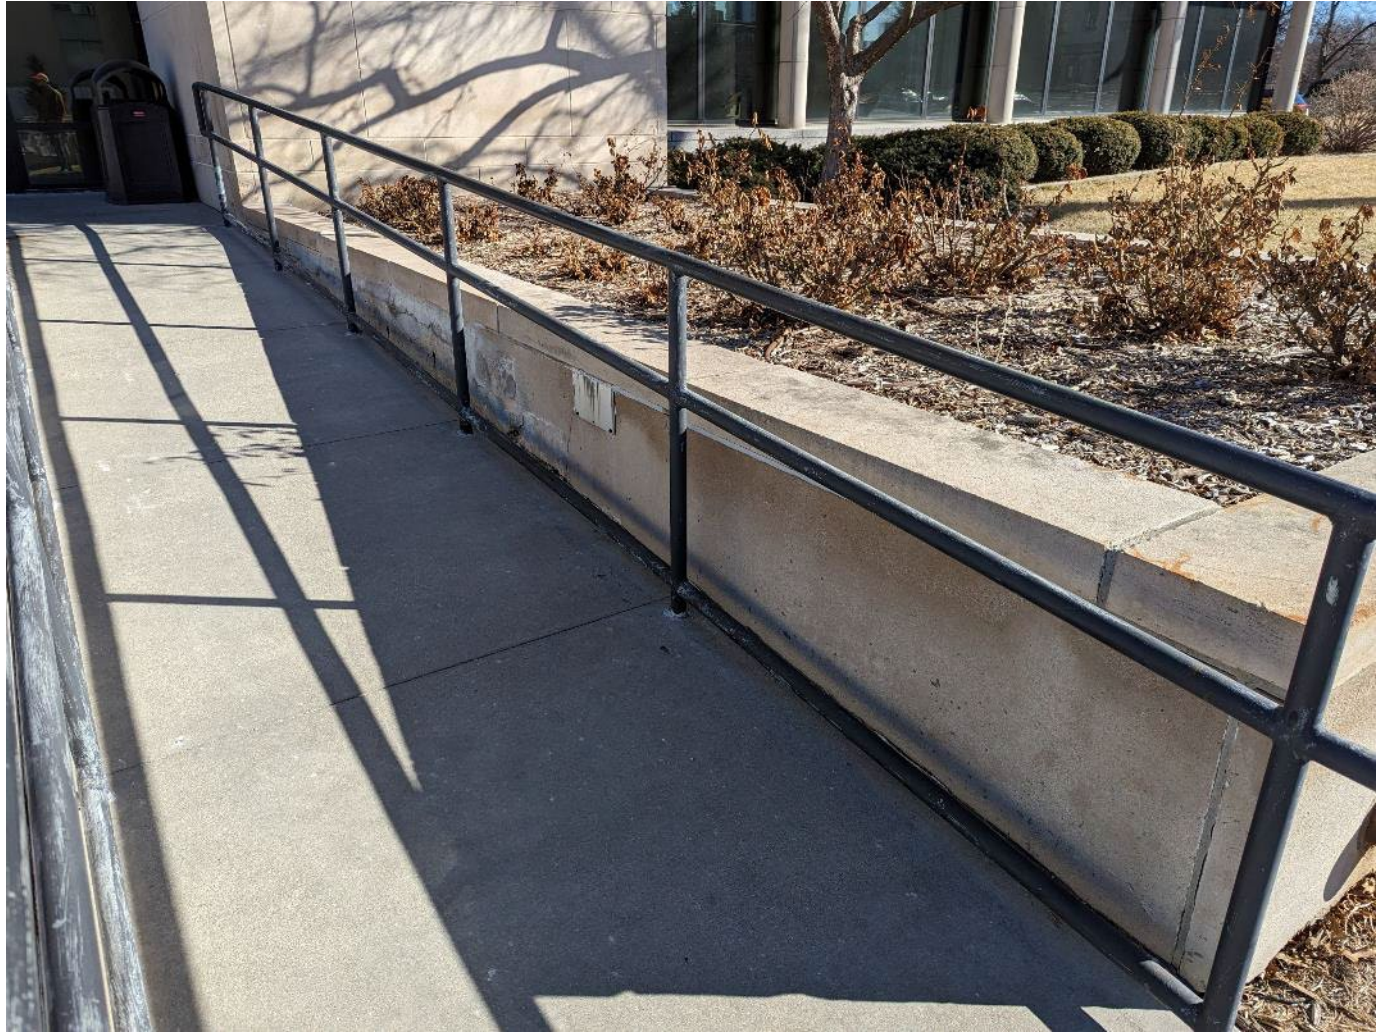
Site – West Entry – Existing Conditions

Damaged Concrete Walkway and Walls

Damaged Limestone Wall and Non-ADA-Compliant Ramp

West Side – Replace the existing walk, steps, and egress ramp with new concrete walk, steps, and ramp to improve accessibility and egress safety. Repair damaged limestone and concrete on exterior plaza wall. Replace existing non-ADA compliant concrete aggregate plaza surface with flat concrete surface. Replace existing plaza guardrail. Clean existing stone and concrete plaza walls.

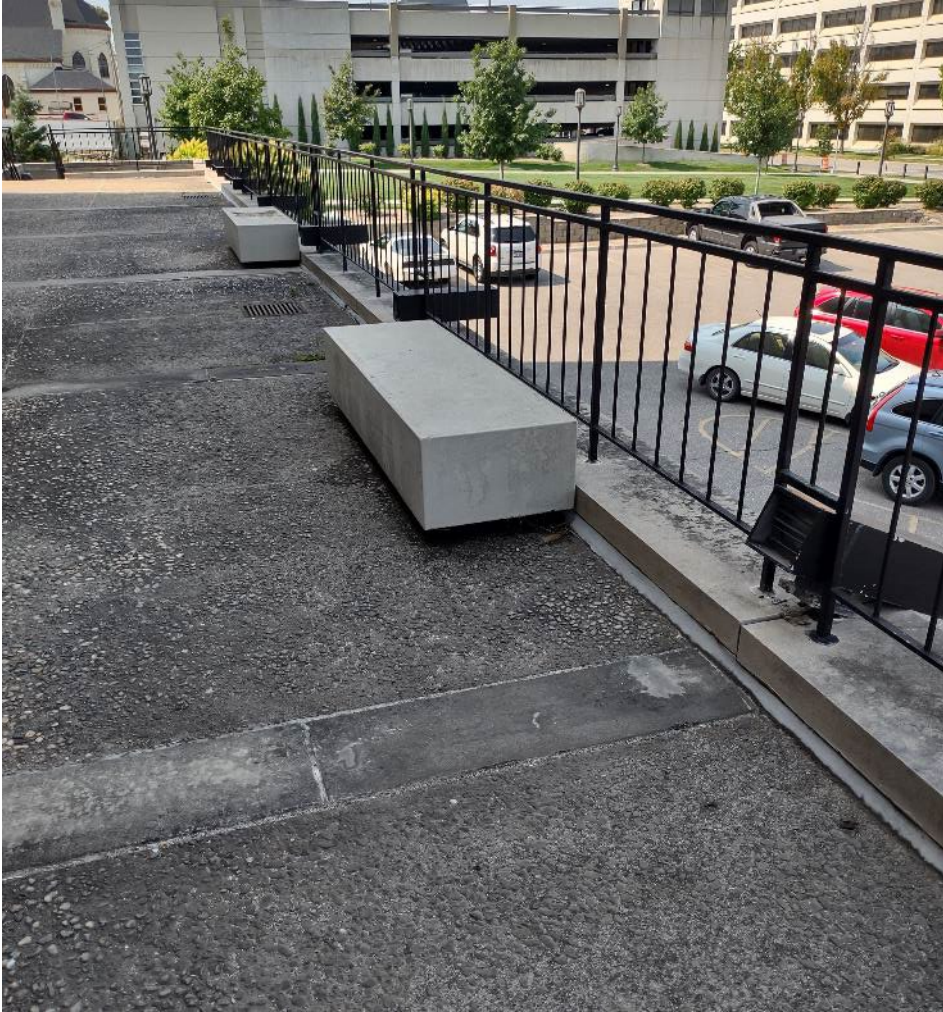
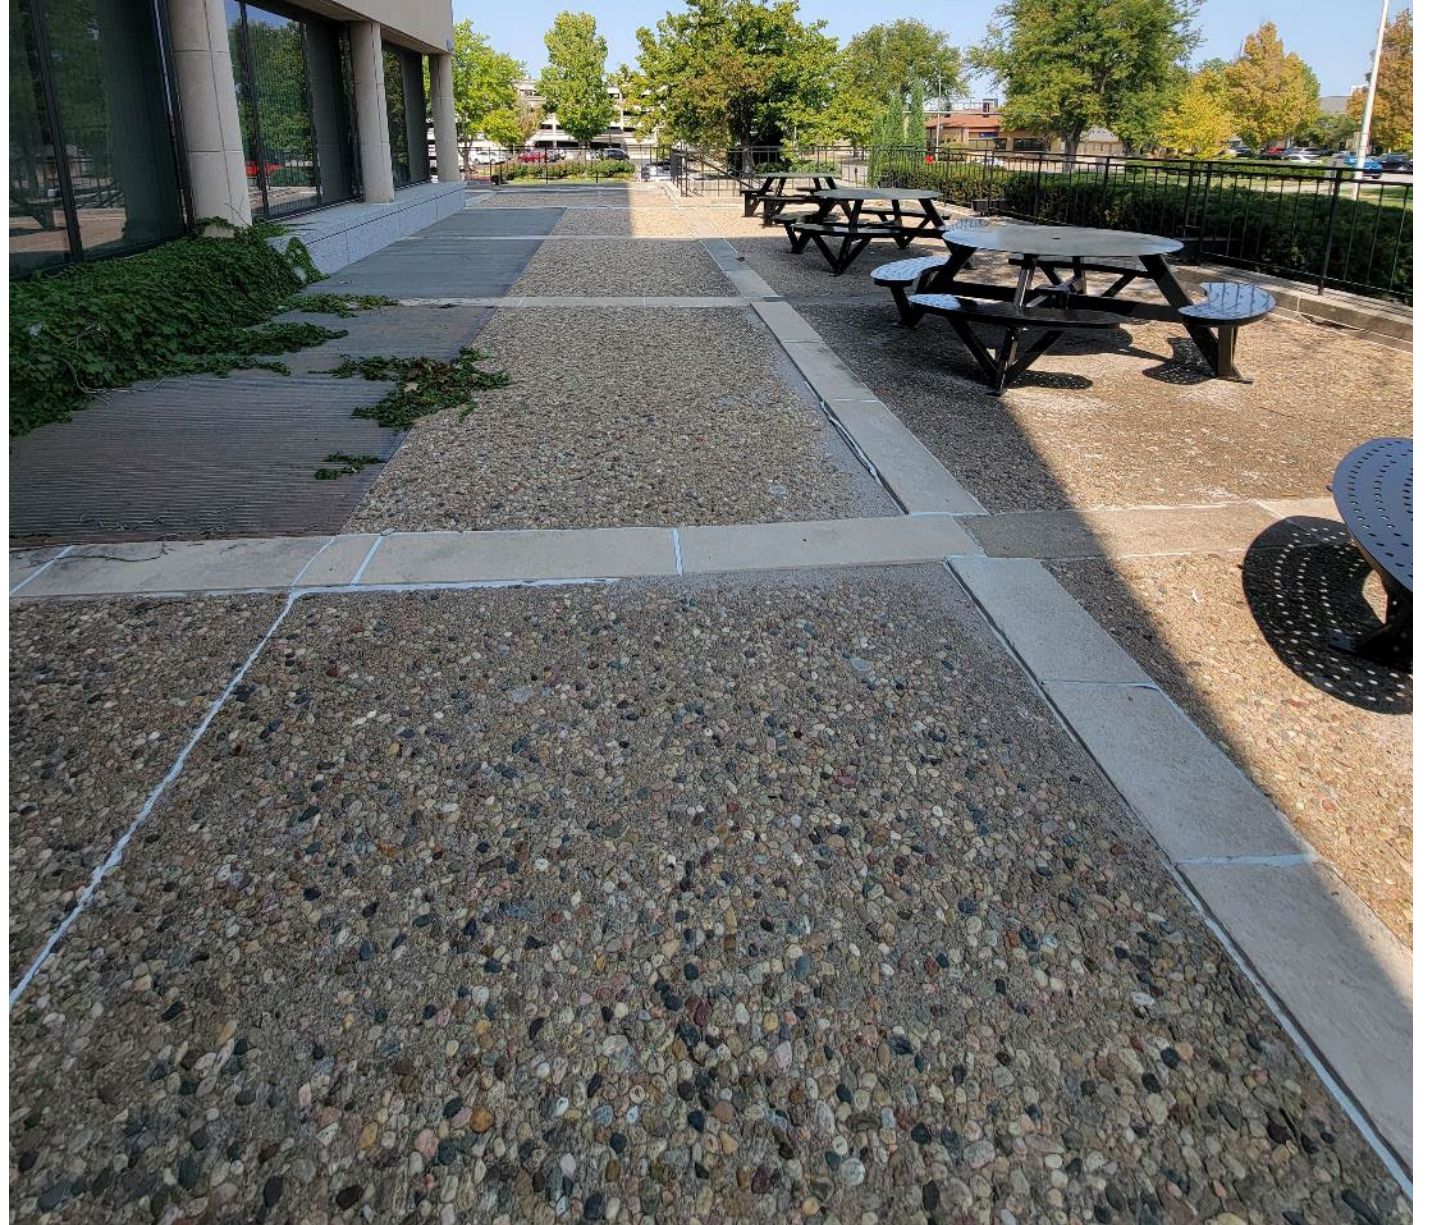
North Plaza Improvements – Existing Conditions

Deteriorating non-ADA-compliant plaza surface, non-compliant railing, joints and sealant

North Side – Replace the existing three damaged concrete egress stairs with new steel stairs and railings to improve accessibility and egress safety. Two of these stairs are internal to area wells, the third, central stair currently blocks functional access to the main north entrance. The intent is to provide a new stair north of the existing wall that has perforated metal screening to provide central plaza access from the north parking lot. Repair damaged limestone and concrete on exterior plaza wall. Replace existing non-ADA compliant concrete aggregate plaza surface with flat concrete surface. Replace existing plaza guardrail. Clean existing stone and concrete plaza walls.

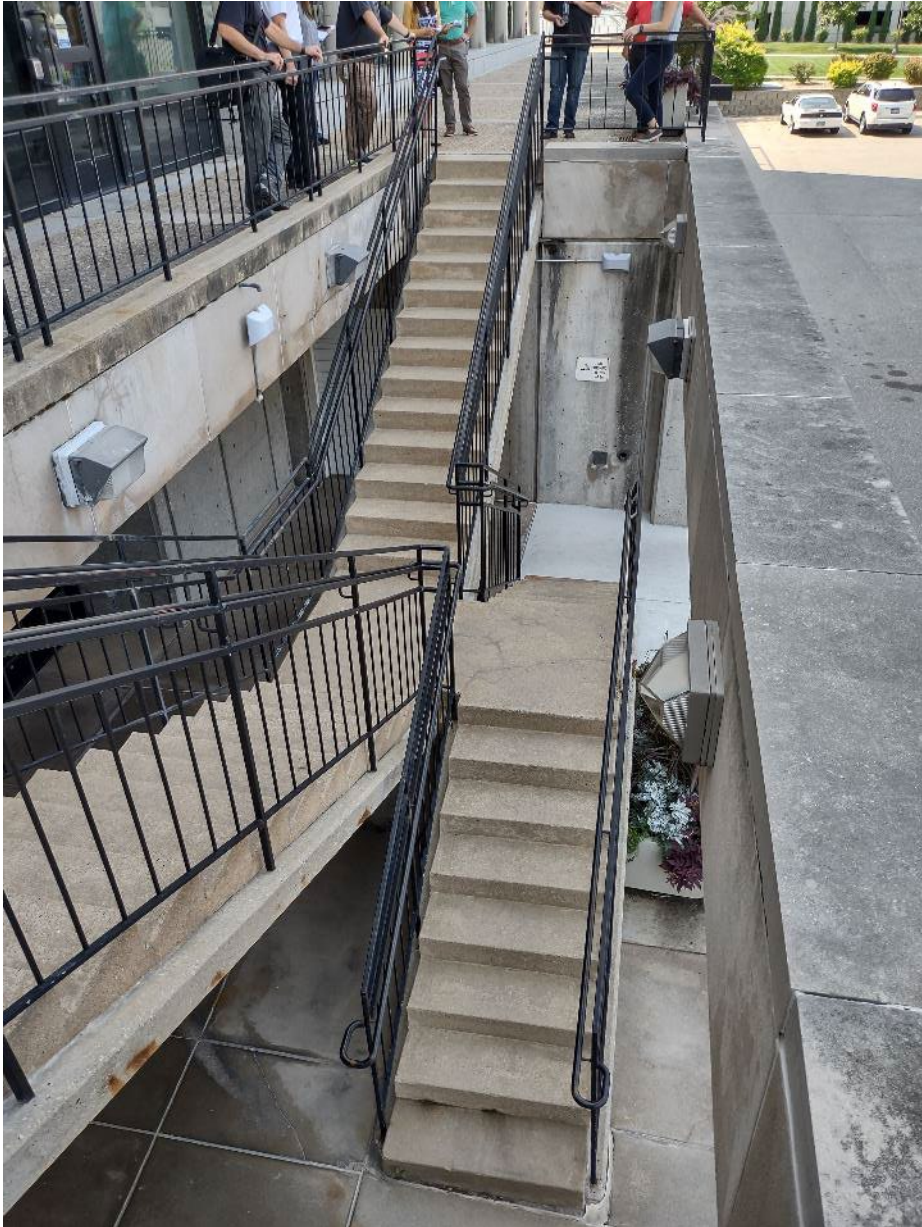
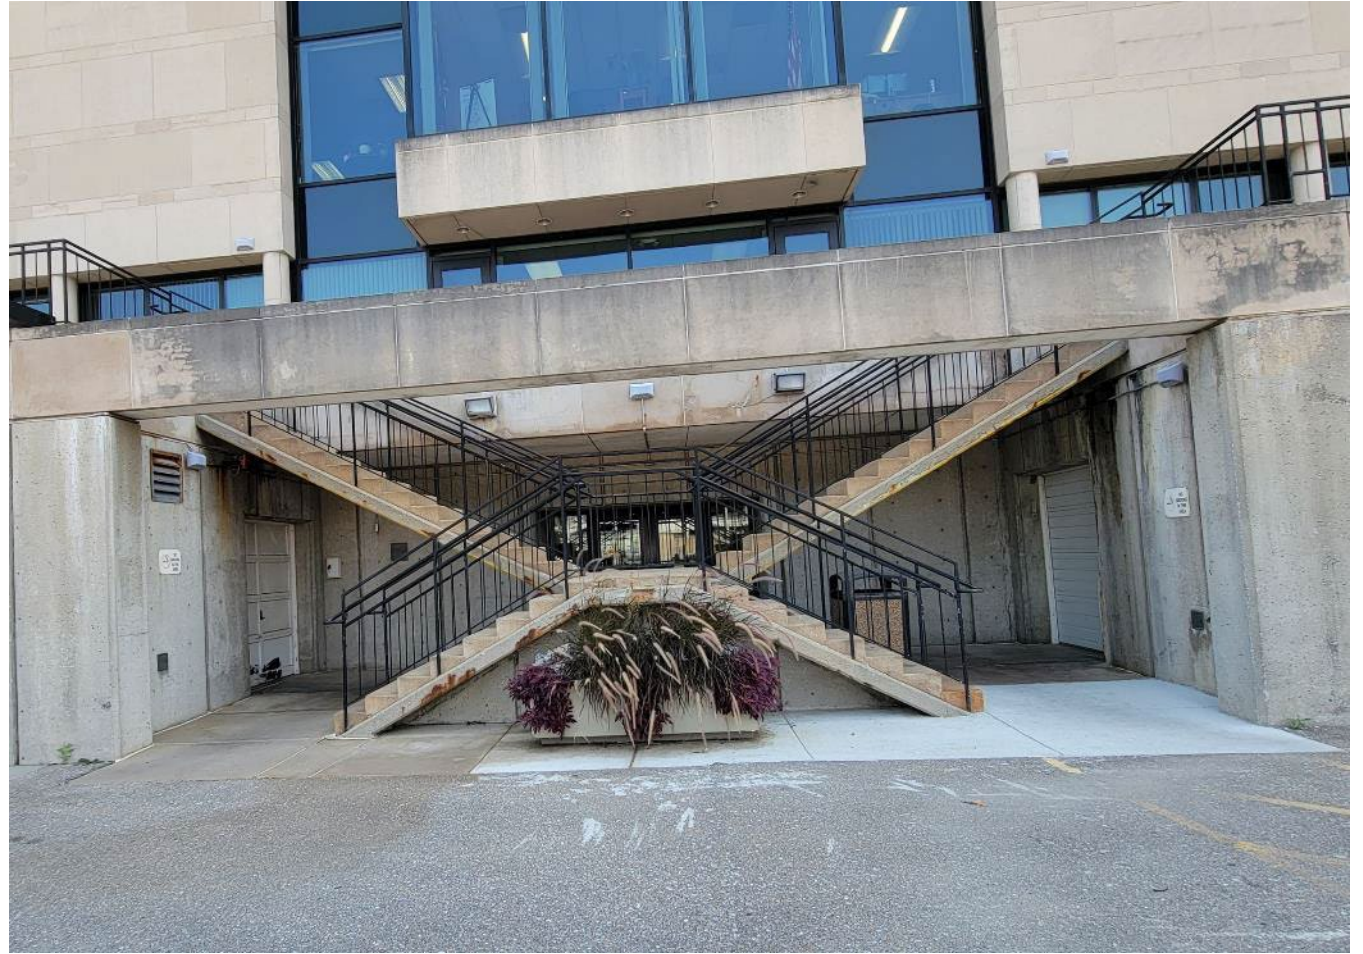
North Plaza Improvements – Existing Conditions – North-Central Egress Stair

Existing deteriorating north-central egress stair with spalling concrete, exposed rebar, and moisture damage. Current stair configuration blocks view to main north entrance and limits mobility. Head clearance does not meet ADA.

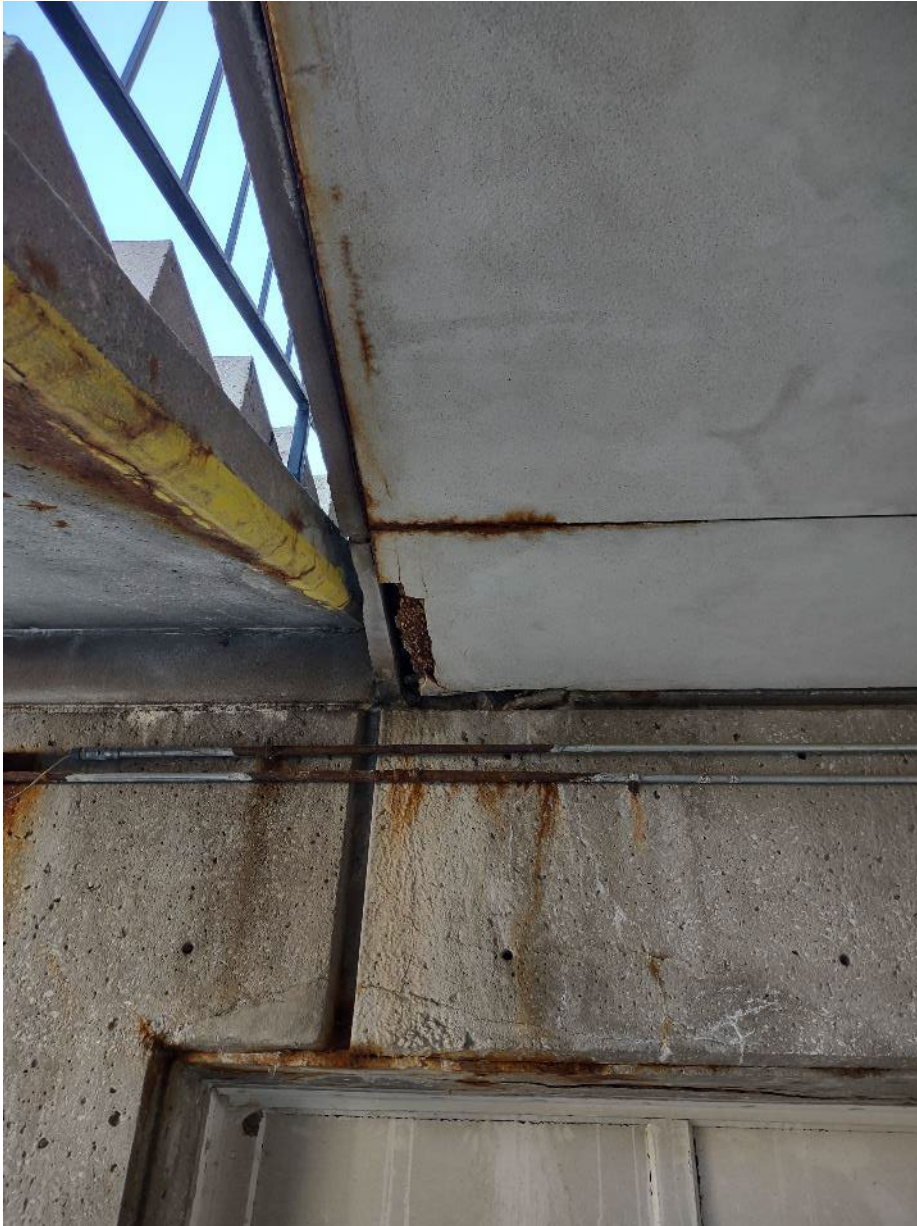
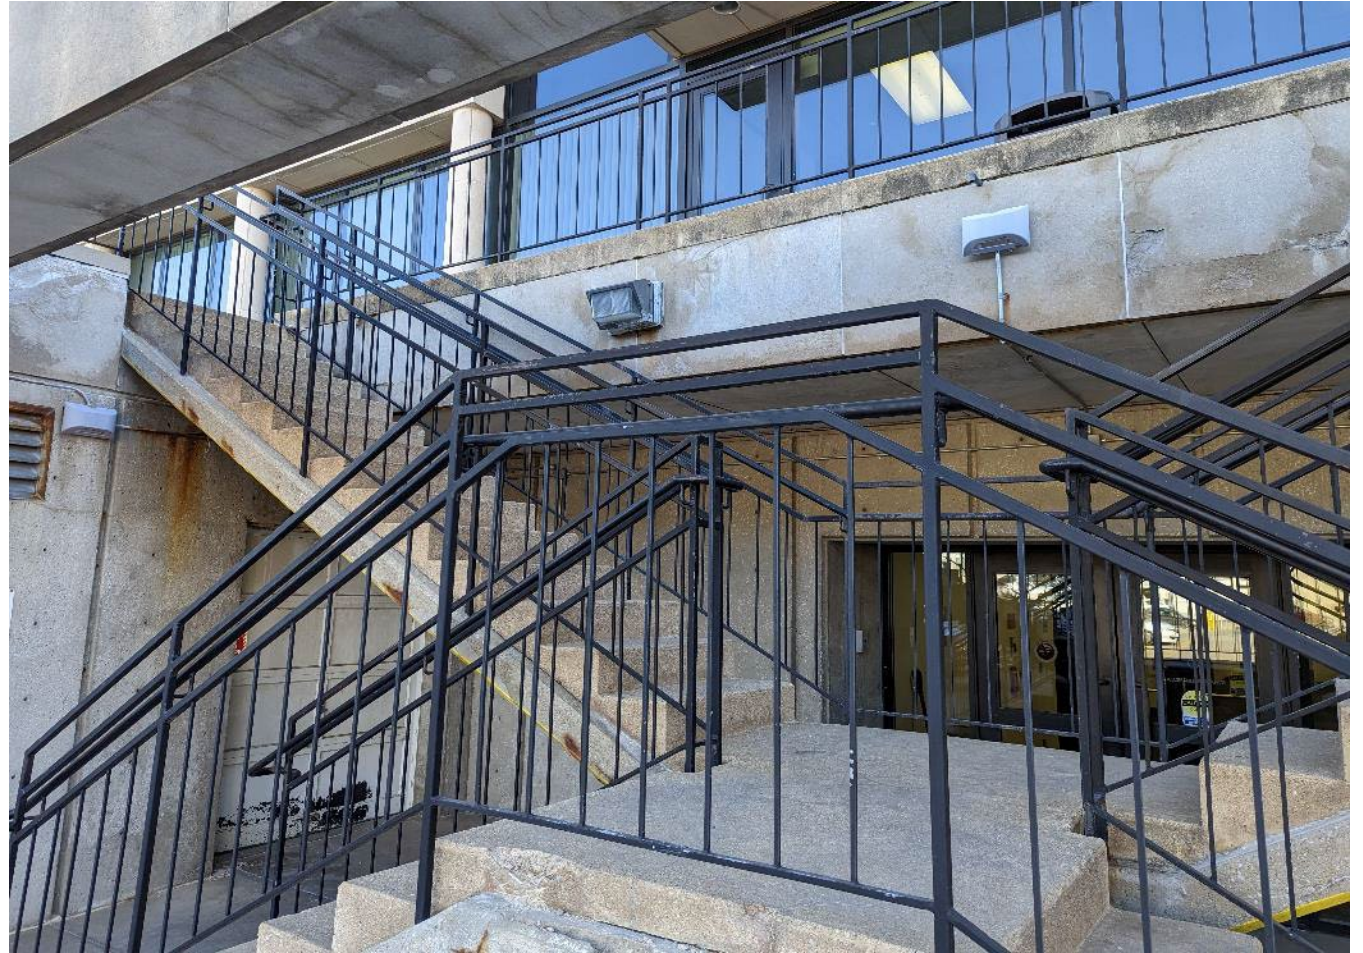
North Plaza Improvements – Existing Conditions – North-Central Egress Stair

Existing deteriorating north-central egress stair with spalling concrete, exposed rebar, and moisture damage. Current stair configuration blocks view to main north entrance and limits mobility. Head clearance does not meet ADA.

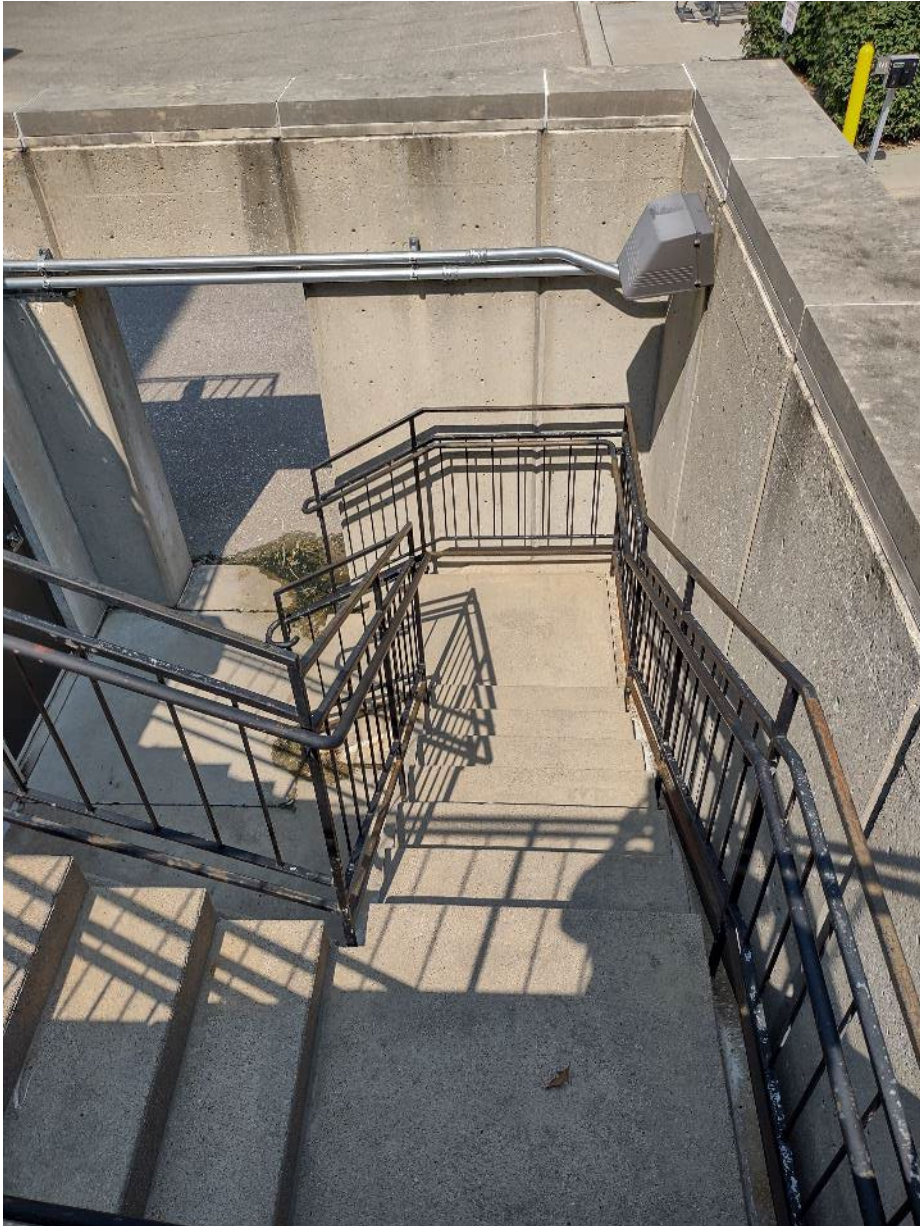
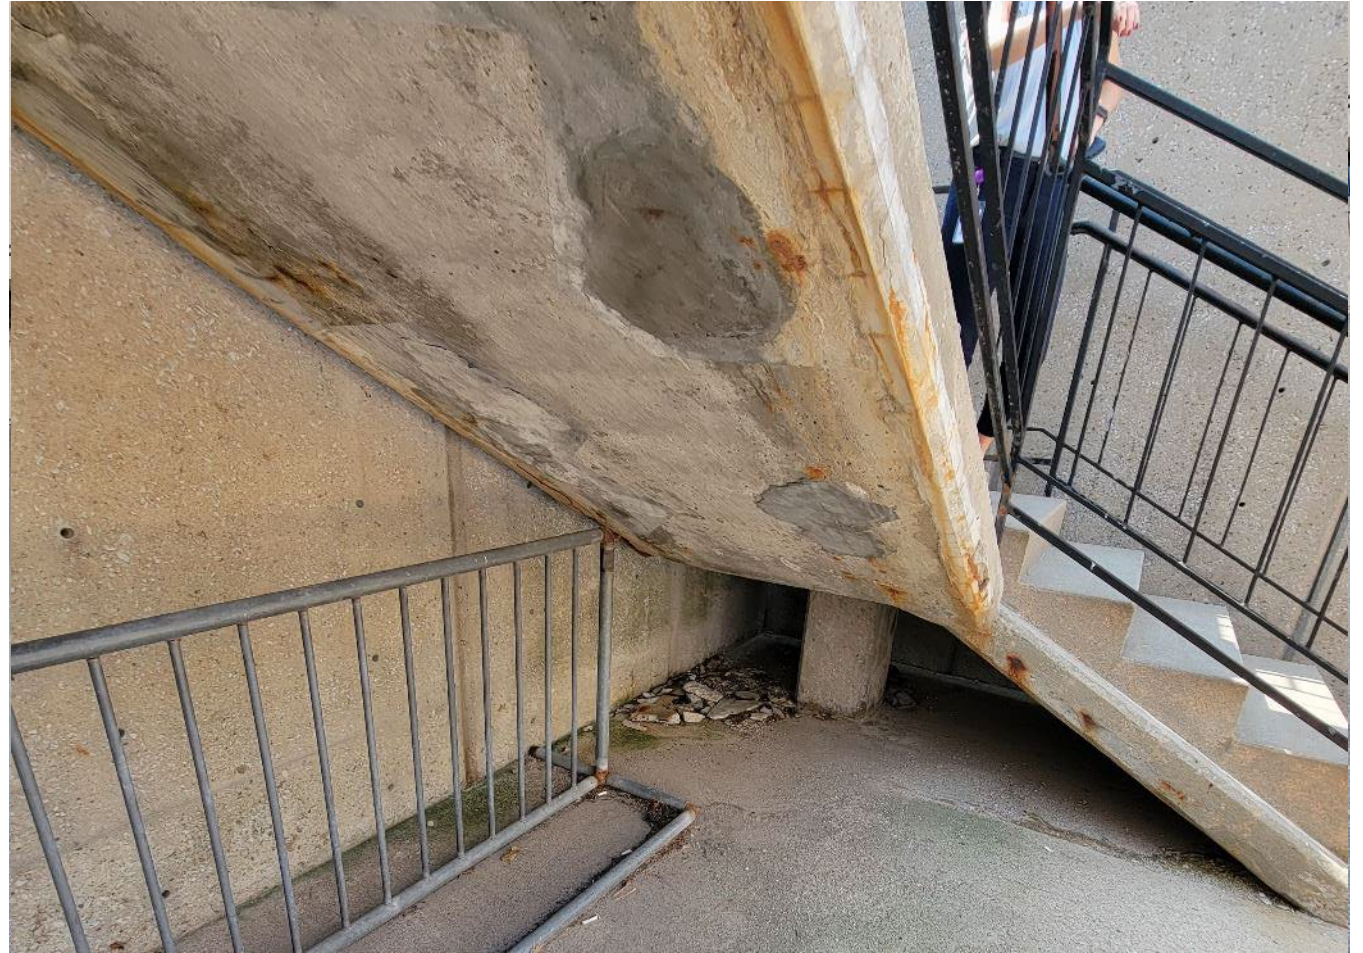
North Plaza Improvements – Existing Conditions – Corner Egress Stairs

Existing deteriorating east and west egress stairs with spalling concrete, exposed rebar, and moisture damage.
