NEBRASKA CAPITOL ENVIRONS COMMISSION

NEBRASKA CAPITOL ENVIRONS COMMISSION STAFF REPORT

APPLICATION NUMBER	Urban Design Record #23016
APPLICATION TYPE	Certificate of Appropriateness
ADDRESS/LOCATION	1526 K Street
HEARING DATE	February 24, 2023
ADDITIONAL MEETINGS	N/A
APPLICANT	Michelle Potts, State Building Division, michelle.potts@nebraska.gov
STAFF CONTACT	Collin Christopher, 402-441-6370, cchristopher@lincoln.ne.gov

NDAS FNAB 1526 Exterior Renovations
Capitol Environs Review

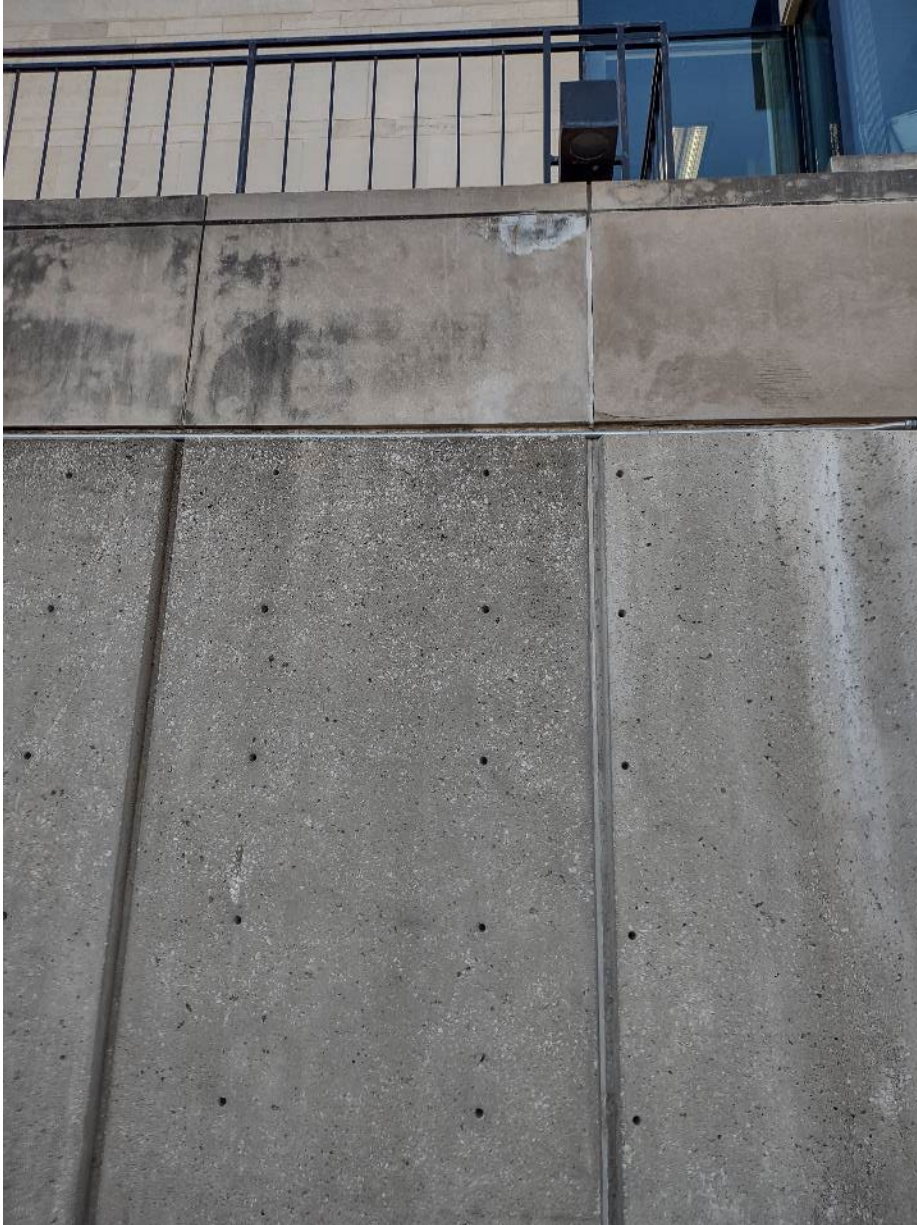
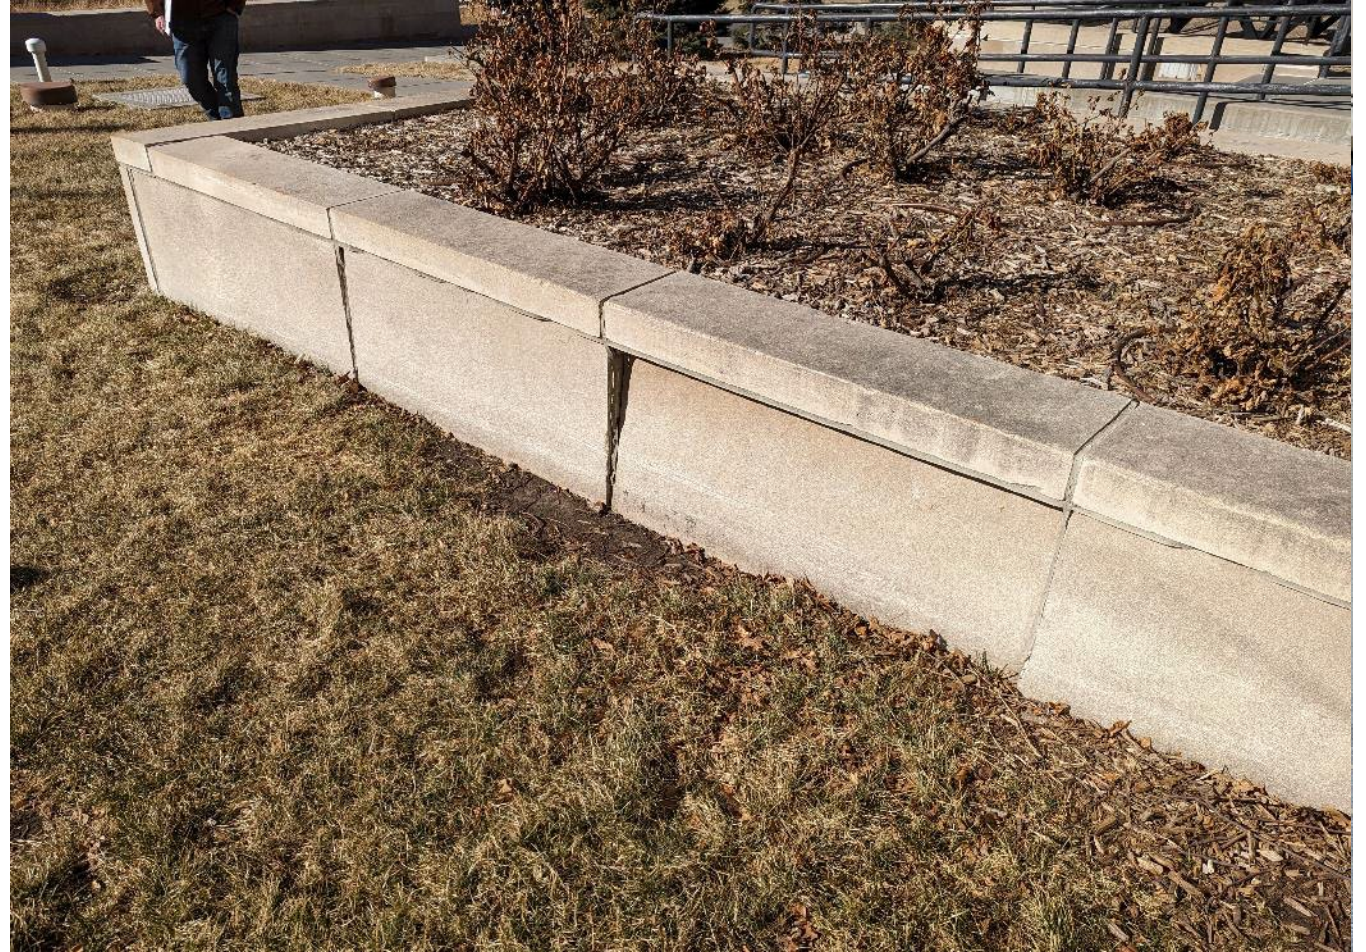
North Plaza Improvements – Existing Conditions – Wall Degredation

Existing deteriorating limestone panels, joints, and sealant. Existing Stone and Concrete requires cleaning, patching, repair, and replacement.

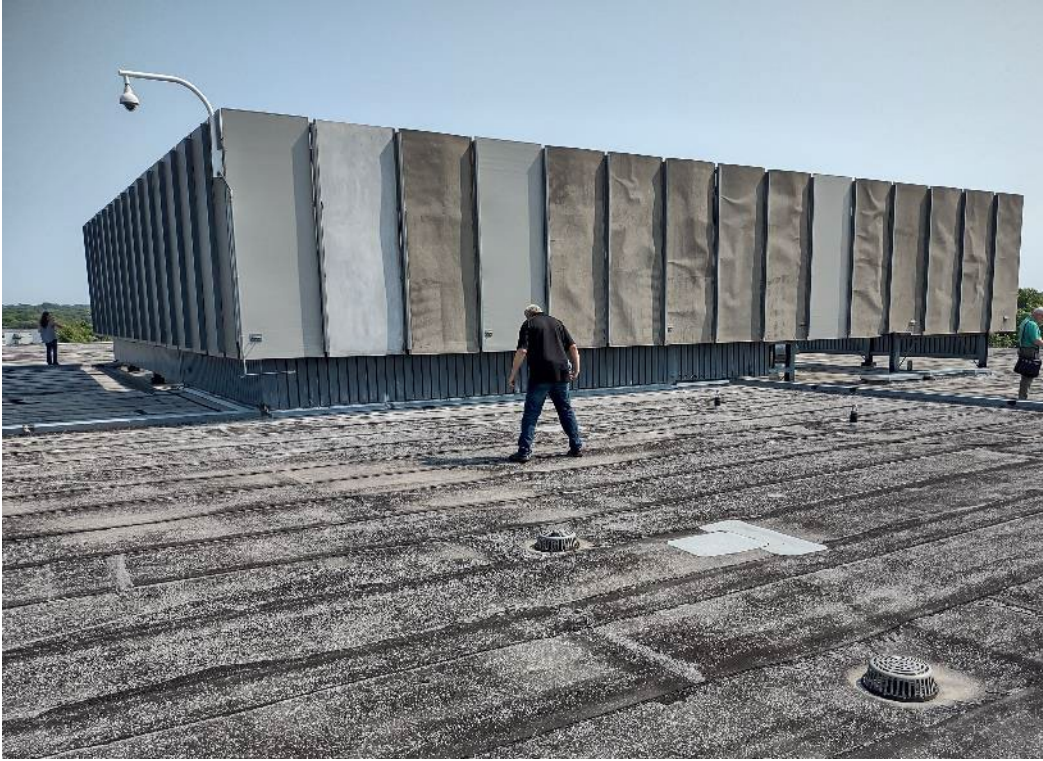
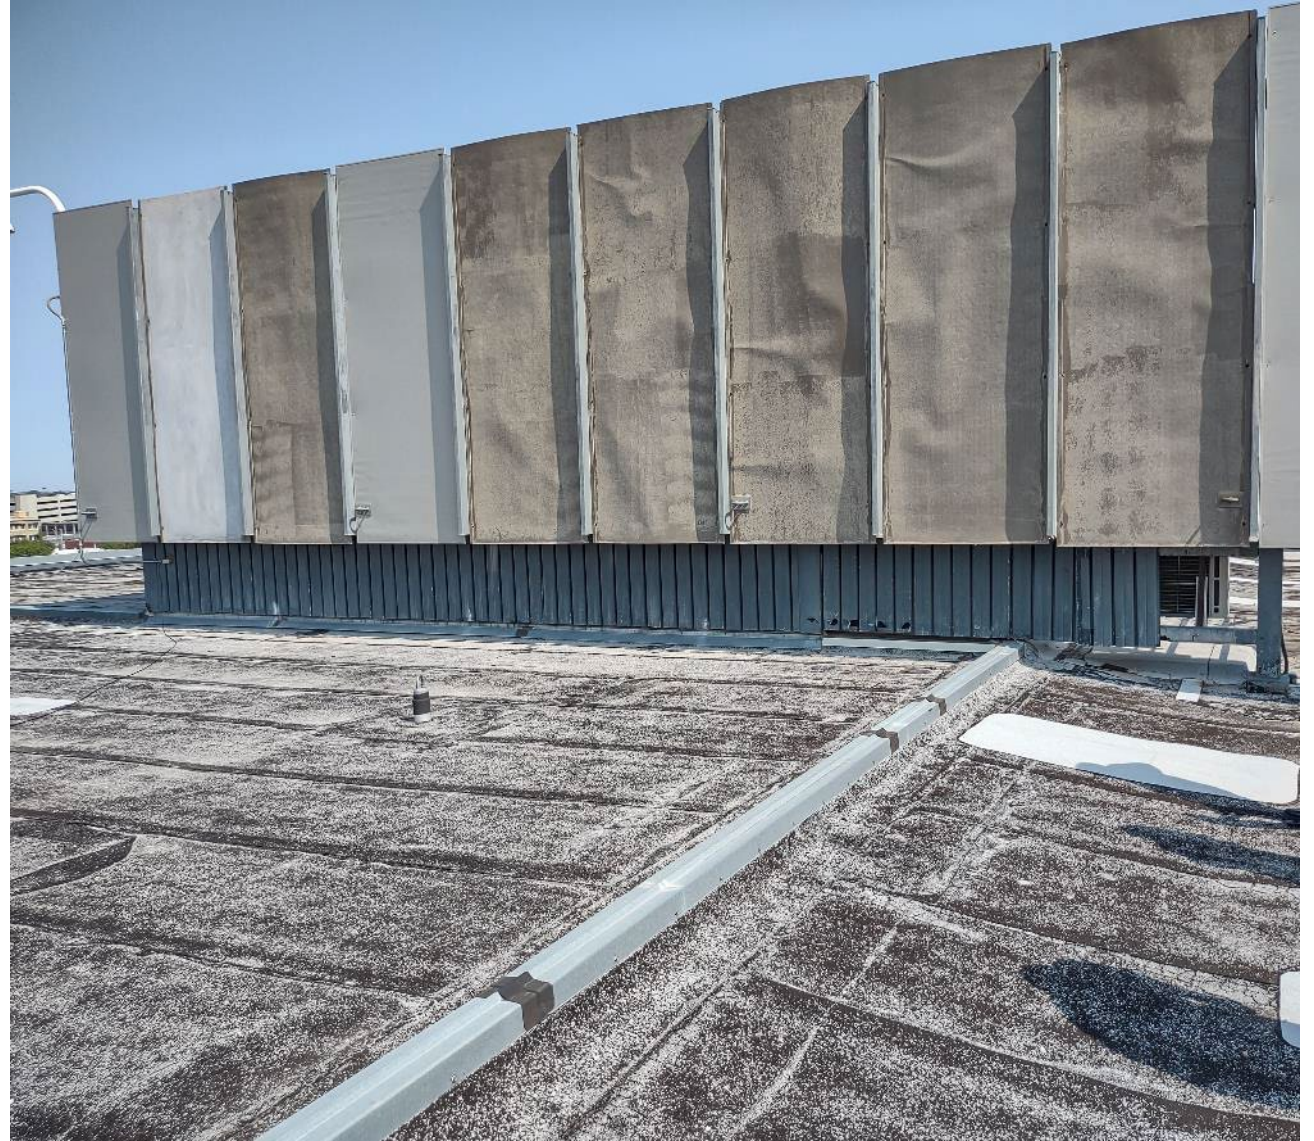
Roof Screen Wall – Existing Conditions

The existing screen wall has delaminated over time and seen additional physical damage and deterioration.

Roof Screen Wall - Reroof and replace the mechanical screen wall material. The color and character of the screening design is intended to maintain the design intent of the existing conditions in height, spacing, and color.
