Section 9
Capital Improvement Projects

9.1 Problem Identification

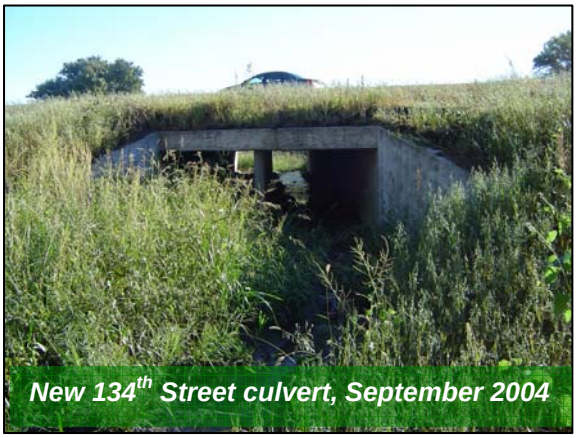
New 134th Street culvert, September 2004

Problem description: During the field reconnaissance of Tributary 250 in March 2004, the culvert under 134th Street had an invert 3 feet above pool elevation and both banks were severely eroded. The culvert has since been replaced with a double box culvert at channel grade, and local bank scouring in the vicinity of 134th Street has been repaired (see picture below). However, bank erosion extends downstream as a result of continued channel incision. The reach confined by the farm fields and 134th Street is distinctly less sinuous than the adjacent streams. The additional increase in channel slope caused by a presumed straightening has increased the driving force for incision. Knickpoints are common throughout the reach occurring roughly 500 feet apart. In addition to bank failures and threats to infrastructure, this tributary supplies excess sediment to the receiving waters degrading water quality and potentially decreasing physical instability. If left untreated, channel incision will progress upstream, posing a threat to the new culvert at 134th Street.

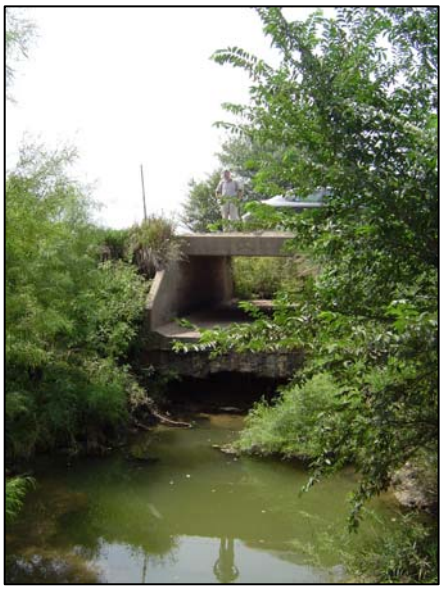
Intervention 18. Tributary 545, River Mile 13.579 - Armored plunge pool downstream of 98th Street culvert

Problem description: Bed scouring downstream of 98th Street has produced a 2-foot drop at the culvert outfall. Due to a lack of bed armoring, localized scouring continues to undermine the lip of the concrete box, threatening the structural integrity of the culvert.

Recommended intervention: Due to the severity of localized erosion downstream of 98th Street, a riprap-armored plunge pool at the culvert outfall is necessary to dissipate energy and prevent continued bed scouring (Figure 9-20). The armored plunge pool should be sized so that the applied shear stress at the downstream edge does not exceed the critical shear strength of the bed. Both banks are already well-vegetated and show no signs of fresh erosion. Therefore, additional bank stabilization is not needed.
