Section 7

Capital Improvement Projects

7.4.1 Project HB-1: Grade Control Main Stem HBR005 at S Folsom St and Pipe Outfall Restoration along Bison Trail at Homestead

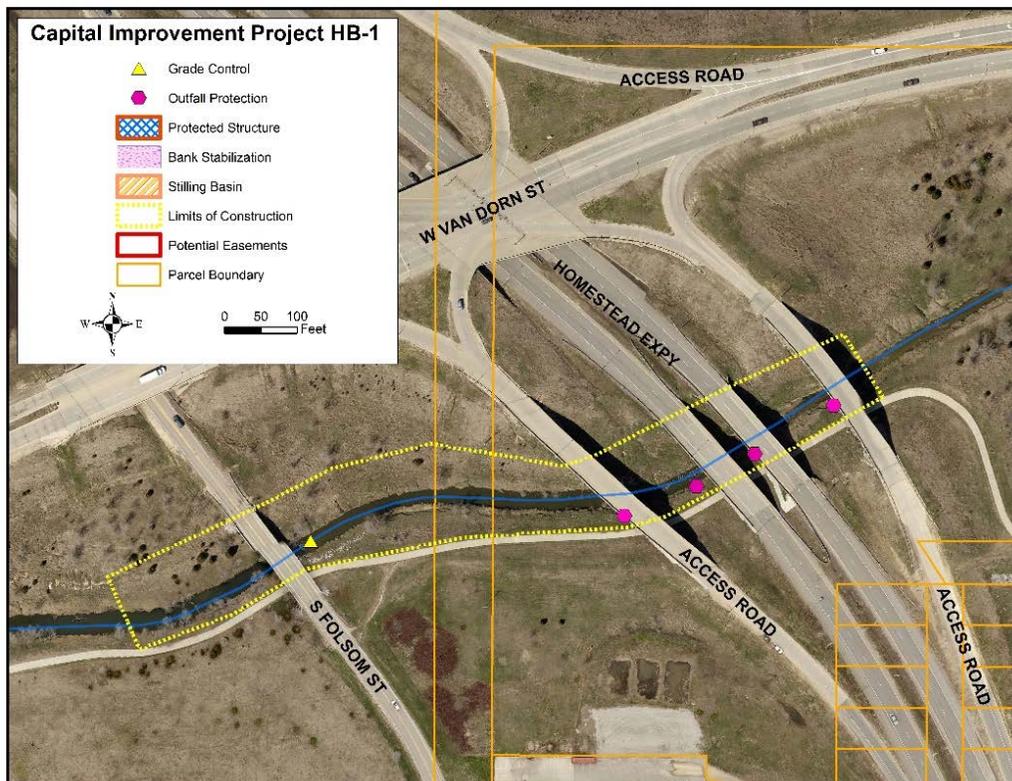
Figure 7-6: Conceptual Layout of HB-1

Problem description: Two knickpoints are located on the main stem HBR005 at the S Folsom St Bridge, one under the bridge, and one approximately 110 feet upstream of the bridge. Each knickpoint is creating approximately a 6 inch to 1 foot drop in the channel. Also, scour and erosion is occurring at multiple pipe outfall locations along Bison Trail at Homestead Expressway. Potentially affected parcels are public and within state right-of-way. Close coordination between the City of Lincoln (City), the Lower Platte South Natural Resources District (LPSNRD) and the Nebraska Department of Roads (NDOR) will be required for the completion of this project.

Recommendation: Construct an engineered grade control immediately downstream of S Folsom St to halt the propagation of knickpoints upstream. Install scour protection at each pipe outfall to eliminate erosion and protect the pipe outfall and stream bank.

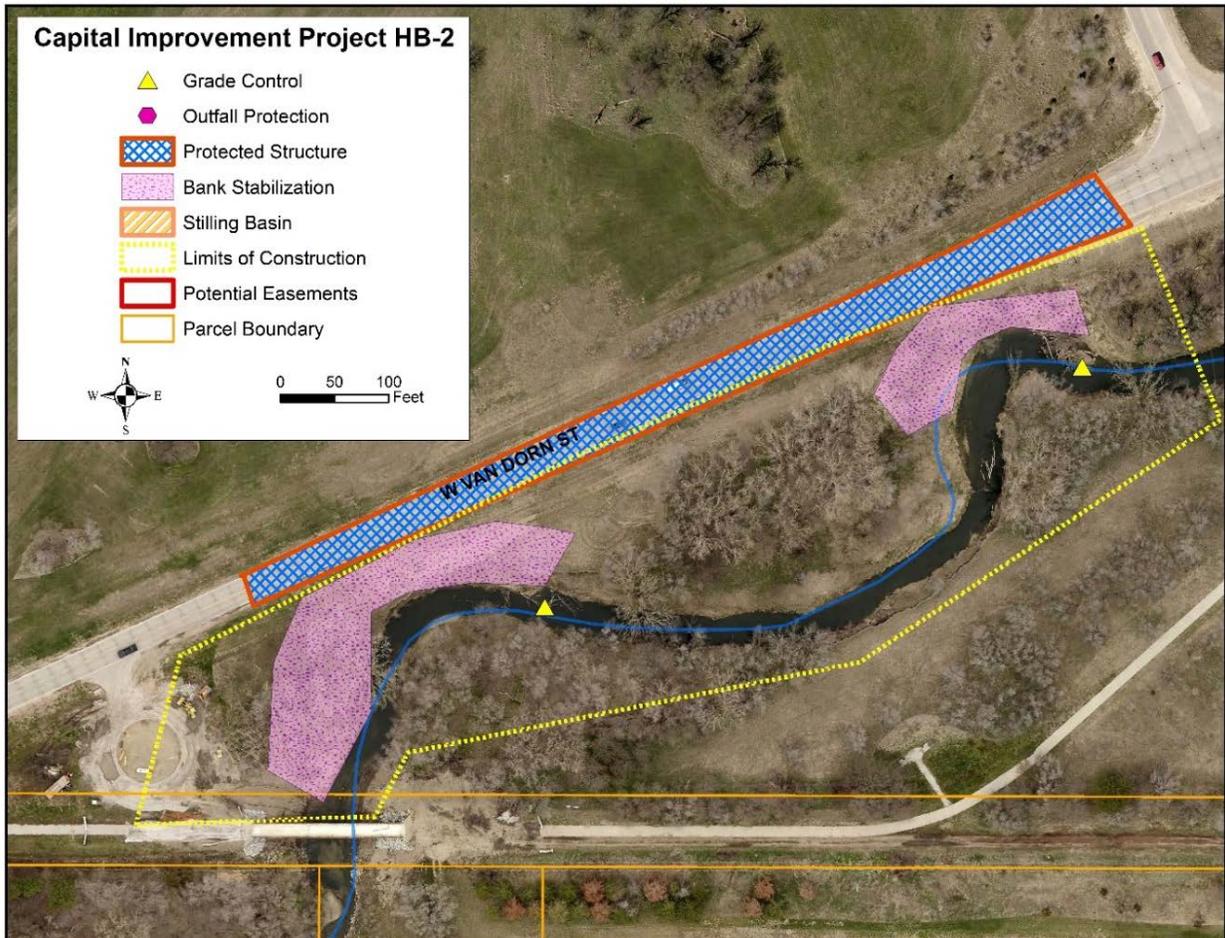
Figure 7-8: Conceptual Layout of HB-2

Problem description: Bank erosion along main stem HBR005 is threatening W Van Dorn St about 1,050 feet southwest of the intersection of W Van Dorn St and S Folsom St. Potentially affected parcels are public and within the State right-of-way. Close coordination between the City, LPSNRD and NDOR will be required for the completion of this project.

Recommendation: Constructing bank stabilization along the left descending bank with associated grade controls as needed to protect W Van Dorn St.

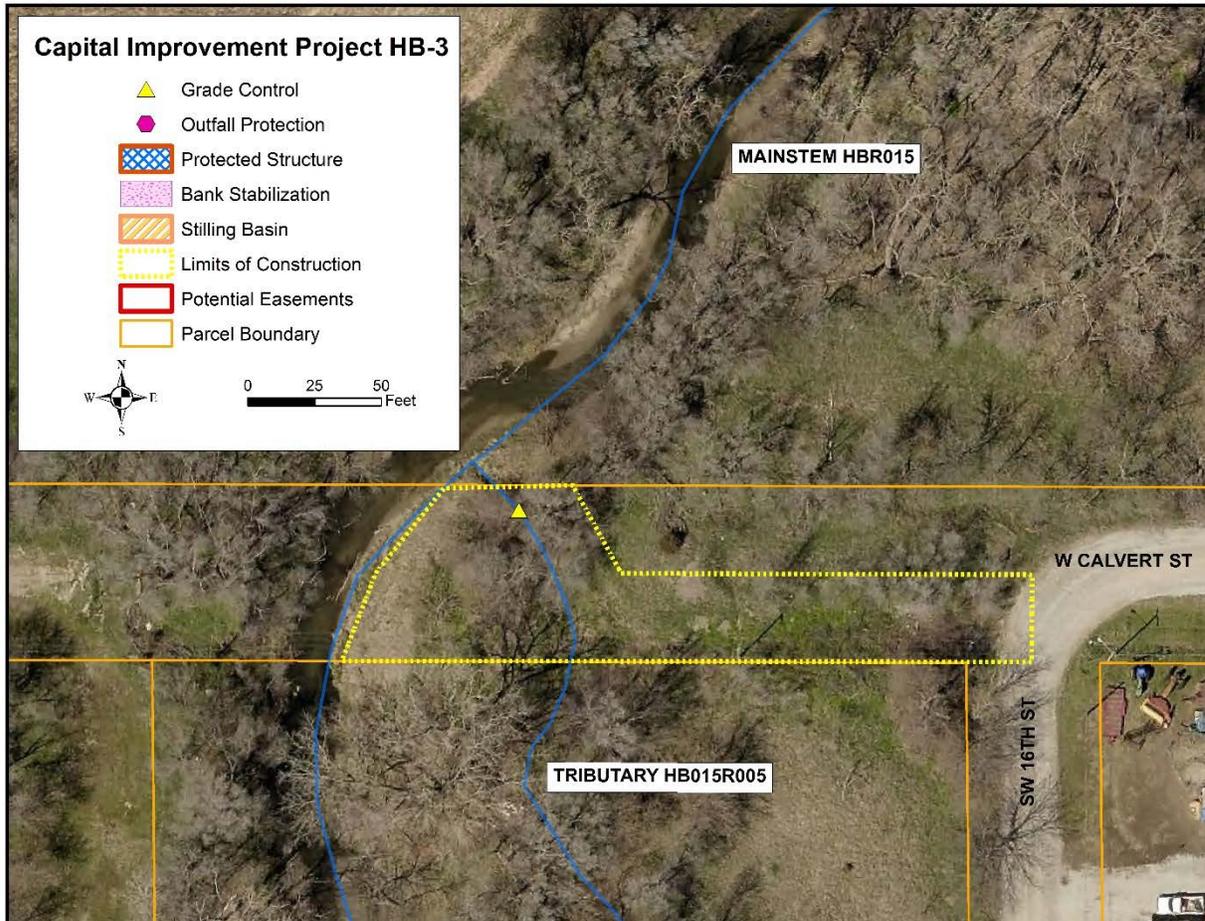
Problem description: There is a tall knickpoint in tributary HB015R005 at the confluence with the main stem. The main stem flowline is several feet below the tributary on the right descending bank west of W Calvert St and SW 16th St. Upstream of the knickpoint, the tributary is showing early signs of incision. Potentially affected parcels are public. Close coordination between the City, County, LPSNRD and NDOR will be required for the completion of this project.

Recommendation: Construct grade control at tributary confluence to halt incision and protect the upstream reach. This project could be combined with a bridge or culvert at W Calvert St.

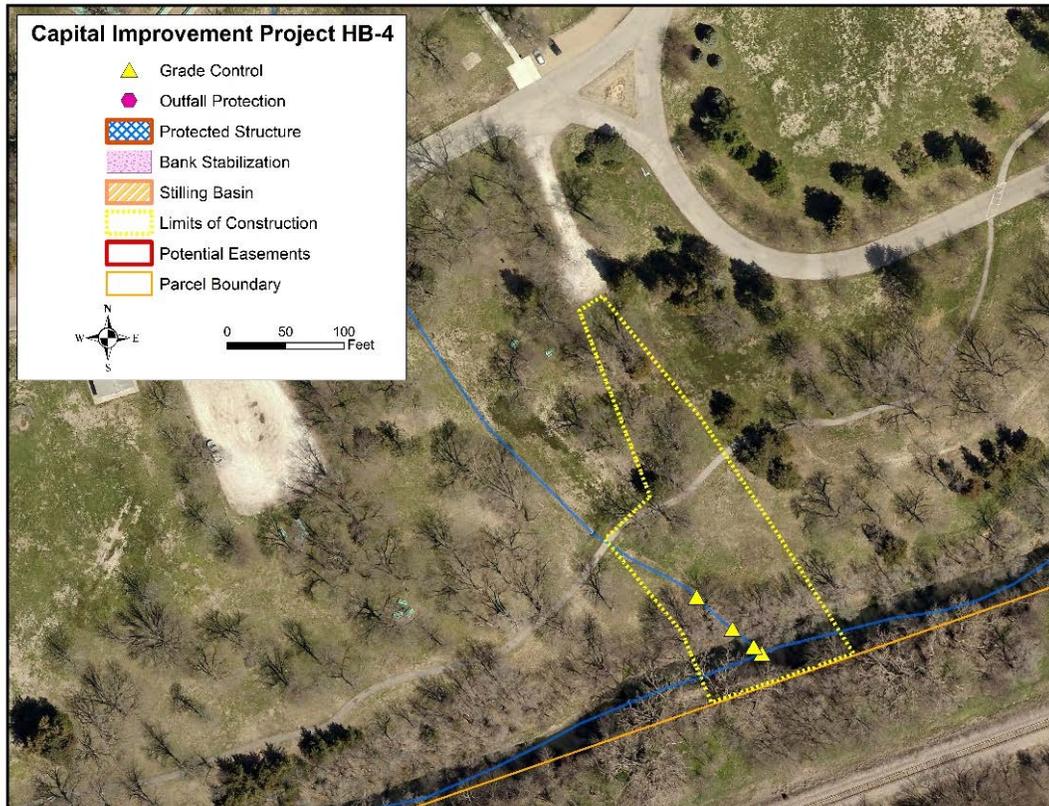
Figure 7-12: Conceptual Layout of HB-4

Problem description: At this location there is an existing knickpoint in tributary HB0040R005 at the confluence with the main stem within Pioneers Park. The knickpoint is stabilized by an existing rubble grade control that is actively failing. This project will protect the pedestrian trail from channel erosion. When entering South Pioneers Park from S Coddington Ave, take the left at the first “Y” in the road. The access will be located directly before the next “Y” in the road. Project will be located on the left side of the road near the RR tracks. Potentially affected parcels are public property.

Recommendation: Remove existing failing grade control and construct one or more new grade controls to stop incision and protect the tributary and park.

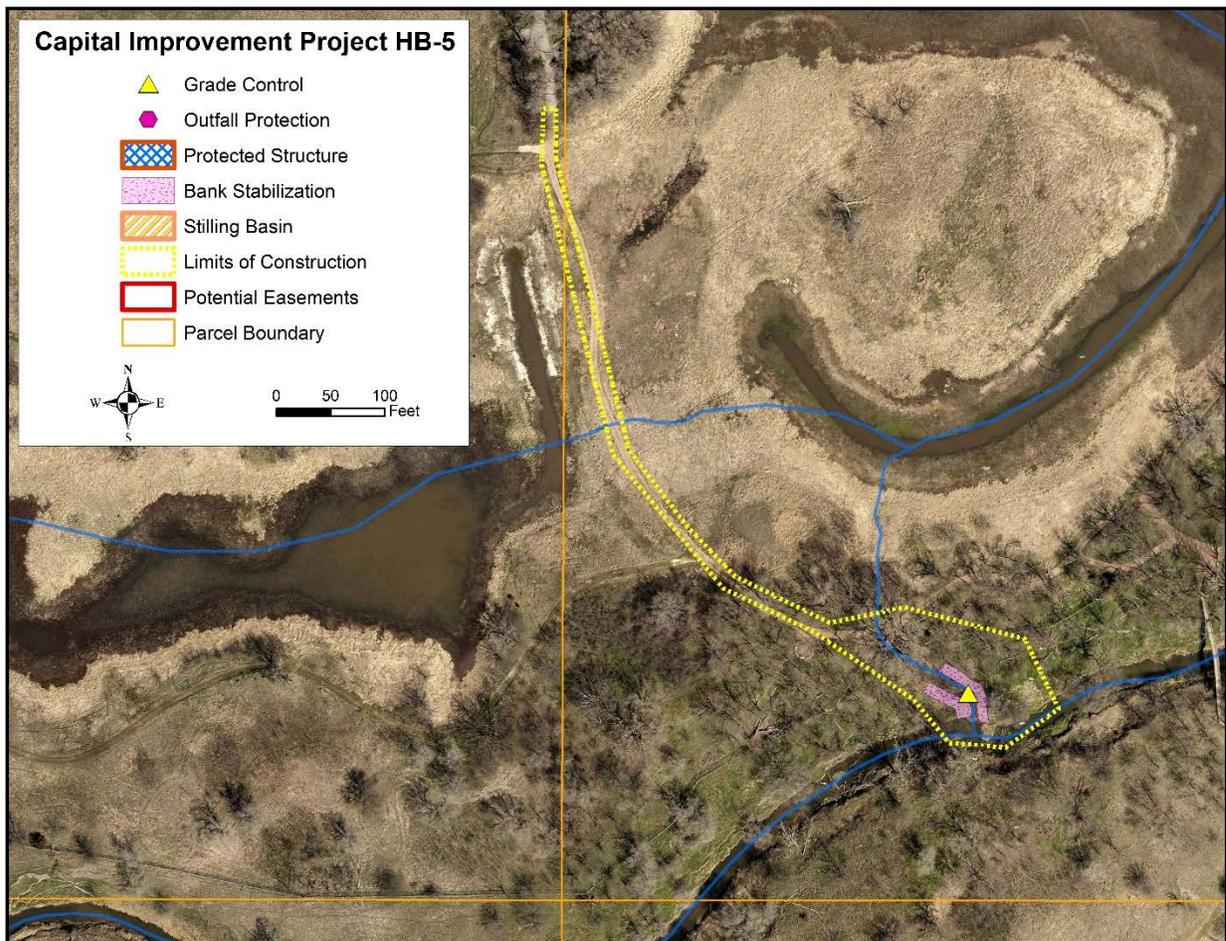
Figure 7-14: Conceptual Layout of HB-5

Problem description: Knickpoints and erosion in tributary HB045R005 from the main stem to the outfall at the fence line on the southwest side of the Nature Center is potentially threatening the outfall. Access for this project is through the Nature Center from the southwest corner of the Pioneer Park Golf Course. Potentially affected parcels are public property.

Recommendation: Construct multiple grade controls and associated bank stabilizations to stabilize the tributary and stop incision.

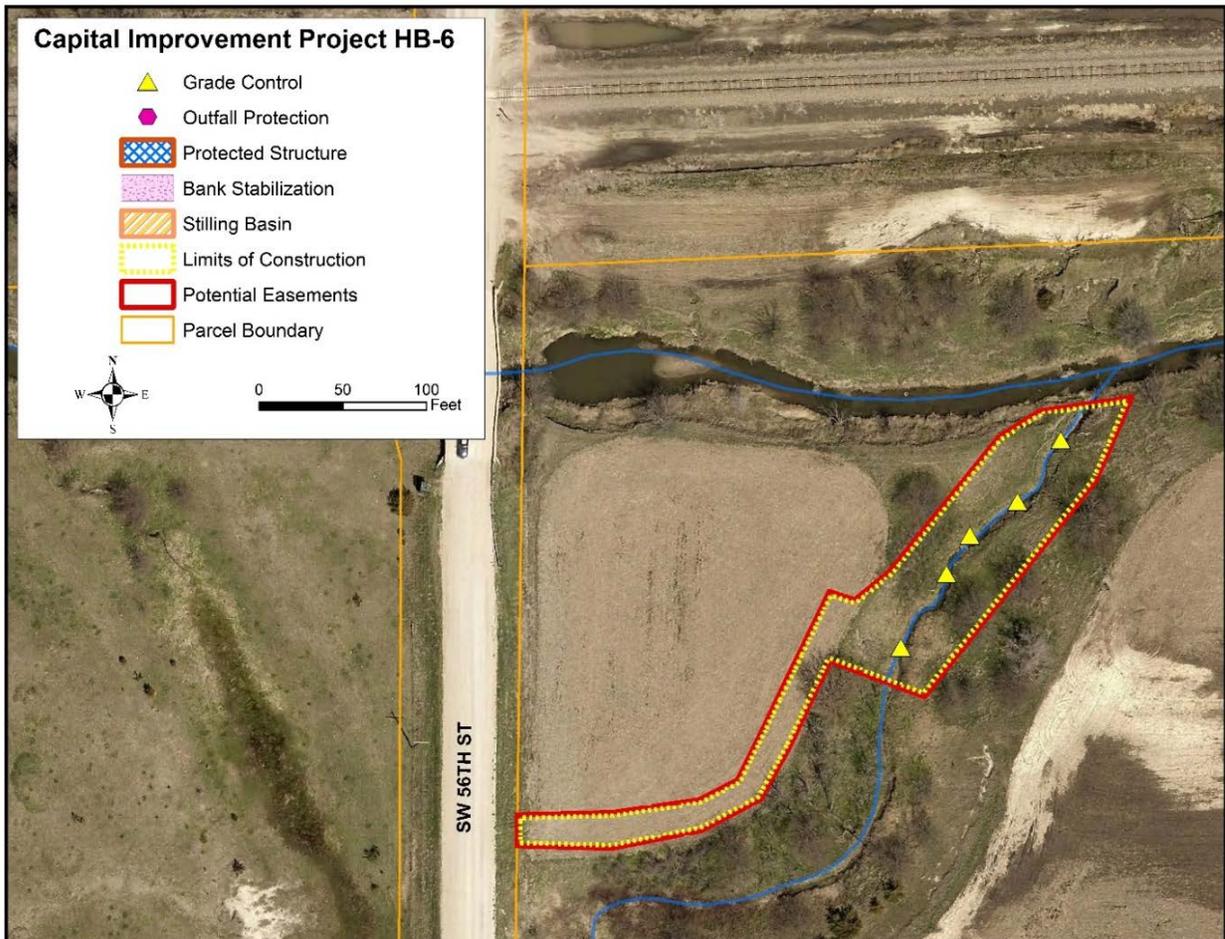
Figure 7-16: Conceptual Layout of HB-6

Problem description: Knickpoint in the tributary HB055R005 near its confluence with Haines approximately 400 feet downstream of SW 56th St. The access is approximately 0.2 miles north of the SW 56th St and W Claire Ave intersection. Potentially affected parcels are private property.

Recommendation: Construct grade controls to stabilize tributary and stop incision.

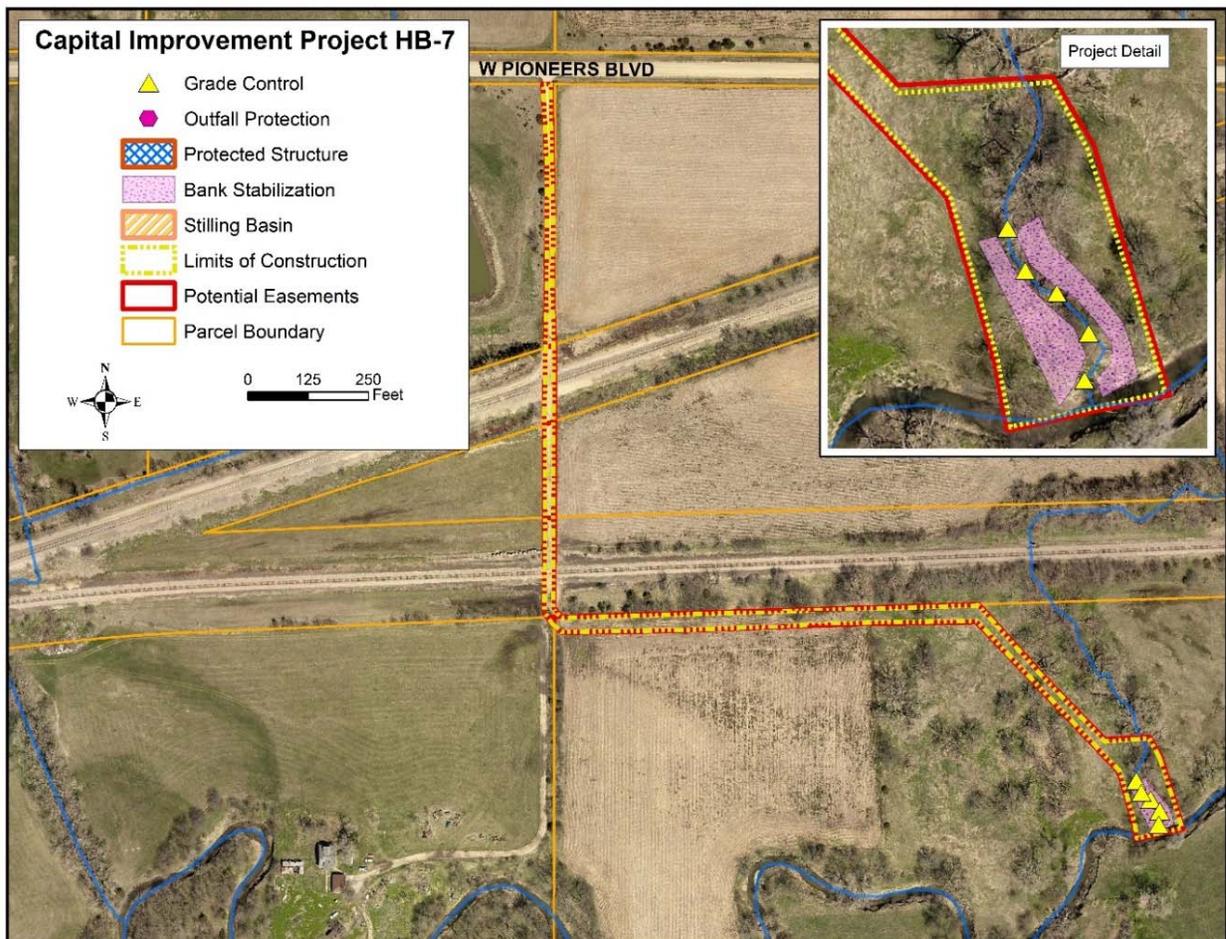
Figure 7-18: Conceptual Layout of HB-7

Problem description: A large woody debris jam is holding up a greater than five foot tall knickpoint at the tributary HB070R005 confluence located approximately 1,500 feet south of W Pioneers Blvd. Potentially affected parcels are private property. Potential access may follow along an existing driveway and will cross two railroad lines.

Recommendation: Remove debris jam and replace with grade control and associated bank stabilization to stop incision.

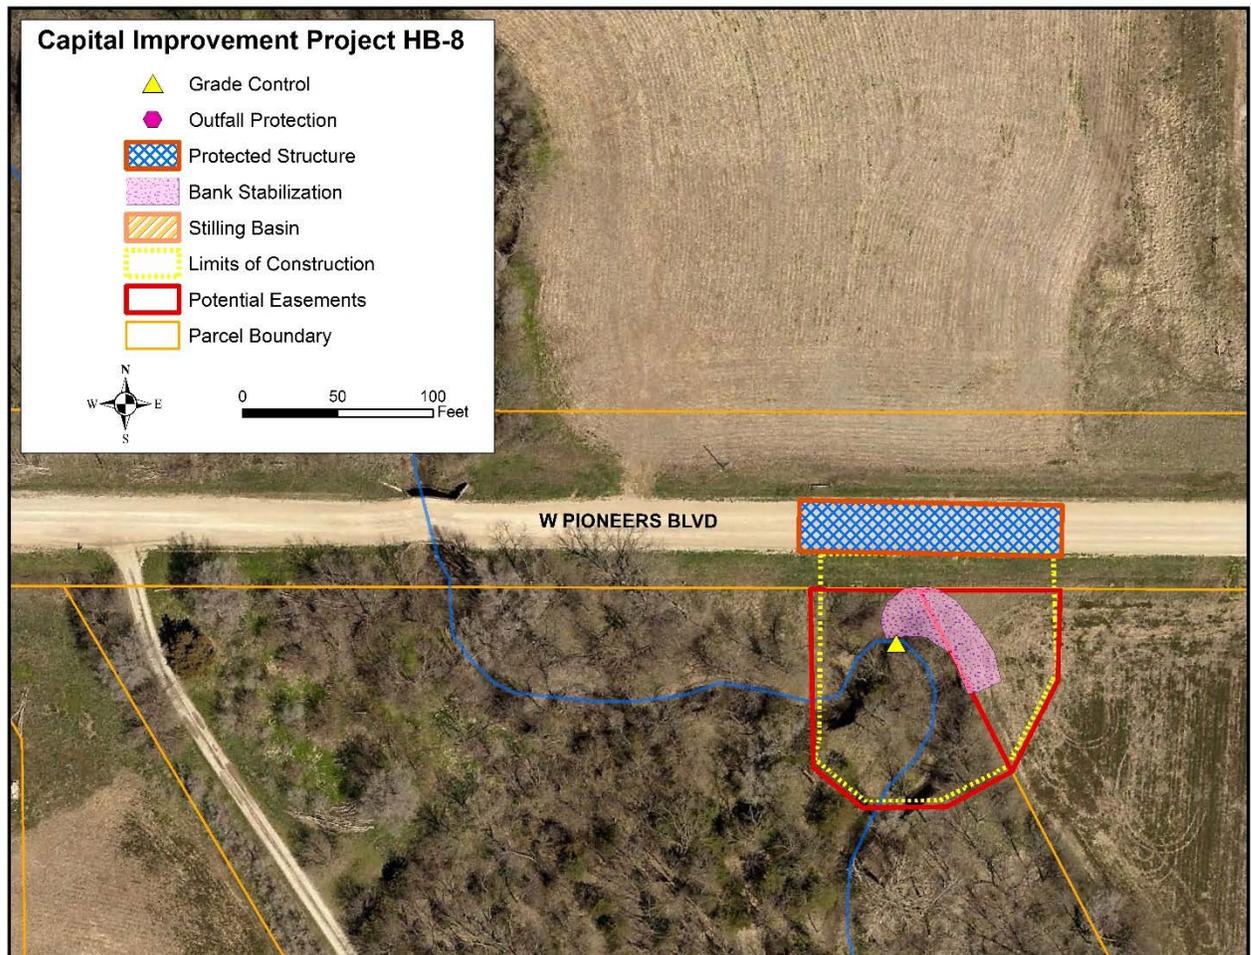
Figure 7-20: Conceptual Layout of HB-8

Problem description: Bank erosion on tributary HB080R005 is threatening W Pioneers Blvd located approximately 1,520 feet east of SW 84th St and W Pioneers Blvd. Potentially affected parcels are both public and private property.

Recommendation: Construct bank stabilization with associated grade controls to stop erosion and protect the road. Include culvert outfall protection for the storm outfall on the right descending bank.

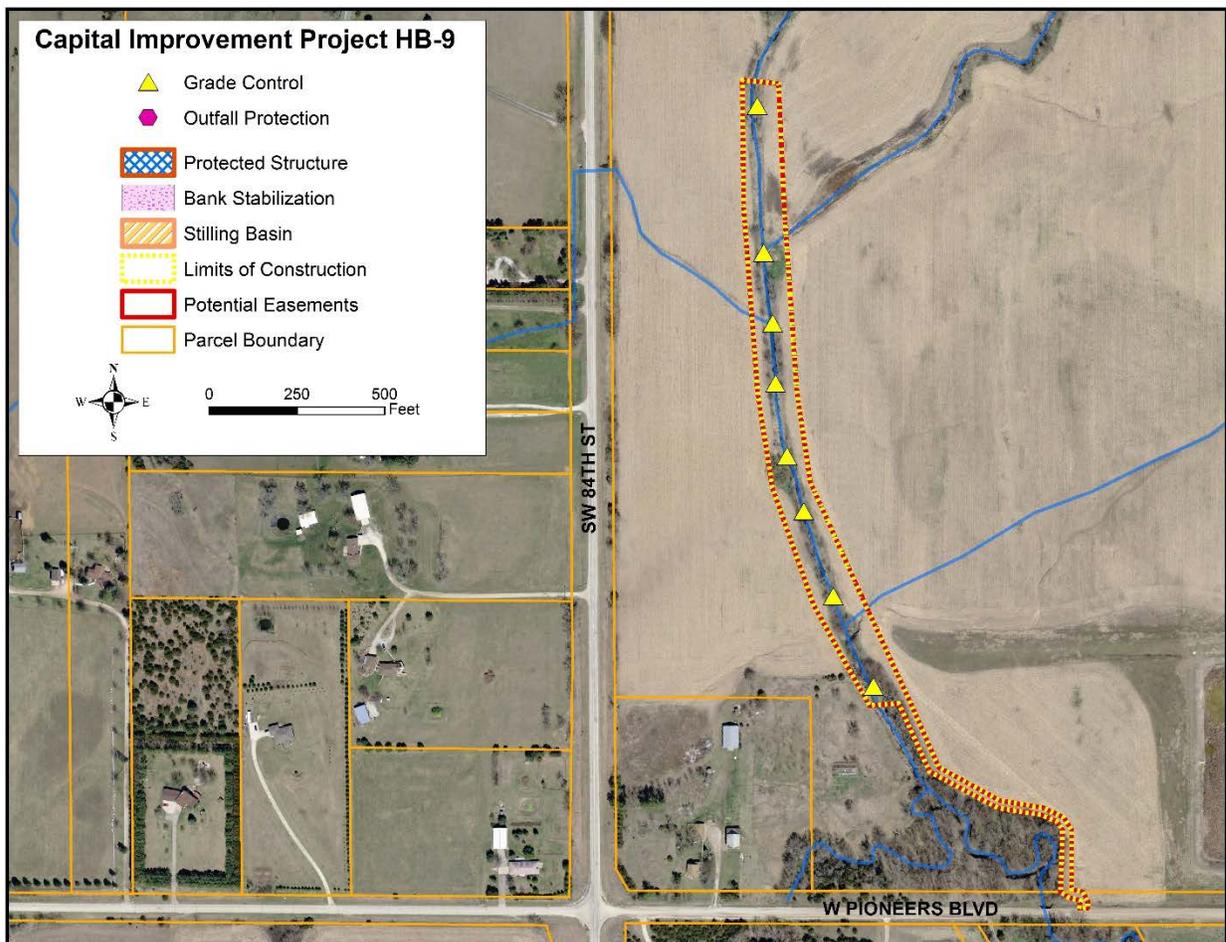
Figure 7-22: Conceptual Layout of HB-9

Problem description: Multiple knickzones and active incision exists along a 1,700 foot section of tributary HB080R010 located east of SW 84th St and north of W Pioneers Blvd. Potentially affected parcels are private property.

Recommendation: Construct multiple grade controls along this reach to stop incision. There is approximately 14 feet of vertical drop in the profile elevation from the upstream to the downstream limit of this reach.

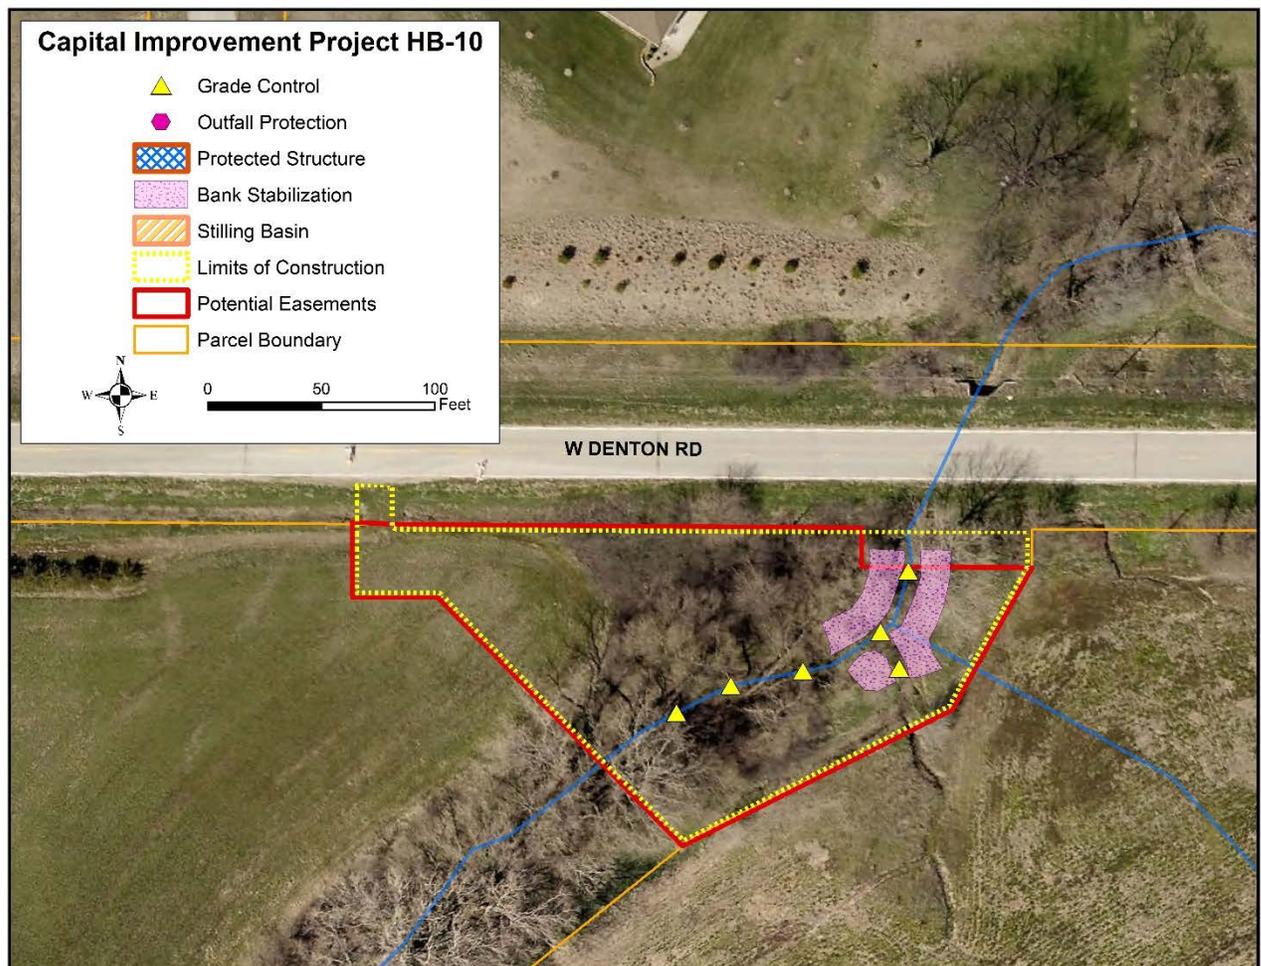
Figure 7-24: Conceptual Layout of HB-10

Problem description: 4 foot knickzone on the tributary HB035R040 immediately upstream of the W Denton Rd culvert (County Structure N-129) located 250 feet east of SW 60th St. potentially affected parcels are private property.

Recommendation: Construct a series of grade controls and associated bank stabilization to stop incision.

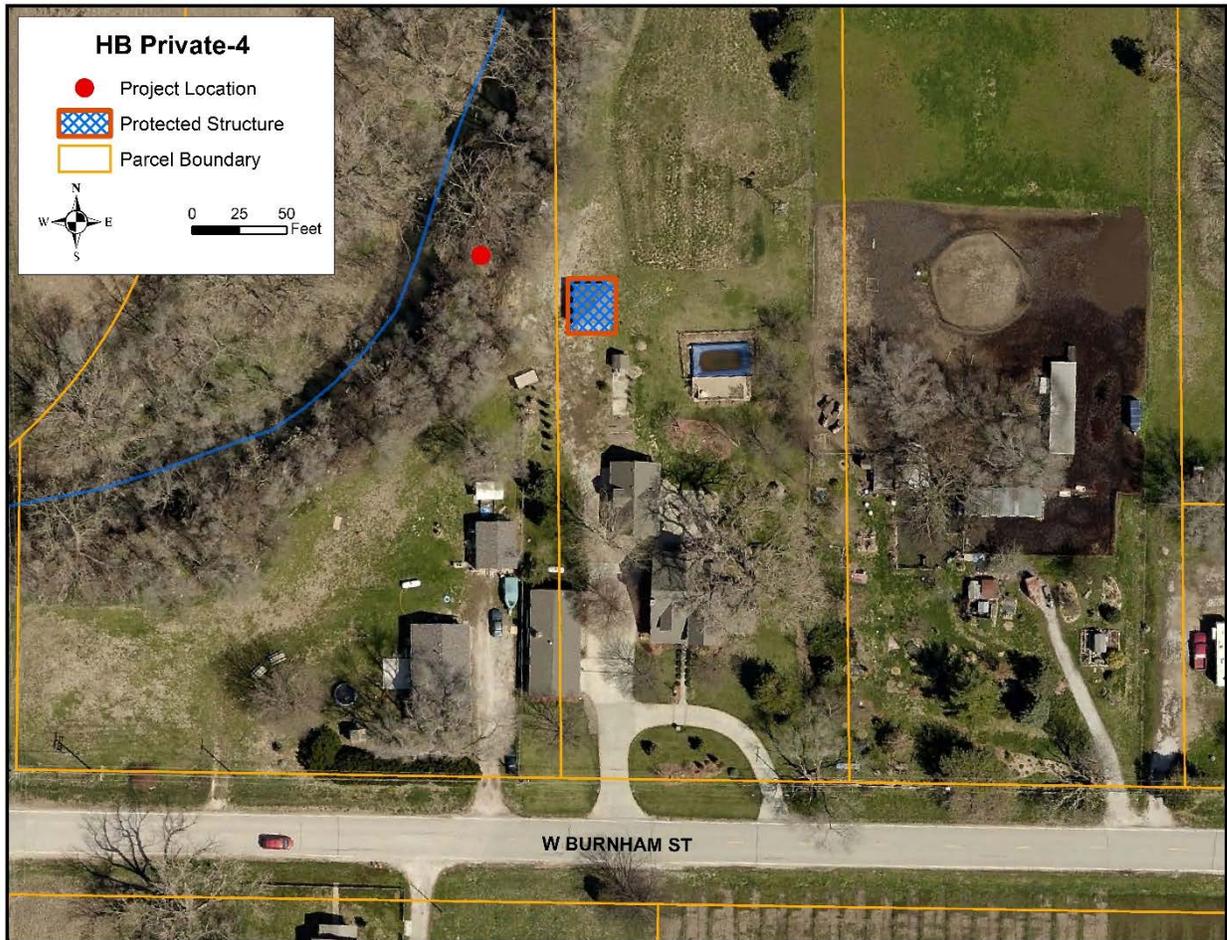
Figure 7-42: HB Private-4 Project Location

Problem description: Eroding high bank on Haines Branch main steam HBR020 is threatening private outbuilding structure at the top of bank located 440 feet northeast of the intersection of S Coddington Ave and W Burnham St.

Recommendation: Notify the owner of the threat of bank erosion to the structure.
