Section 7

Fluvial Geomorphic Evaluation

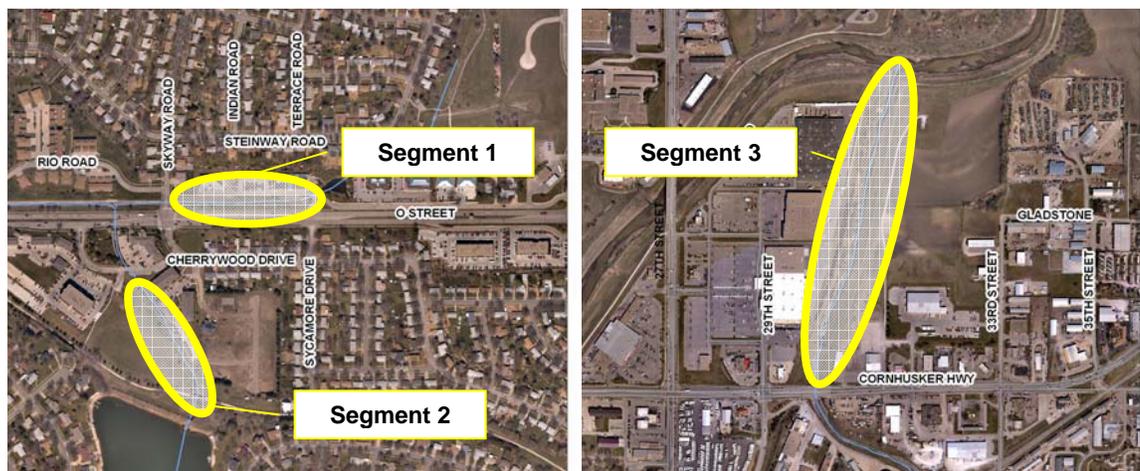
Figure 7-1
Geomorphic Evaluation Stream Segments

The purpose of the Deadmans Run geomorphic investigation was to determine the geomorphic conditions of three stream segments, including two unlined stream segments of the main stem and one unlined tributary segment. By understanding the geomorphic conditions of the watershed, the locations and prioritizations of interventions can be determined for managing the main stem and tributary. Primary elements of this investigation included a field reconnaissance and classification of the current condition of the waterways along the following segments of the Deadmans Run Watershed (Figure 7-1):

- Segment 1: Tributary upstream of Sycamore Drive Extension to Skyway Road
- Segment 2: Main channel downstream of Wedgewood Lake to Corporate Drive
- Segment 3: Main channel extending from Cornhusker Highway to the confluence with Salt Creek

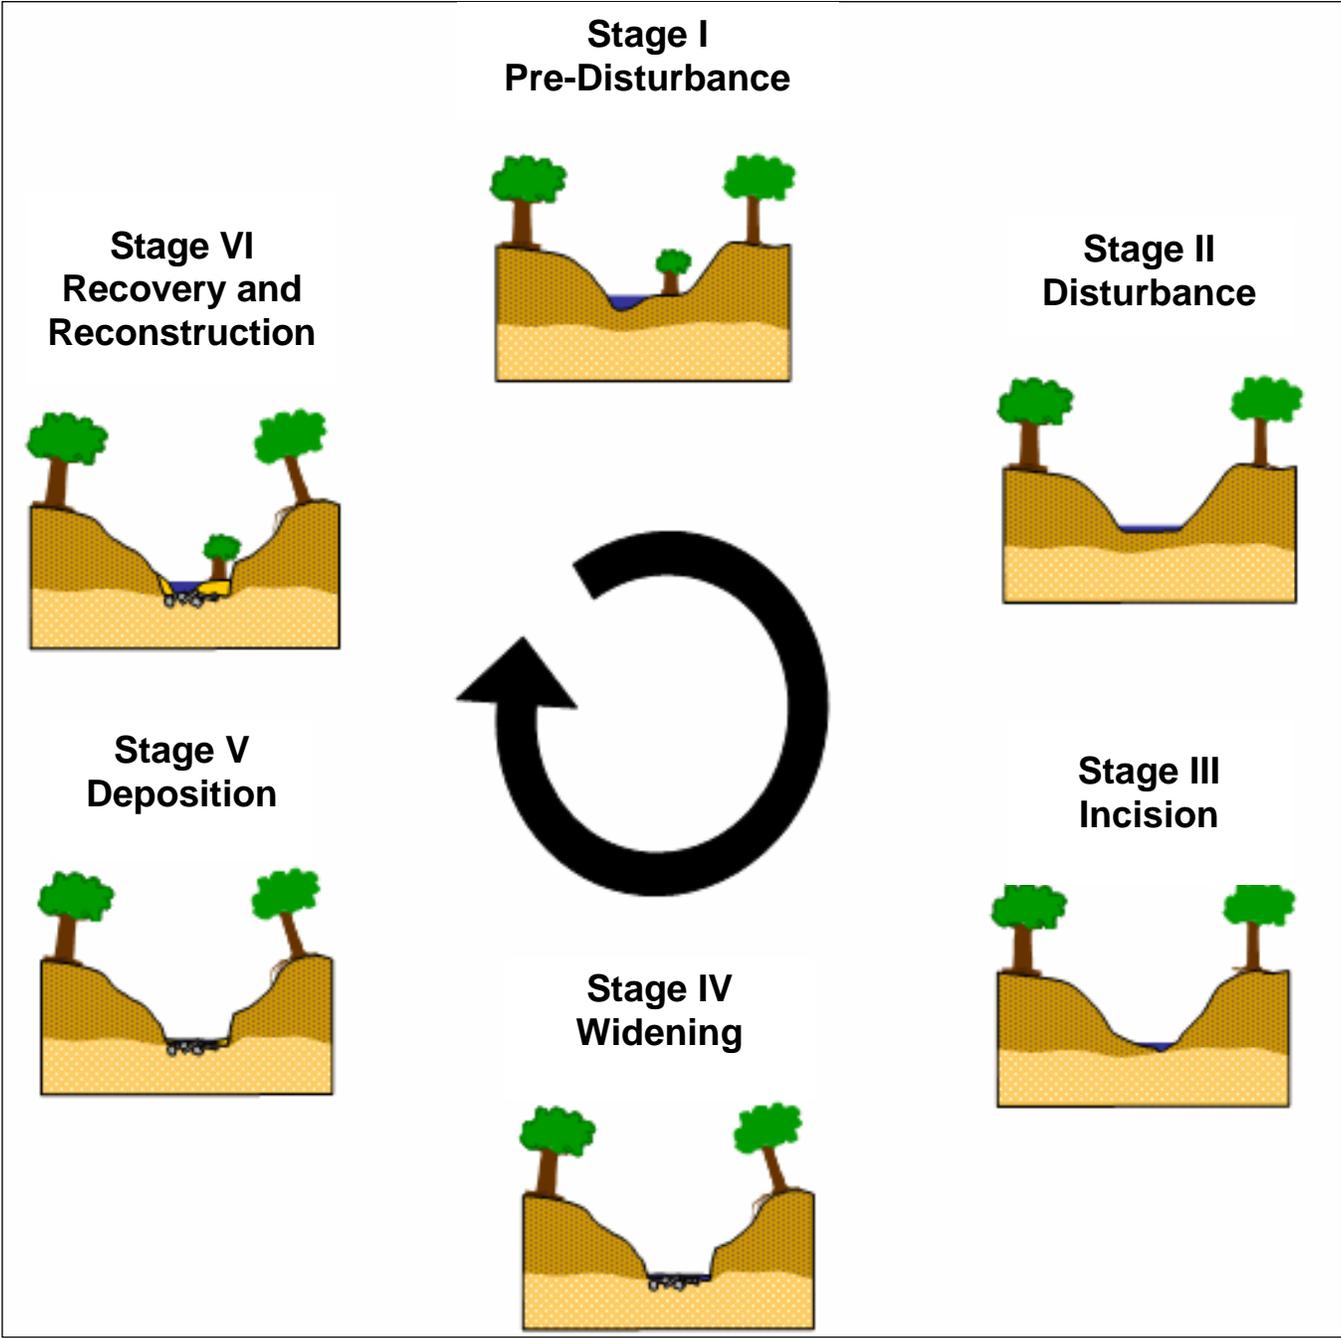
Figure 7-4
Channel Evolution Model (Simon 1989)

As summarized above, one of the key objectives of the evaluation was to evaluate the current conditions of the stream system. Schumm (1984) and Simon (1989) have classified the process of how streams reestablish equilibrium after a disturbance to the channel or the watershed. Simon classifies this reestablishment into six stages: I) Pre-Disturbance, II) Disturbance, III) Incision, IV) Widening, V) Deposition, and VI) Recovery and Reconstruction. Figure 7-4 schematically depicts each of these stream stages.

Evidence of incision and active meandering as seen in the historical aerial photographs was not observed. The 6- to 8-inch diameter pieces of crushed limestone in the channel have apparently abated incision since repairs to the banks and channel. However, current practices of mowing the shallow-rooted grass as close as possible to the waters edge (including rushes) and close to the ground have seriously reduced the potential of filtering surface water before it reaches the channel and of the roots reinforcing the banks. Several areas of the banks were scalped to bare ground, thus eliminating the potential for the turf grasses from reinforcing the near surface and providing a stormwater buffer. The combination of shallow-rooted grasses along the banks and current mowing practice may have initiated the bank instabilities in the past. Using Simon's Classification for urban channel evolution as seen on Figure 7-4, this reach is classified as Stage V/VI.

Downstream of the pedestrian bridge, the tributary is wider and appears to form a backwater condition upstream of the Corporate Drive crossing. Erosion is not a factor for this portion of the stream reach and sedimentation is less of a concern because of the limited sediment source along the banks and the upstream sediment sink of Wedgewood Lake. The main limiting factor for this portion of the reach is the narrow vegetative buffers along either side of the tributary. Algae and duckweed were of limited presence, but the potential for both species thriving following the loading of nutrient-rich surface waters flowing to the channel was apparent. Using Simon's Classification for urban channel evolution, this reach is classified as Stage V/VI.

Between Outfall 3 and Outfall 6, localized bank degradation is observed, where the flows have acted as turning vanes. Sedimentation through bar deposition is prevalent along the entire unlined portion of this reach. The bars within the re-meandering segment are irregular, which would be expected. Downstream of Outfall 6, the bars become somewhat more regular-shaped. Closer to the confluence with Salt Creek, submerged ripples and megaripples of sand along the channel bottom are prevalent. Using Simon's Classification for urban channel evolution, this reach is classified as Stage IV/V.
