LINCOLN, NEBRASKA  
BLIGHT & SUBSTANDARD DETERMINATION STUDY.

***“PIEDMONT  
REDEVELOPMENT AREA.”***

**HANNA:KEELAN ASSOCIATES, P.C.  
COMMUNITY PLANNING & RESEARCH**

August, 2013

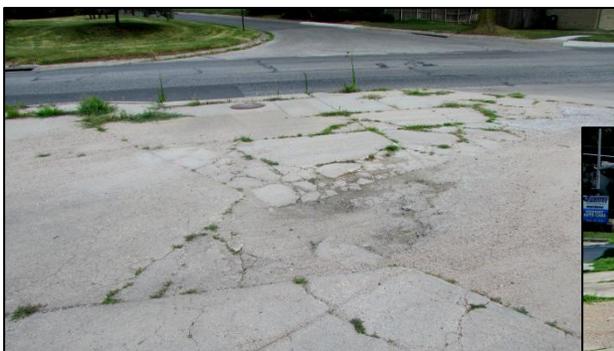
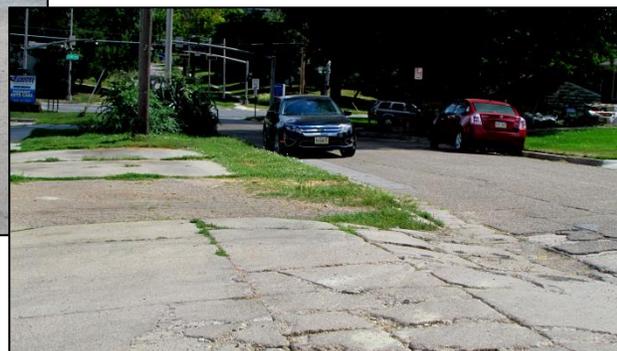
*The prevailing substandard conditions, evident in buildings and the public infrastructure, as determined by the field survey, include:*

1. Age of structures in excess of 40+ years of age;
2. Masonry buildings with wooden structural components in buildings as potential fire hazards; and
3. Portions of the **Piedmont Redevelopment Area** having utility mains that have deteriorated due to excessive age and obsolete materials.
4. Concrete sidewalks and driveway entrances that are cracked, broken and have sections settling that are hazards to pedestrians.

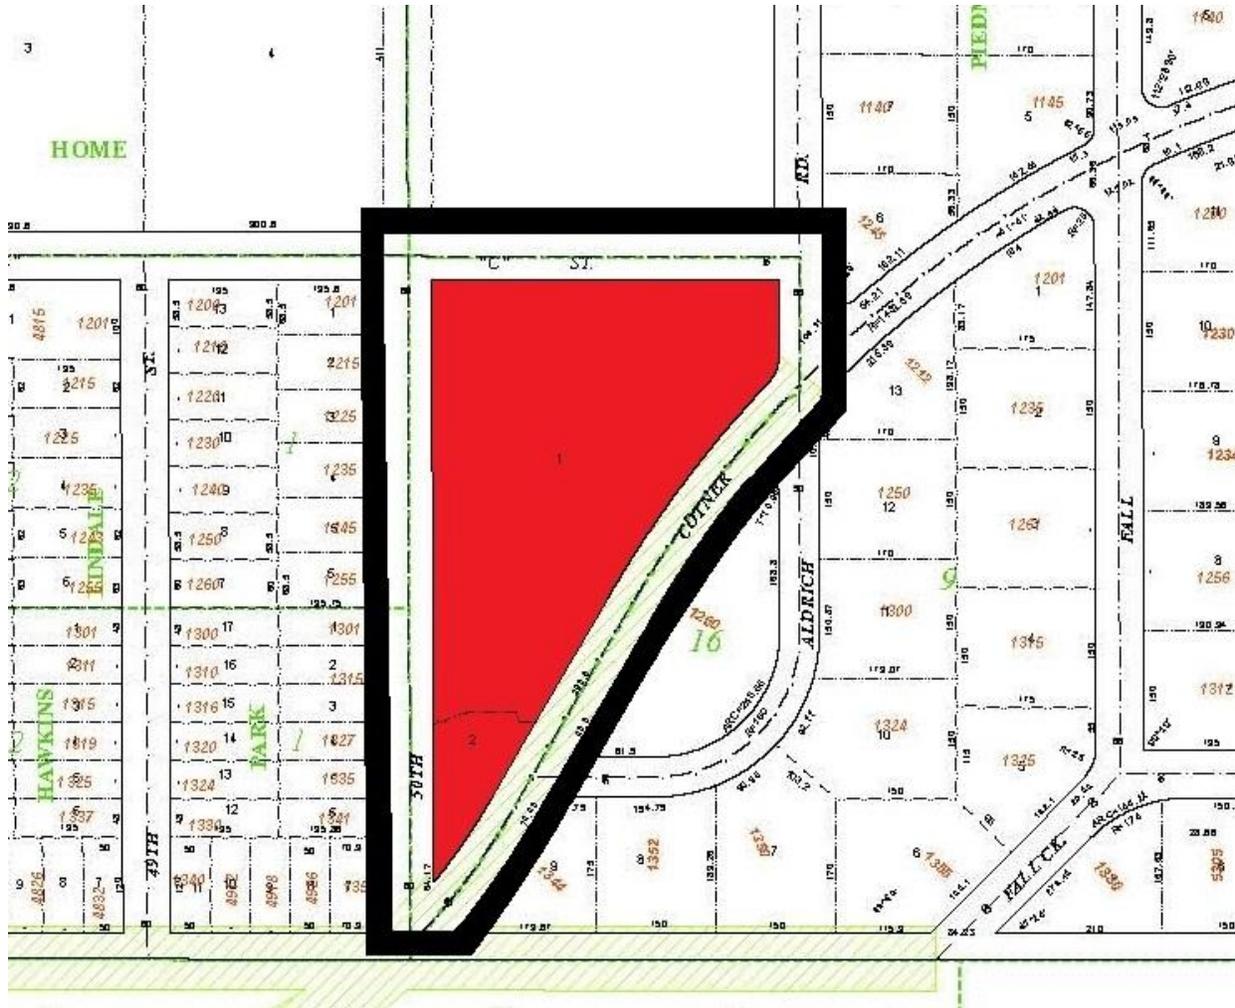
# EXISTING LAND USE MAP

PIEDMONT REDEVELOPMENT AREA  
LINCOLN, NEBRASKA

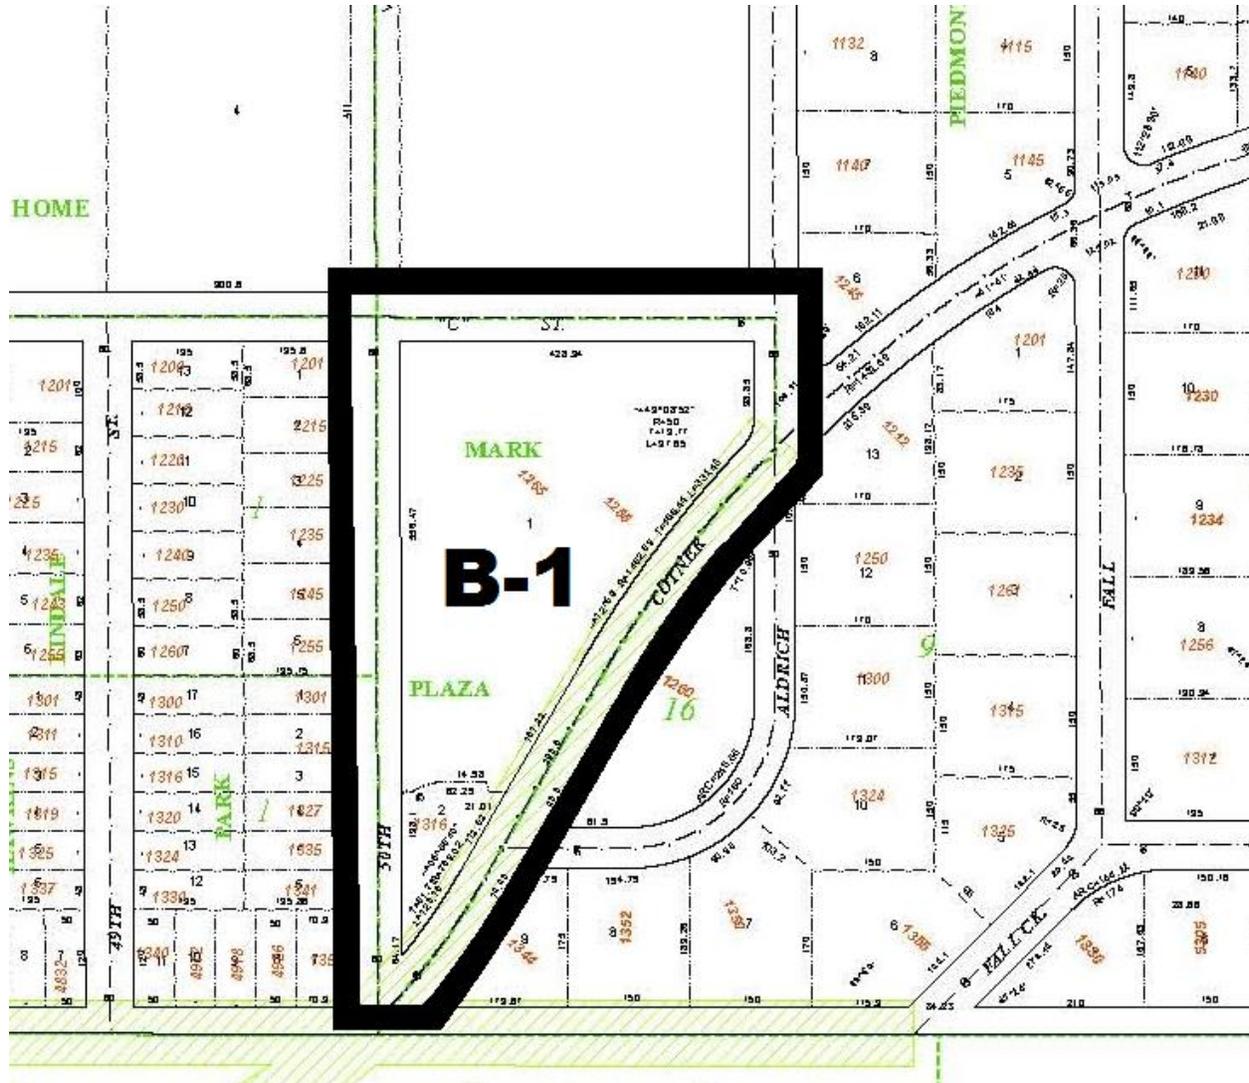
# EXISTING ZONING MAP

PIEDMONT REDEVELOPMENT AREA  
LINCOLN, NEBRASKA

B-1 Local Business District

**Illustration 3** identifies the existing **Zoning Classification** within the **Piedmont Redevelopment Area**. Zoning activities throughout the **Piedmont Redevelopment Area** are administered by the City of Lincoln. The entire **Area** is zoned “**B-1**” **Local Business District**, which is appropriate for the existing land use.

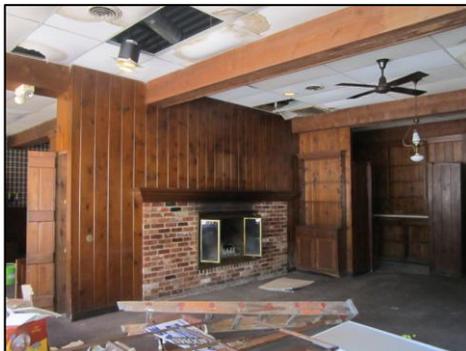
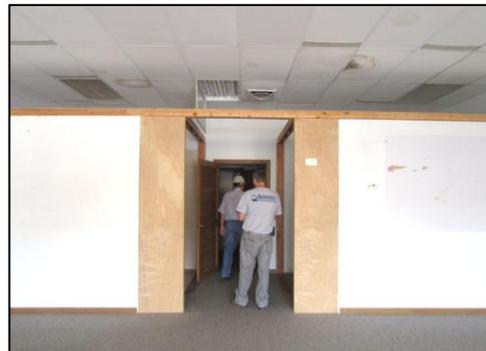
The results of the structural condition survey indicate deteriorating structures are a strong presence throughout the **Piedmont Redevelopment Area**. Table 5 identifies the results of the structural rating process per building type.
