Using Video Inspection for CIP Rehabilitation Planning Spring Meeting 2013

Brian A. Kramer, P.E.
Superintendent of Collection
City of Lincoln, Wastewater
bakramer@lincoln.ne.gov

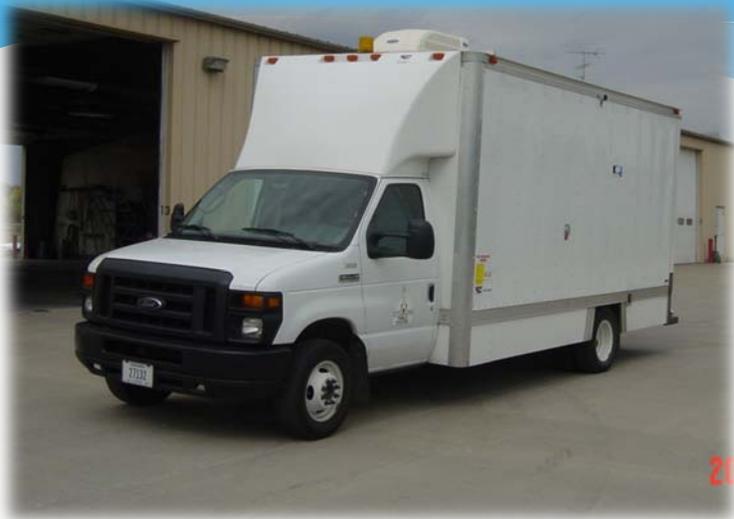
LWWS Equipment and Crew

- * There are 2 – T.V. trucks
- * With crews of 2 people
- * Inspect 100 mile annually
- * Truck equipped with multiple cameras

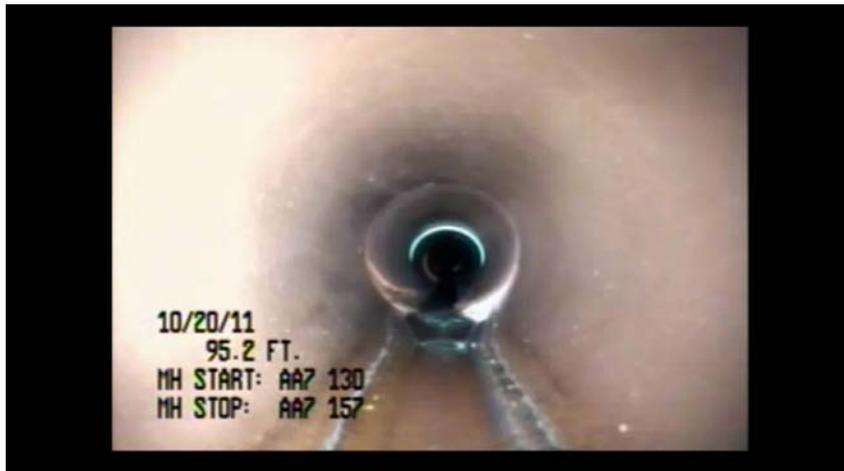
CIPP candidate

- * Line with roots

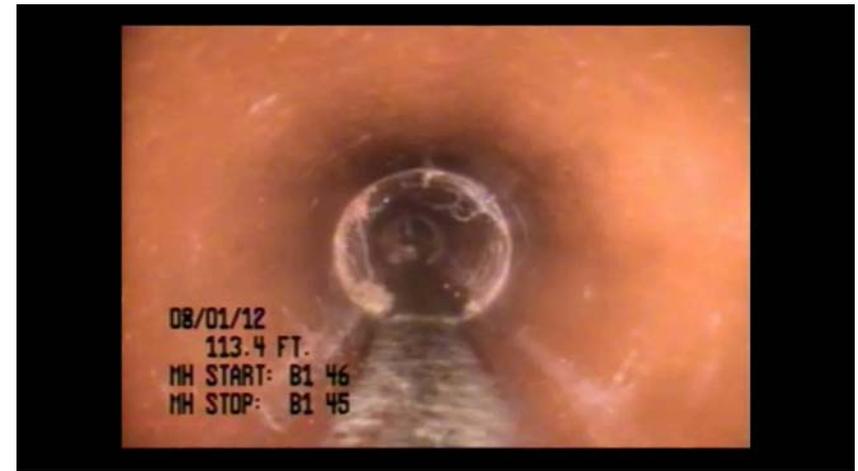
CIPP candidate

Line with deformities

Line with low spot

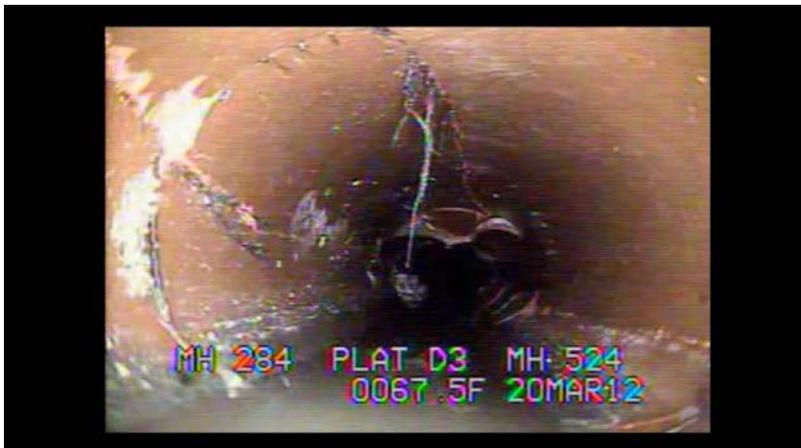
Spot lining

Spot Repair

- Line generally good shape
- Large voids
- Adjacent to services
- Large joint off sets

- Surface disruption ok
- Voids > 2' in length
- Deformities of pipe

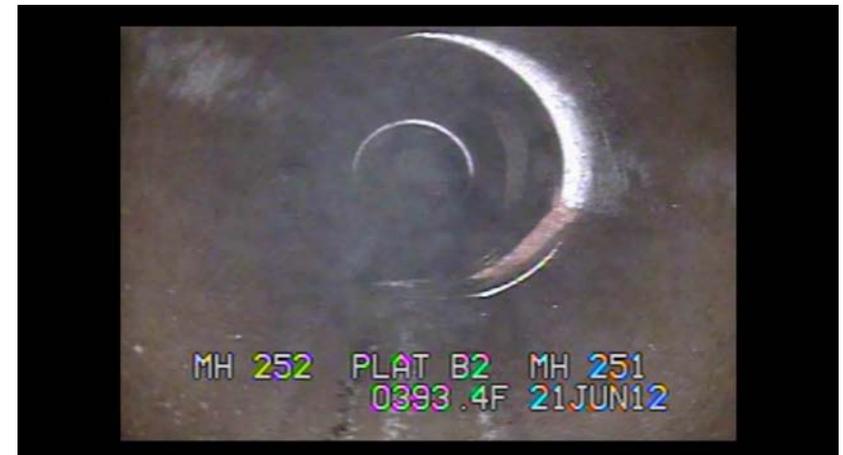
- Line generally good shape
- No large voids
- Not impacting services
- Surface issues

- No surface disruption
- Voids < 2' in length
- No Deformities of pipe

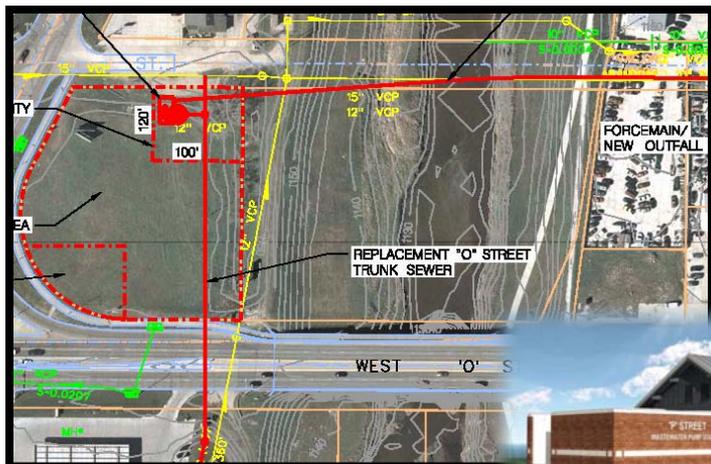
P Street Lift Station Replacement

- New Lift station
- 800' – 24" bore under salt creek
- 1500' – 30" outfall in P st.
- 1050' – 30" connection to West O trunk
