Appendix C. Transmission Main Condition Assessment

BLACK & VEATCH CORPORATION
Lincoln Water System
2020 Facilities Master Plan Update
Transmission Main Condition Assessment

B&V Project Number 401472
January 31, 2020

Condition Assessment of Water Transmission Mains

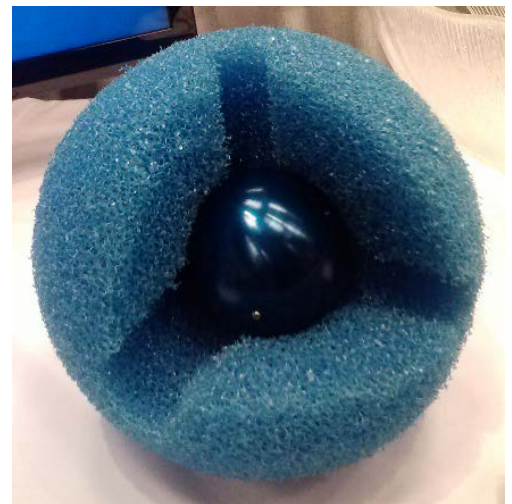
The SmartBall is inserted through a 4-inch tap and retrieved with a net that is inserted in the pipeline. The battery life is an estimated 15 hours and provides approximately 15 miles of inspection per insertion. The recommended segment of the 36-inch Transmission Main could be inspected with one insertion and retrieval.

Figure C-2 SmartBall Components

The SmartBall technology has been used in the United States for over 10 years and there are several case studies showing the advantages and disadvantages of this tool. The improved tracking of the tool with sensors spaced about 2,000 feet apart has reduced the potential to “lose” the ball during the inspection. The SmartBall has an inner core with the sensors protected by a foam outer layer as shown in Figure C-2. The sensor can detect very small leaks and air pockets since it is inside the pipe.
