PROPOSAL:

Greg Munn of BVH Architects requests a certificate of appropriateness for work at 1143 and 1149 S. 17th Street, in the Capitol Addition Landmark District.

Chi Phi Fraternity Expansion
1149 and 1143 S 17th Street, Lincoln NE

Project Narrative

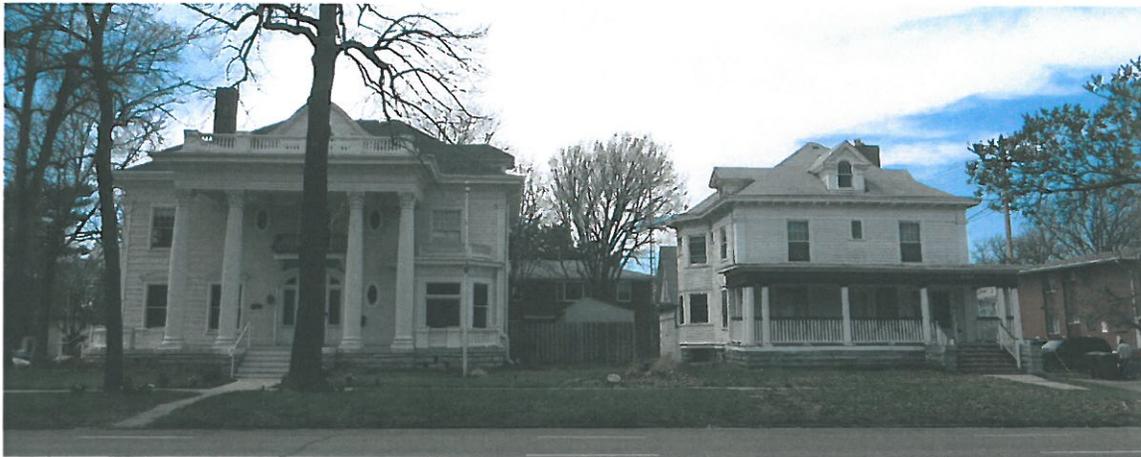
1149 S 17th St (left) and 1143 S 17th St (right)

Banker Morris Weil constructed the mansion at 1149 S. 17th Street in 1902-1903 south across the alley from William Jennings Bryan’s D Street house. Bryan was building his Fairview mansion east of Lincoln at the same time as Weil was building at 17th & C Streets, and contemporary accounts rated Weil’s house as second only to Fairview among Lincoln-area homes then under construction. The Weil House is one of a small group of Neo-Classical Revival style mansions located on or near 17th Street in the Near South Neighborhood. Among its unique features are the stone porch, which extends into stone terraces on either side, and the large dormer above the portico with a broken scroll pediment.

The house to the north, 1143 S. 17th Street, was built just a few years after the main house for Weil’s son Carl, who worked at his father’s bank. The carriage house for the mansion is located behind the son’s house.

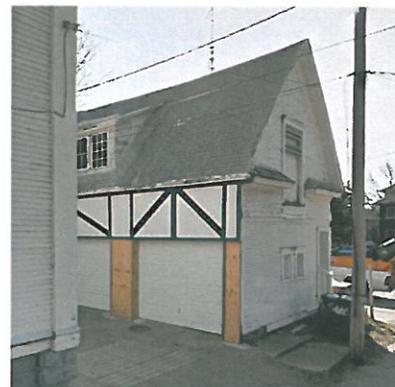
Carriage House

The Chi Phi Fraternity would like to use both houses, and proposes to link the two with an addition. Both houses are to be restored with like details and materials as original. This proposal would also demolish the carriage house behind the north house which is in poor condition and has been substantially altered.

Old asphalt parking area to be removed. Carriage house to be removed. New asphalt driveway to be constructed.

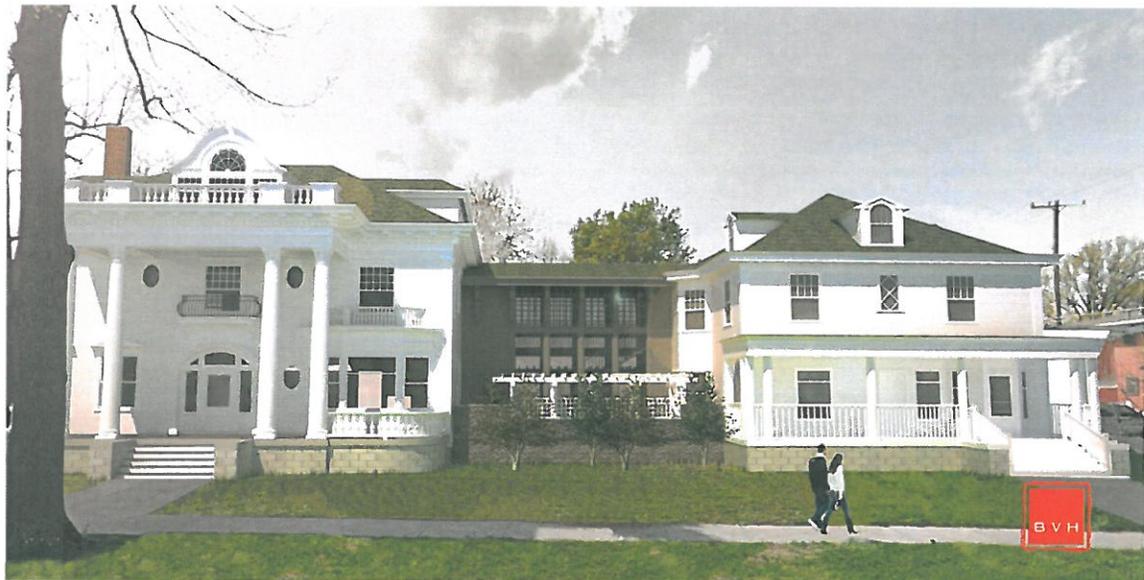
Proposed Design

The link is shown to be two stories and provide an outdoor area between the houses. It is not designed to look original, but draws details from the architecture of the two houses, like the pitched roof, eave brackets, and window muntins. The darker color provides a clear distinction between old and new, maintaining the visual appearance of two separate houses.

Overall the link is compatible in scale. The proportion of solids and voids may not exactly match the pattern of the houses, but it is appropriate that a structure connecting two houses be more transparent to further maintain the visual appearance of two separate houses.
